German Panzers 1914–18

Steven J Zaloga • Illustrated by Brian Delf

GERMAN PANZERS 1914-18

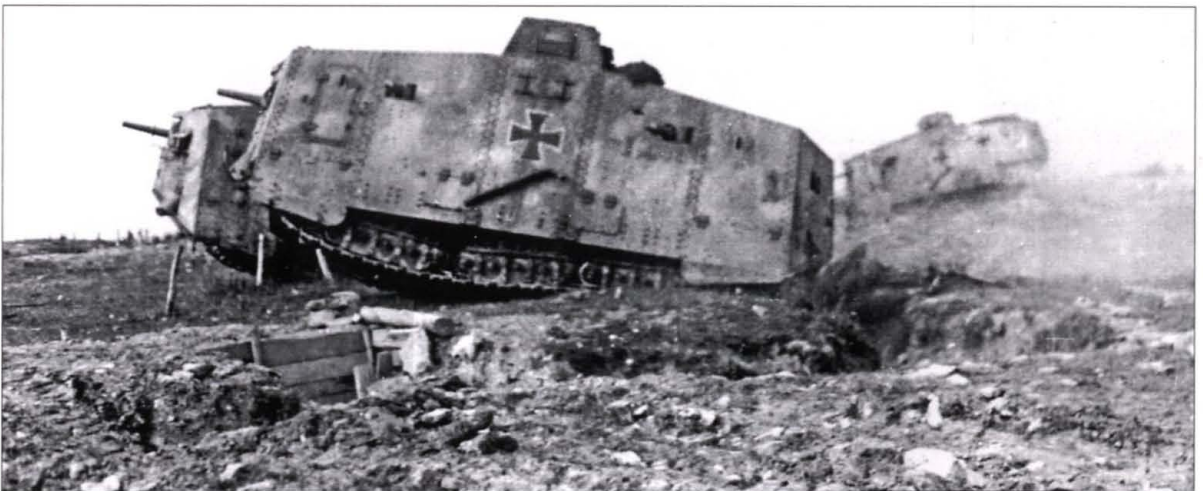
Panzer attack. A dramatic view of a trio of A7V tanks during a training exercise in the summer of 1918. (NARA)

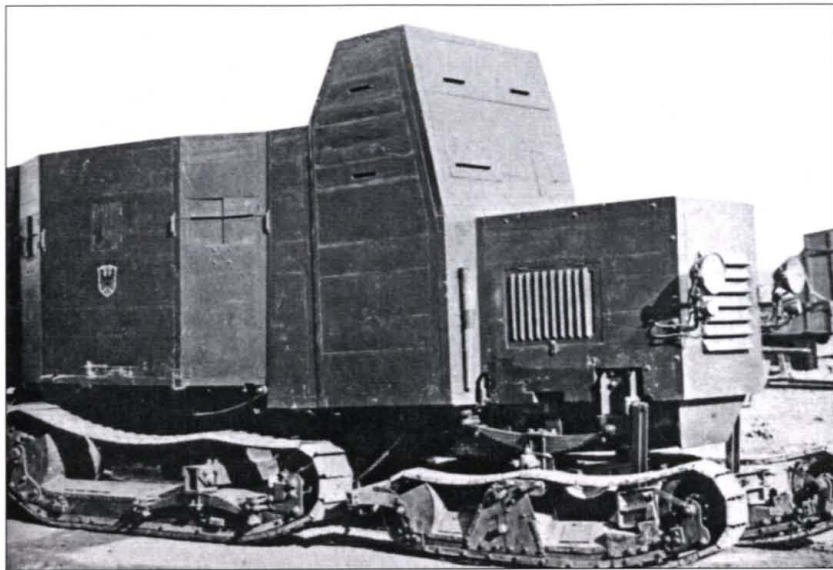
The first serious German effort to develop an armored fighting vehicle was an armored version of the tracked Bremer-Marienwagen. Even with only a mocked-up wooden superstructure, it proved to be hopeless in cross-country travel. (Patton Museum)

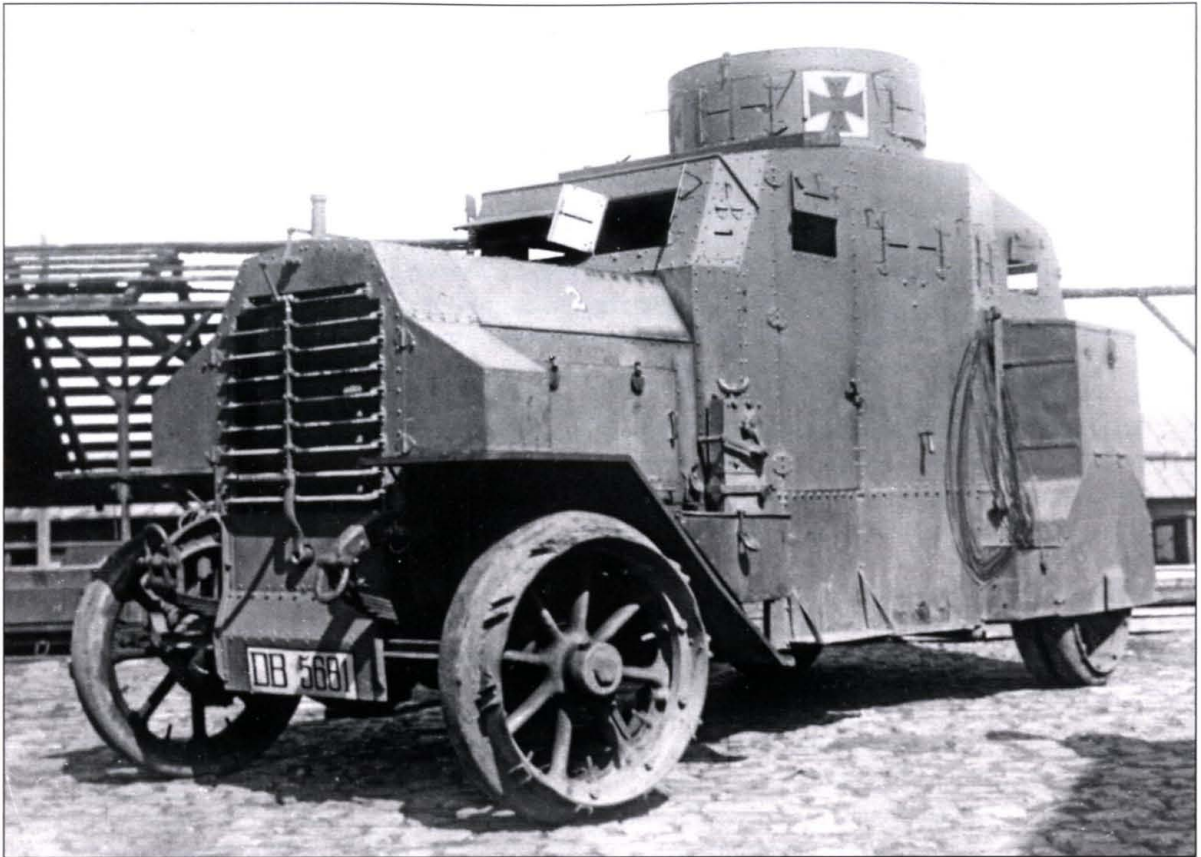
The only type of German armored car to reach serial production was the Erhardt E-V/4 in 1917. Most of these saw service in 1918 in Russia on occupation duty, which is when this one is seen in Rostov. (NARA)

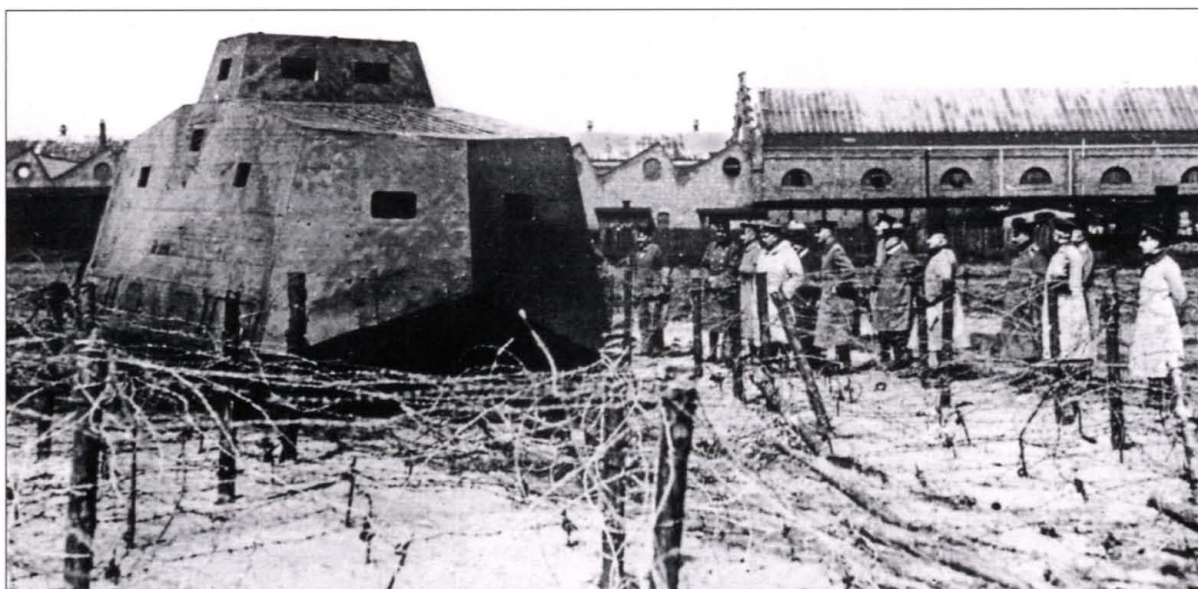
The A7V prototype with a mocked-up wooden hull is demonstrated for Kaiser Wilhelm II at the Daimler factory in Berlin-Marienfelde on June 19, 1917. Although not evident here, the prototype was fitted with a small unditching tail at the rear that did not carry over to the production tanks. (Patton Museum)

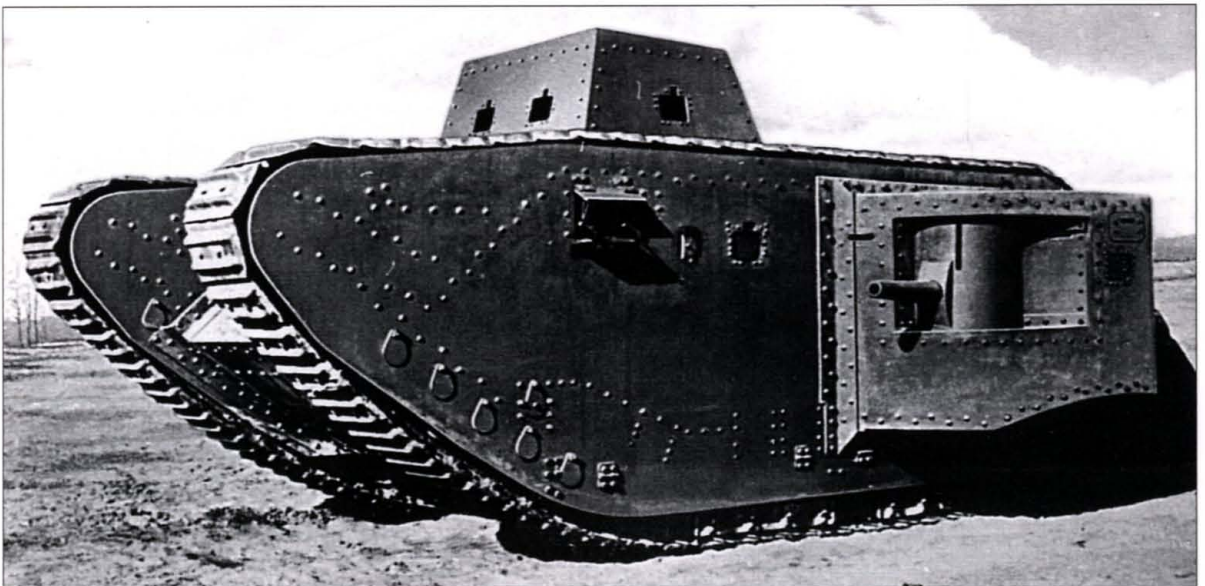
A single A7V chassis was built in the A7V-U configuration, mimicking the British rhomboid tank. Its late completion and poor performance prevented any serial manufacture. (Patton Museum)

Besides the pilot chassis 500 used as a driver trainer, at least ten other A7V chassis were assigned to other variants. The best known was 524, used as the basis for "Hedi," the A7V-U, which was completed in late June 1918 and used for trials. In April 1918, Chefkraft recommended a program to build 240 A7V-U's by 1919, but this did not take place due to its poor performance in trials. After testing, the A7V-U was assigned to the tank driving school of the Garde Kraftfahr battalions in Berlin and later dismantled. Three chassis were assigned to a project to develop an A7V-Flakpanzer for mobile antiaircraft defense. This resembled the Gelandewagen but had two 76.2mm antiaircraft guns on pedestal mounts on either side of the engine platform. Although photographs of these exist, little detail has survived about them. One of the more unusual applications for the A7V chassis was as a trench-digging machine – the A7V-Shützengrabenbagger. At least one was deployed in the field in late 1918. Two chassis were set aside for an A7V-Funkpanzer (radio-tank) based on a March 1918 order from the Signal Troops. Surviving drawings show a conventional A7V tank with multiple aerials and a "clothes-line" antenna circling the roof. The Graben-Funkstation 16 radio transmitter was tested for use on the A7V tank, but it is unclear if any radio-command tanks were ever built. One chassis was set aside for the Artillery Test Commission to examine its use as a heavy artillery tractor.

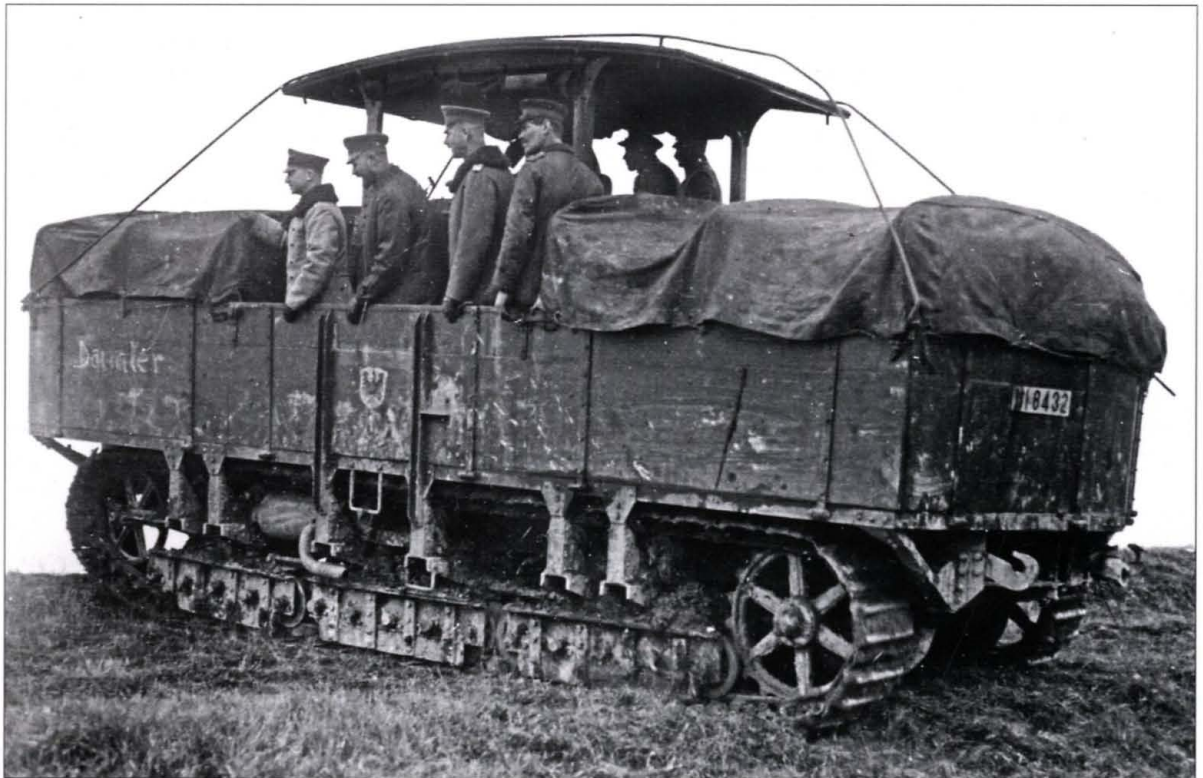
The first version of the A7V to enter production was the Gelandewagen prime mover, designed to bring critical supplies to the frontline troops across rough terrain. (NARA)

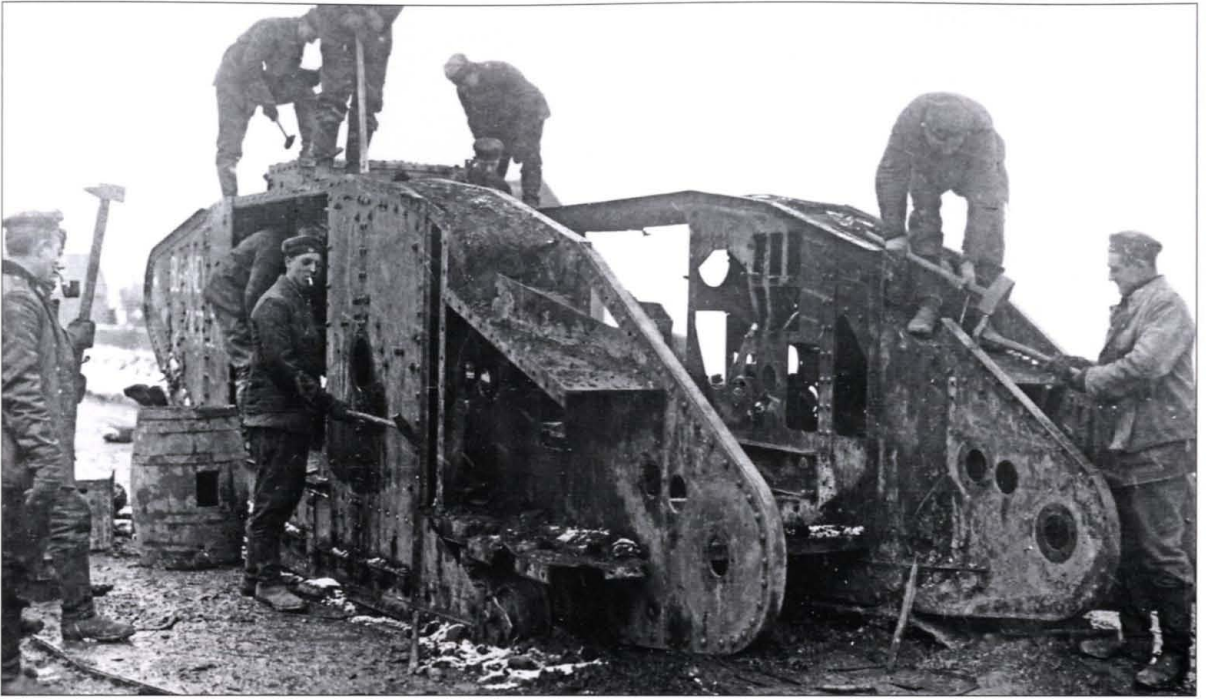
British Mark IV tanks recovered from the Cambrai battlefield were transported to the Germaine plant in Charleroi, where BAKP 20 (Bayerischer Armeekraftwagen Park 20; Bavarian Army Motor Vehicle Park 20) restored them to working condition before reissuing them to the new German captured-tank units. (NARA)

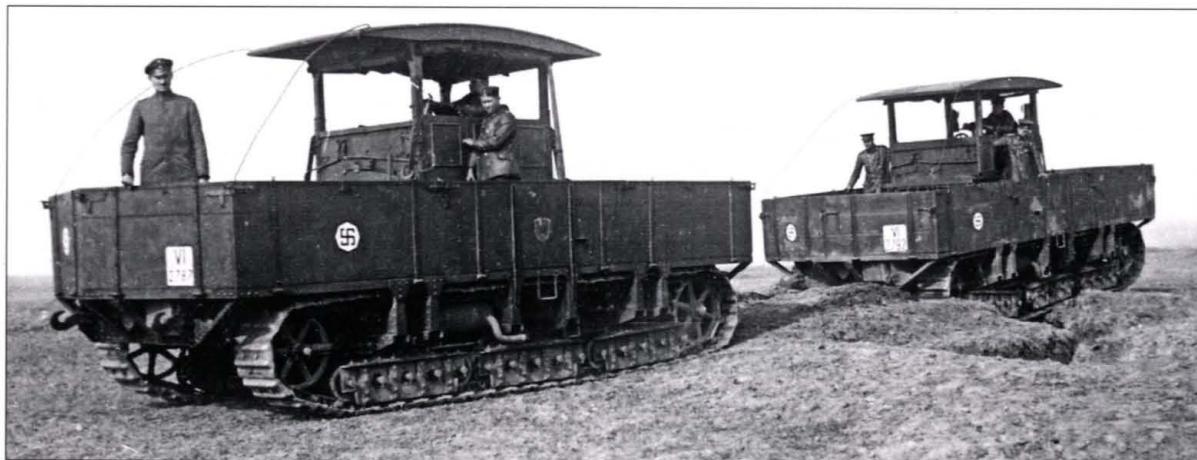
A pair of A7V Gelandewagen in service with the AKK(R) 111. Neither vehicle is carrying a load and this is probably a training exercise. The swastika in a white octagon insignia was the AKK(R) 111 tactical symbol. (NARA)

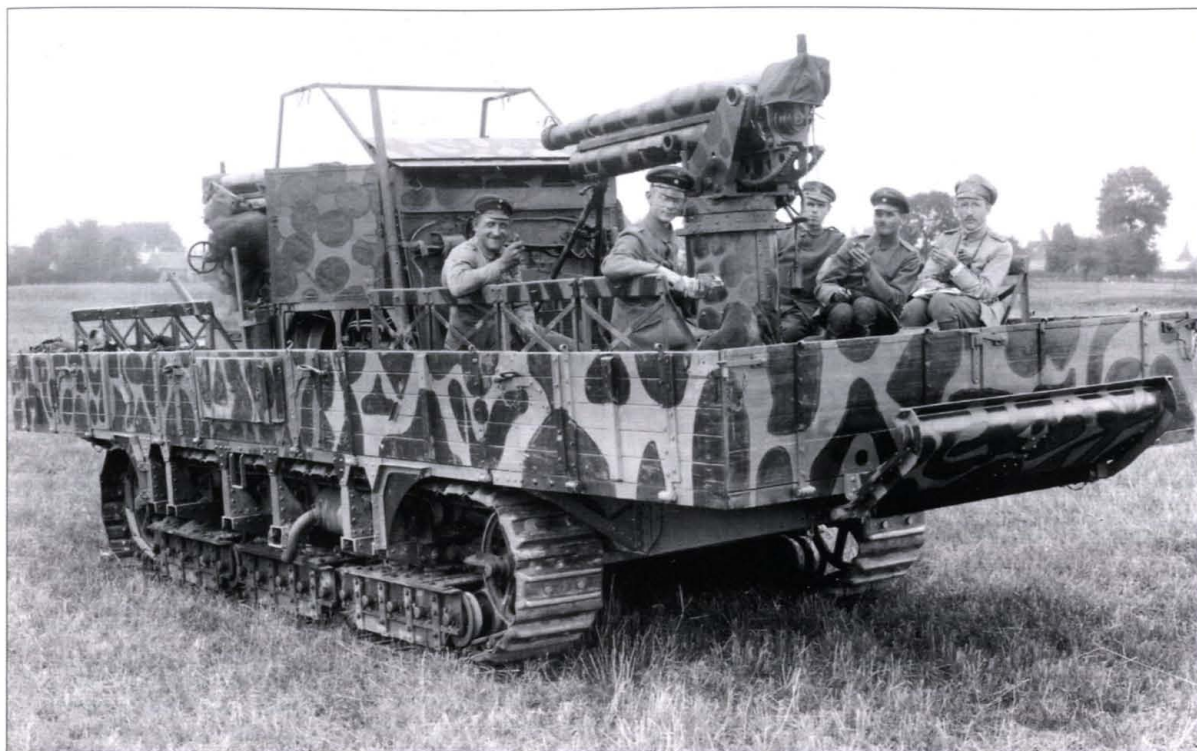
Three chassis were set aside to construct prototypes of the A7V-Flakpanzer, part of a broader effort to develop motorized antiaircraft batteries. The weapons appear to be captured Russian 76.2mm Model 1902 guns, which have had a new trunnion and elevation assembly added for high-elevation fire. (Thomas Anderson)

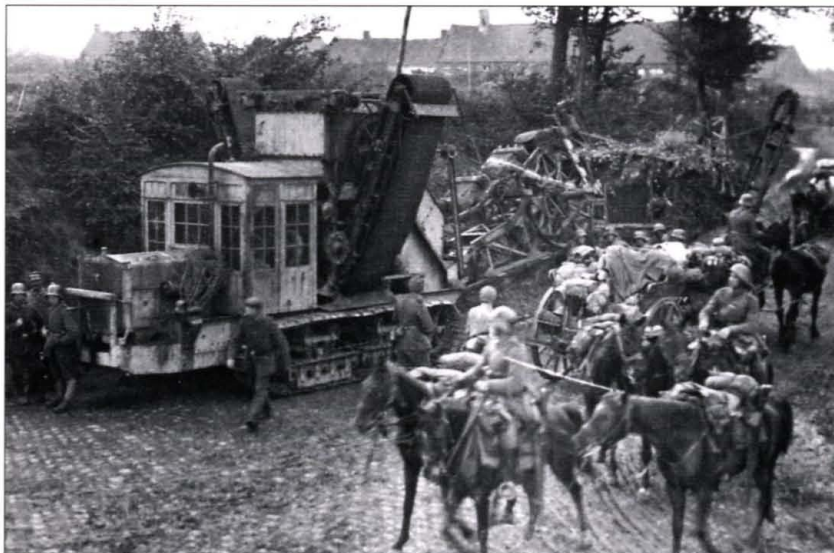
At least a single example of the A7V-Schützengrabenbagger trench-digger was completed, and it is seen here moving to the front on October 28, 1918. (NARA)

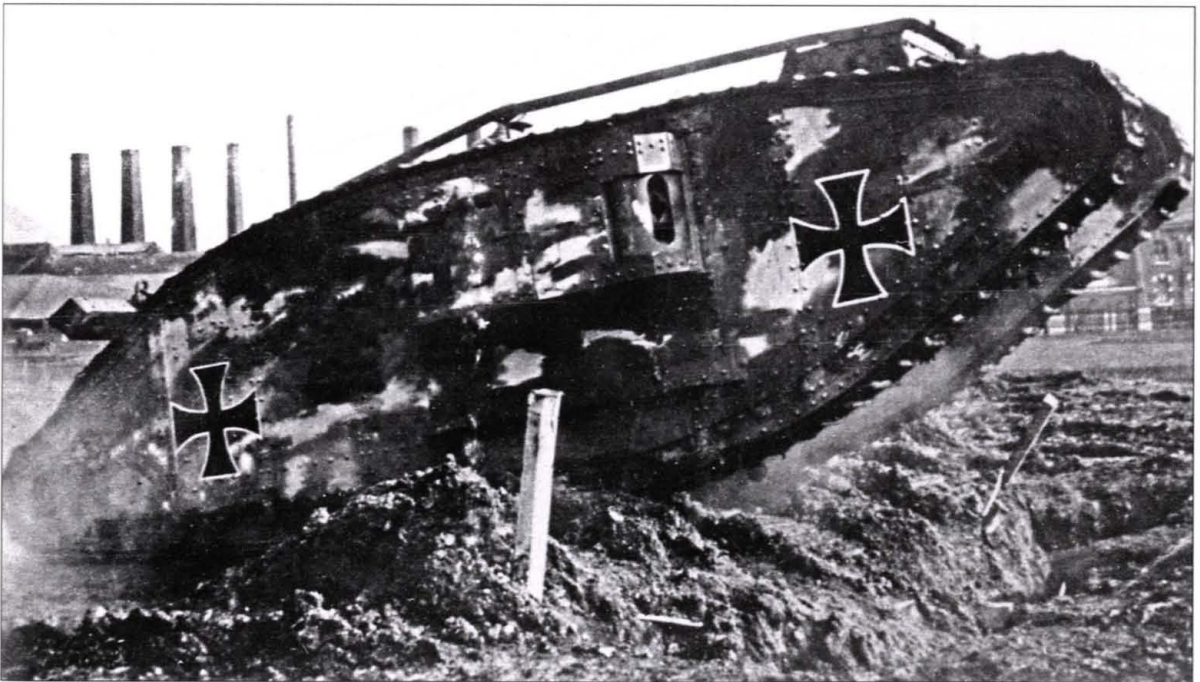
A captured Mark IV Female tank is put through its paces in training near Essen during the spring of 1918. (NARA)

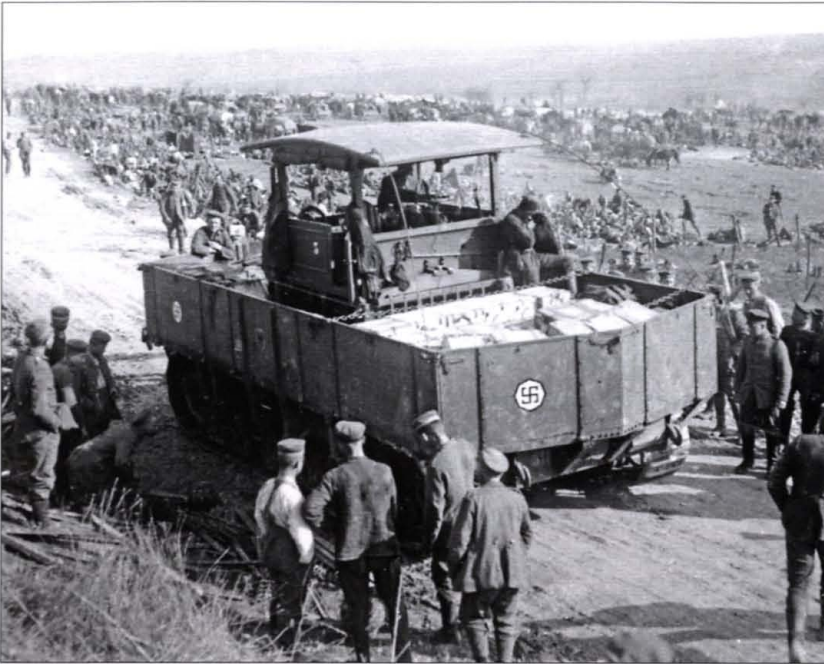
An A7V Gelandewagen of AKK(R) 111 is seen bringing forward ammunition in northern France on April 5, 1918. (NARA)

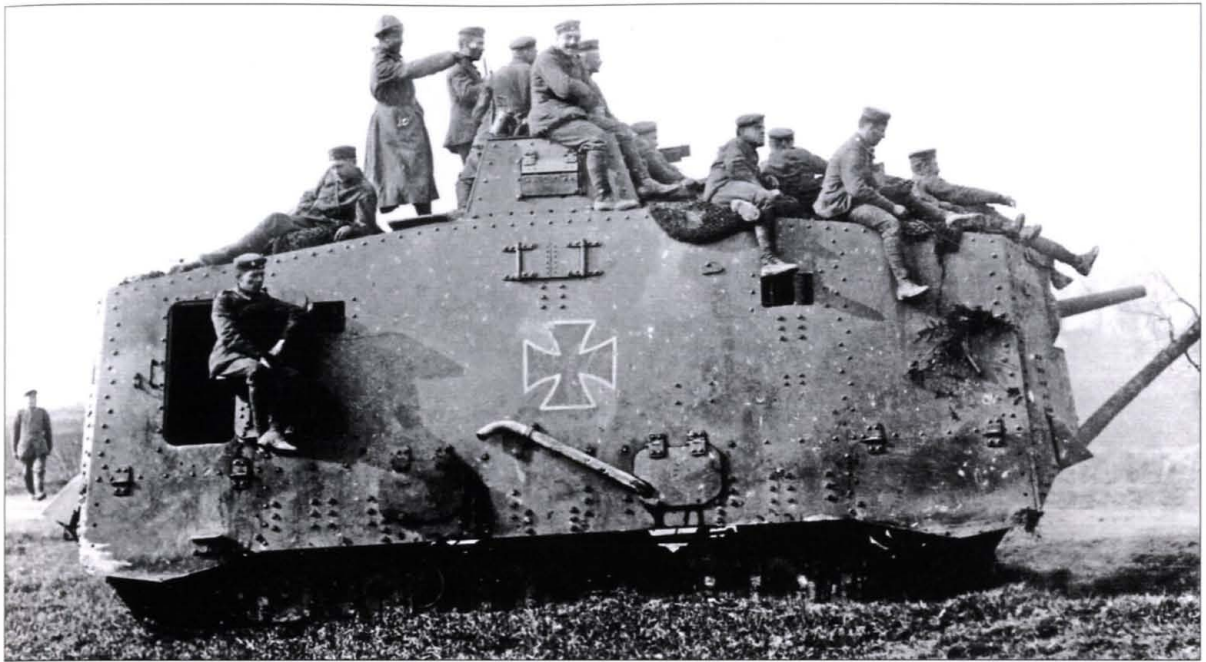
Panzer 525 "Siegfried" is seen in the summer of 1918 after the Villers-Brettonneux fighting. Close examination of the photo shows evidence of numerous machine-gun strikes on the side armor. The interior of the tank was extremely hot and noisy, so the crew rode outside when possible. (NARA)

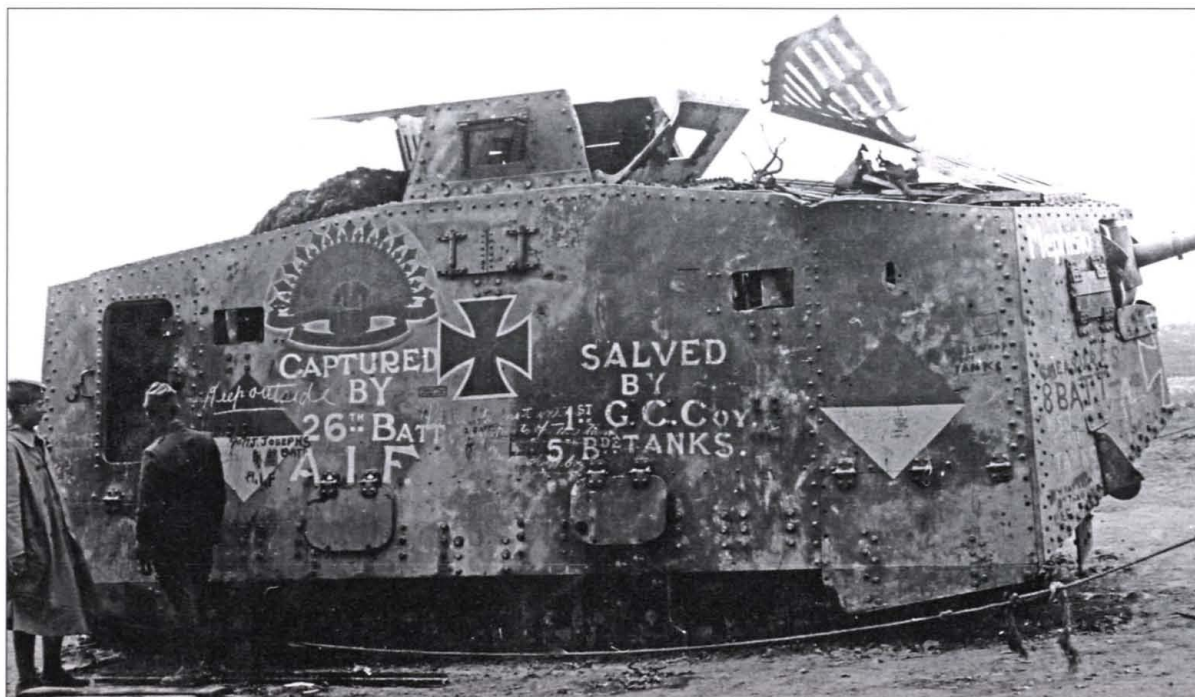
Panzer 506 "Mephisto" is seen here in September 1918 near Poulainville after having been recovered by the Australians. The heavy damage to the roof was caused by a German patrol sent out to demolish another abandoned A7V, "Elfriede." Mephisto is the only surviving A7V, preserved at the Queensland Museum. (NARA)

demolish the abandoned Elfriede, but instead the German patrol blew up Mephisto, which was 2,300ft (700m) away. Elfriede was dragged away by the French on May 15, 1918, the first A7V to fall into Allied hands, while Mephisto rested in no man's land until July 14, when it was recovered by the Australians. It was shipped back to Australia after the war and is the only surviving example of the A7V still in existence.

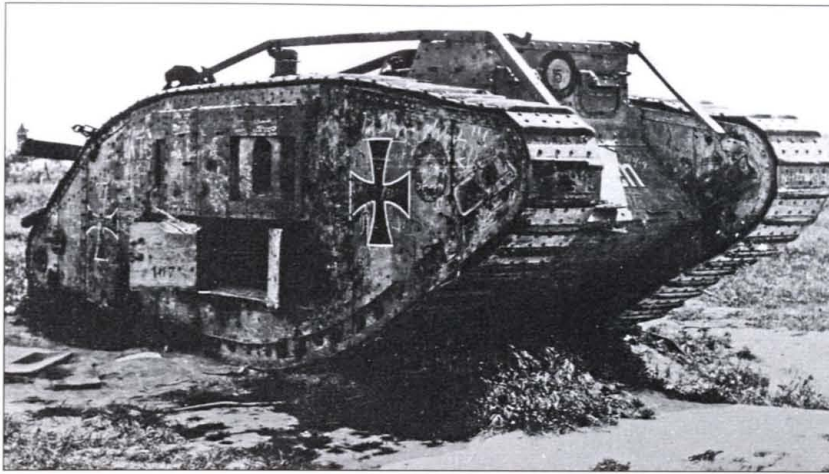
During the fighting near Fort de la Pompelle on June 1, 1918, Lt Burkhardt and the crew of Panzer 107 "Ännchen" of Abteilung 12 dismounted from their captured Mark IV Female to assist the infantry in repulsing a French infantry attack. The crew later retreated with the German infantry, leaving Ännchen behind. (NARA)

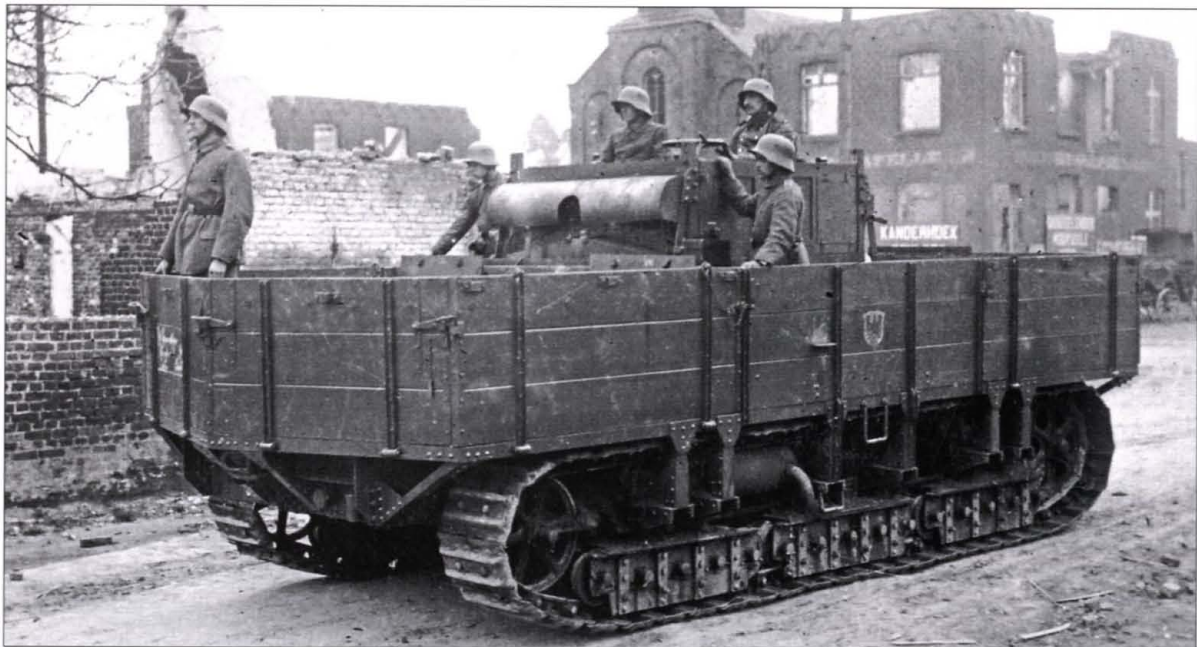
An A7V *Gelandewagen* moves through Ypres during 1918. In this view, the protective roof has been removed from over the driving compartment. (NARA)

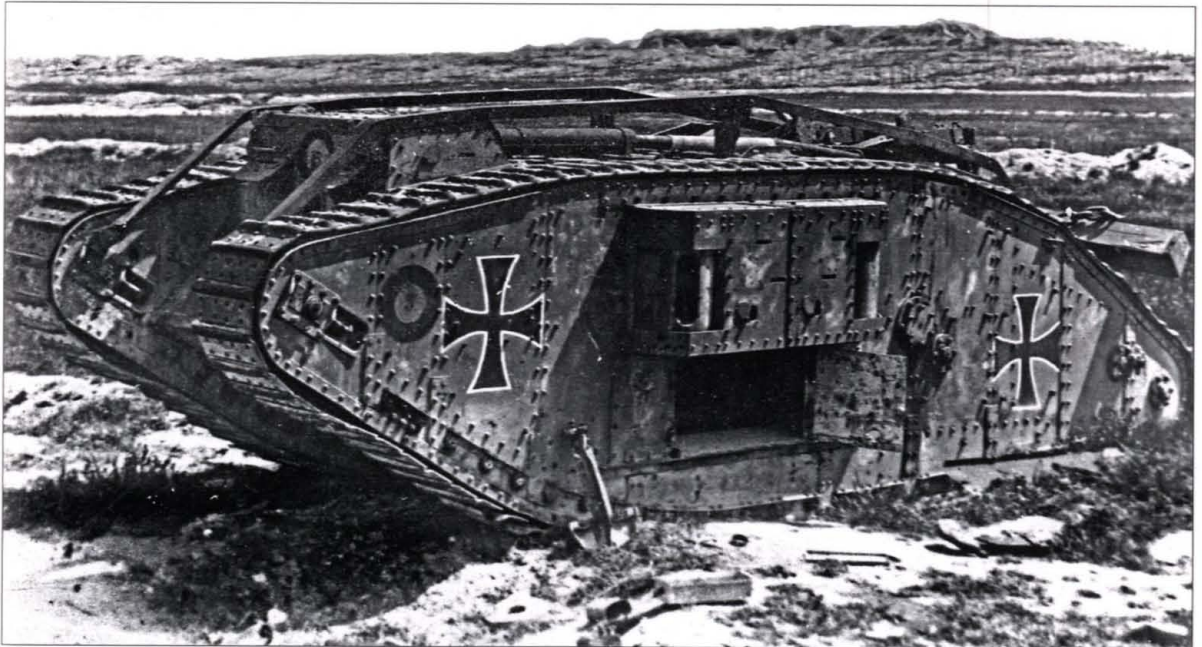
Another view of Panzer 107
Ännchen after it was abandoned
near Fort de la Pompelle on
June 1, 1918. (NARA)

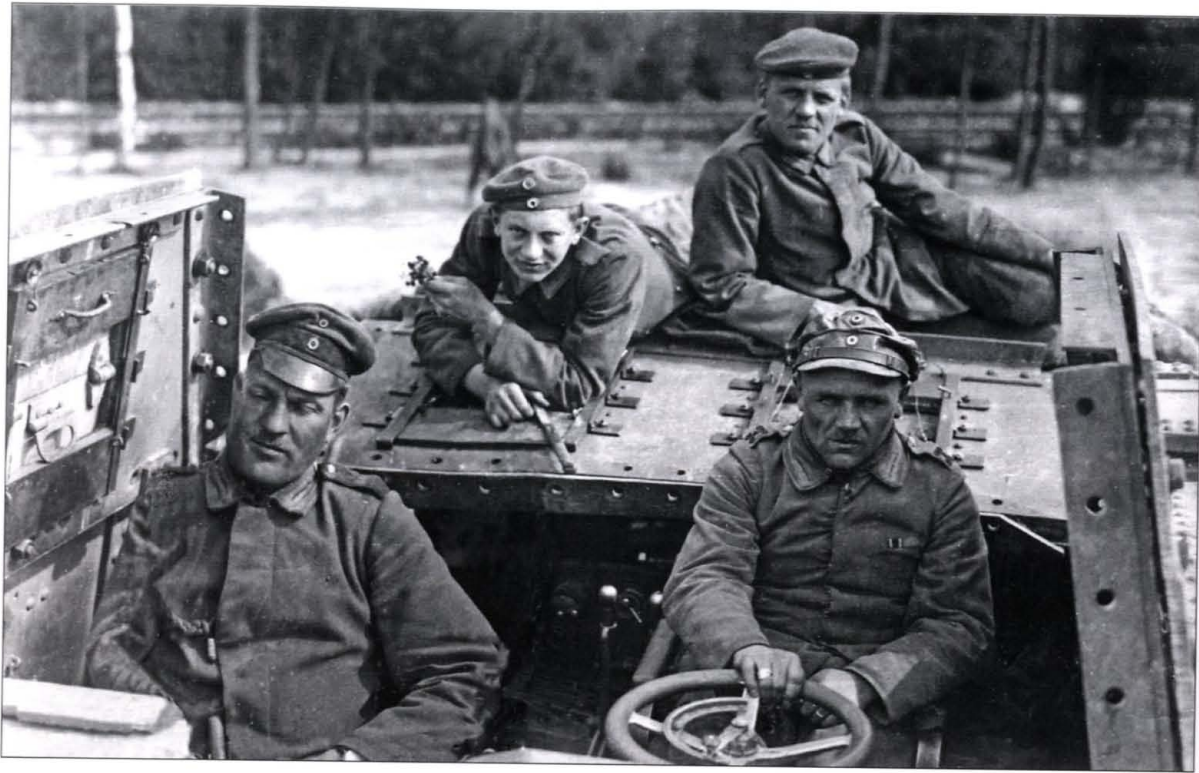
ABOVE The roof of the command cupola could be removed and the front and rear panels folded down to make it easier to drive the A7V when outside the combat area. This is the crew of Panzer 563 "Wotan" during a rail movement in July 1918. Like the rest of the final production batch, Wotan was fitted with appliqué armor on the cupola. (NARA)

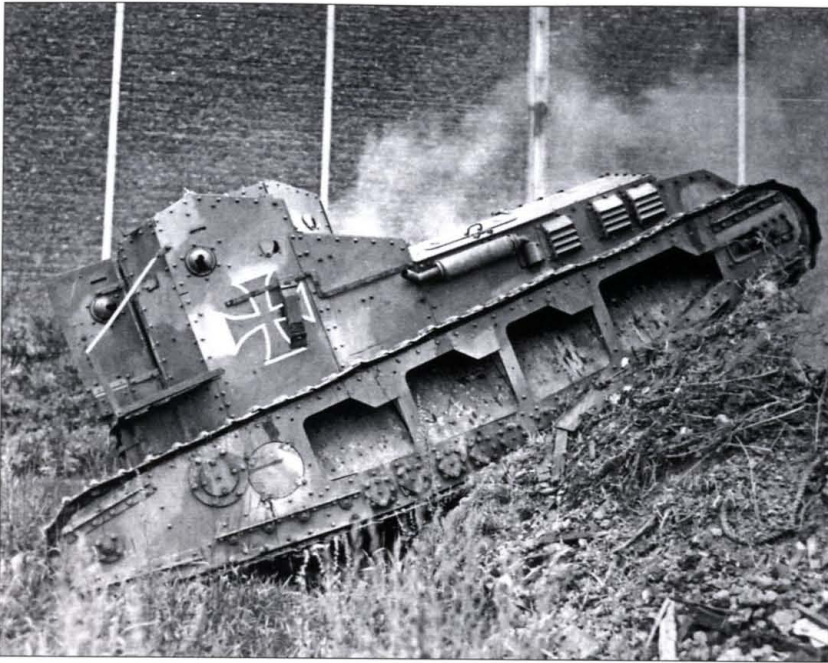
At least two Whippet tanks were put back in running order at the BAKP 20 facility in Charleroi. Although the type was highly regarded by Capt Friedrich Borschlegel, the commander of the German tank units, the type was not used in combat by the German tank units in 1918. (NARA)

some instances of German infantry capturing French tanks intact and using them in combat until they broke down or were knocked out. The first intact Renault FT was captured in early May and sent to Charleroi, but it was not well regarded due to its poor trench-crossing ability. At least two Whippet tanks were captured in the spring fighting and they were rebuilt at Charleroi. Although the Whippet was well regarded by the German tank units, it was not put into German service due to the preference for gun armed tanks.

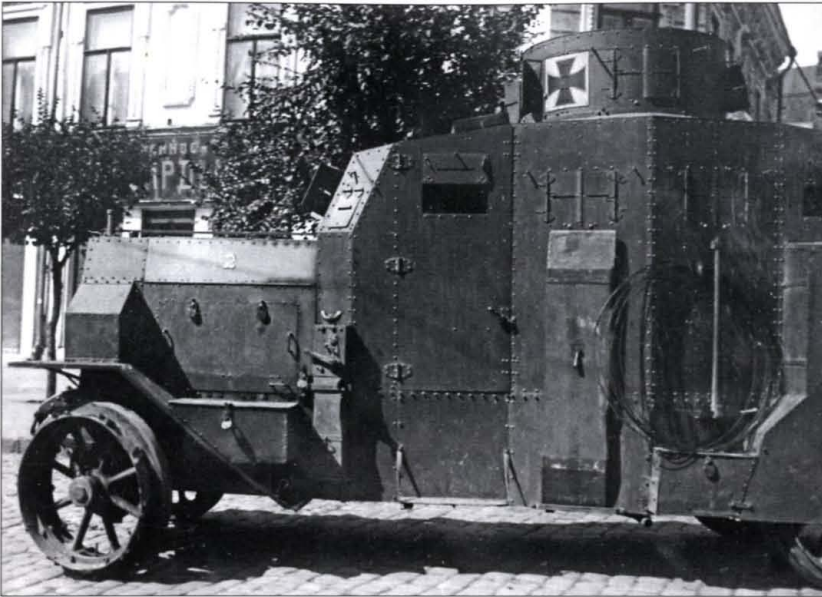
German tanks were never deployed on the Russian front, but there was a proliferation of armored car units there in 1918 for occupation duty. This is an Erhardt E-V/4 1917 on patrol in Rostov in Russia in 1918. (NARA)

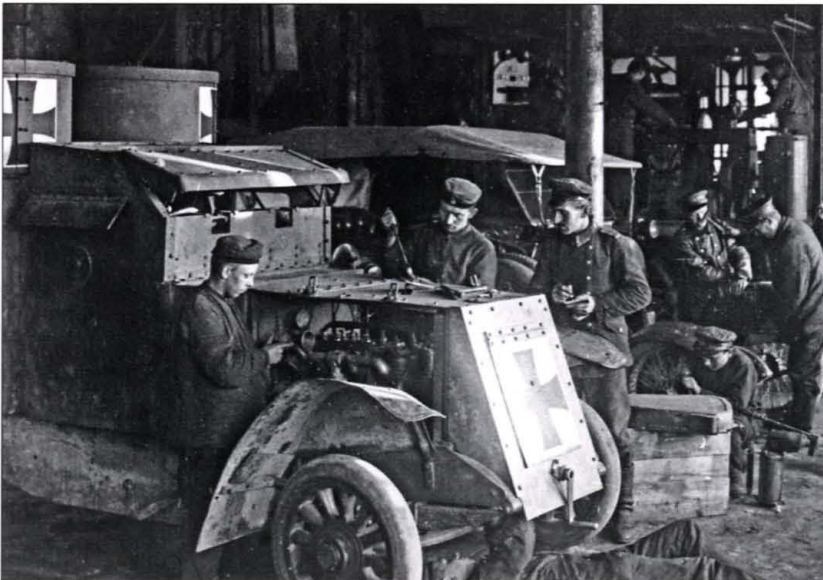
As was the case with German tank units, German armored car units were heavily dependent on captured armored cars like this Russian Austin. This type was used by several PzKw-MG-Züge in 1918. (NARA)

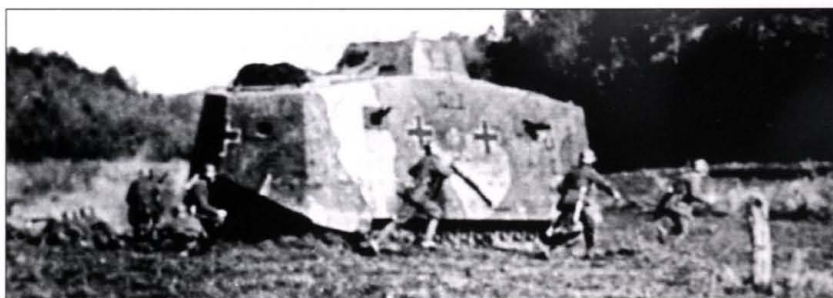
An A7V in action with German assault troops in the fall of 1918. In October, the tank units began to employ the simple Balkan cross as national insignia instead of the Maltese cross previously used. (NARA)

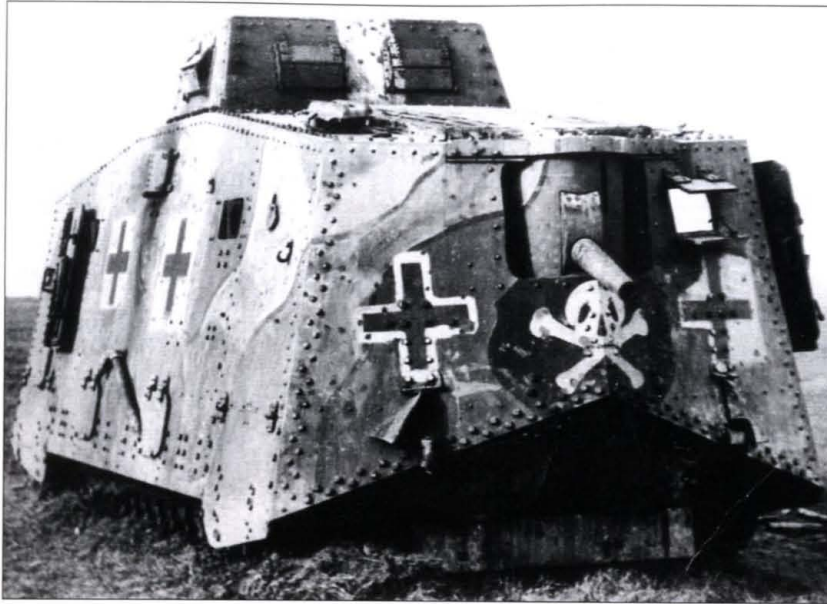
Panzer 503 of Abteilung 3 survived the final fall 1918 battles, but had to be abandoned at Charleroi when BAKP 20 evacuated to Wiesbaden in October 1918. The photo provides a good view of the new markings adopted on October 6, 1918, which were supposed to consist of a Balkan cross on a white square. This A7V was one of the early production batch with the trestle gun mount, later rebuilt with the pedestal mount as seen here. (Patton Museum)

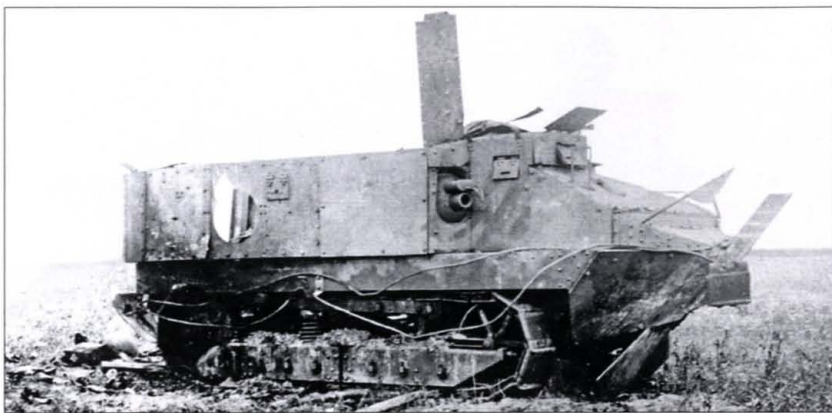
Although German tank units did not use captured French tanks, on occasion German infantry units would employ tanks they had captured. This Schneider CA.1 tank was used in an attack against the US 1st Infantry Division on July 20, 1918, near Froissy, where it was destroyed by 75mm field guns of the divisional artillery. (NARA)

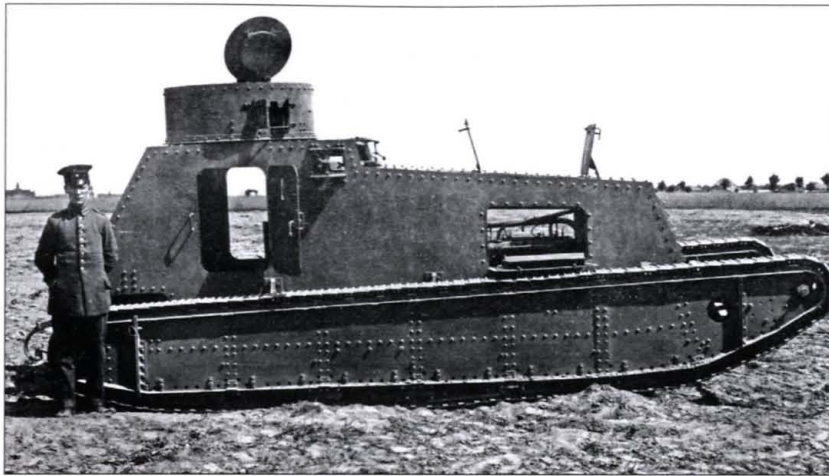
This single LK I light tank was constructed in 1918, but the armor was unacceptably thin. Plans were underway in the fall of 1918 to build the improved LK II but the war ended before any were ready for army service. (Patton Museum)

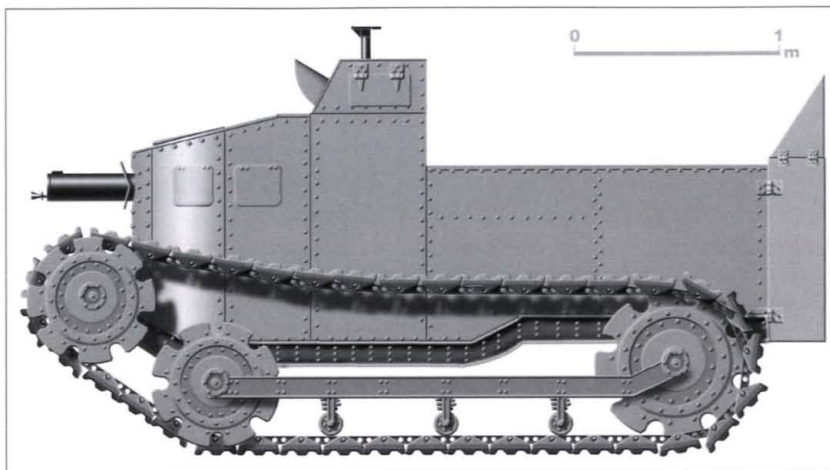
A total of 20 Krupp leichte Kraftprotze tankettes were under construction when the war ended. No known photos survive; this illustration shows their configuration. (Author's collection)

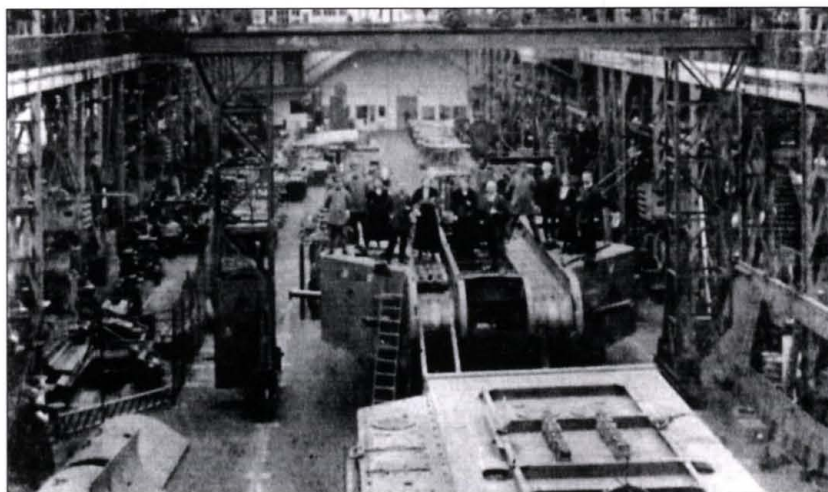
Two K-wagen heavy tanks were under construction at the Riebe plant near Berlin. Although one was ready for trials, the war ended before it ever left the factory. Under the watchful eyes of the Allied Control Commission, both were broken up. (NARA)

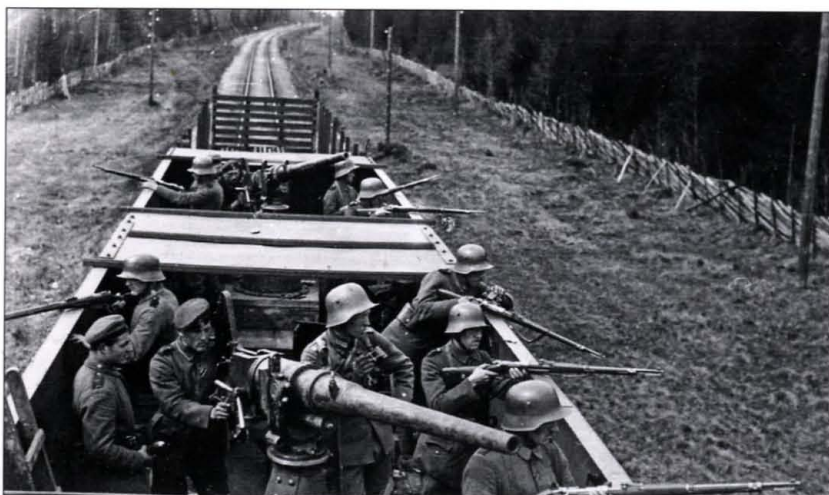
The German Army did not make extensive use of armored trains compared to the Austro-Hungarian or Russian armies. By the end of the war, seven German armored trains were operational. This particular armored train is seen in action in Finland on June 14, 1918, and is armed with what appear to be pedestal mounted 57mm guns. (NARA)

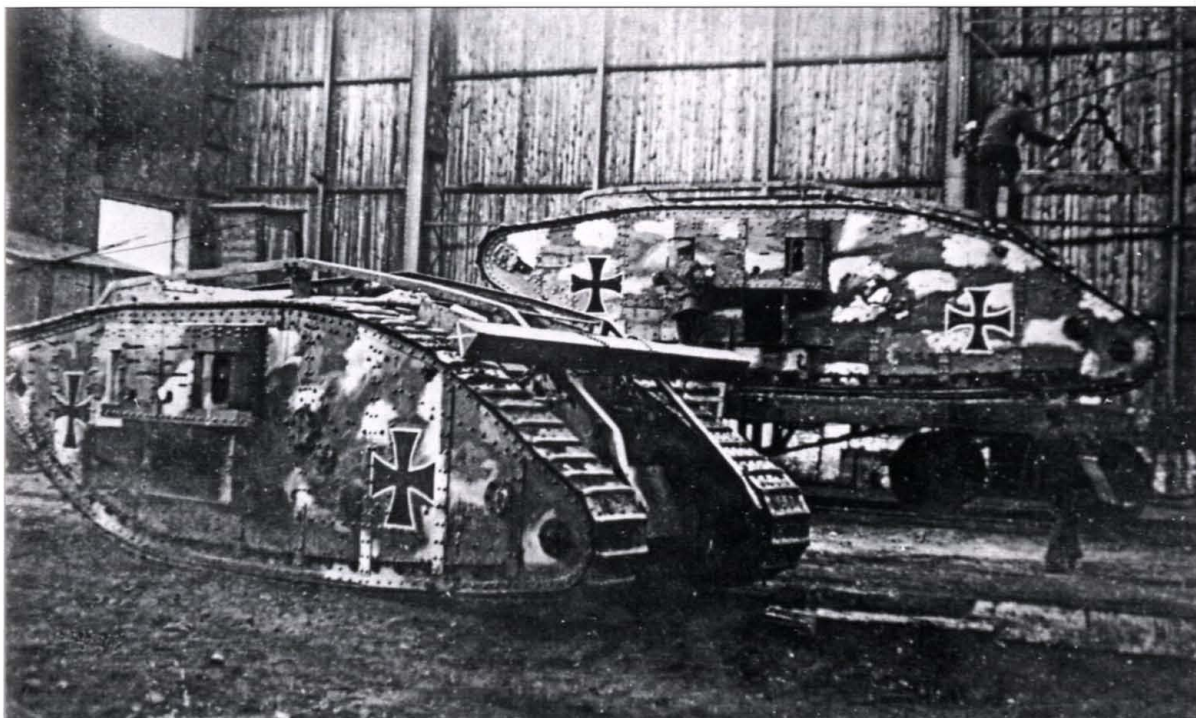
This photo shows a good example of the type of camouflage applied to captured tanks at the Germaine plant in Charleroi by BAKP 20. These two Mark IV tanks are finished in a pattern of mustard and red brown over the base color of field gray, with Maltese crosses prominently carried for national identification. (NARA)

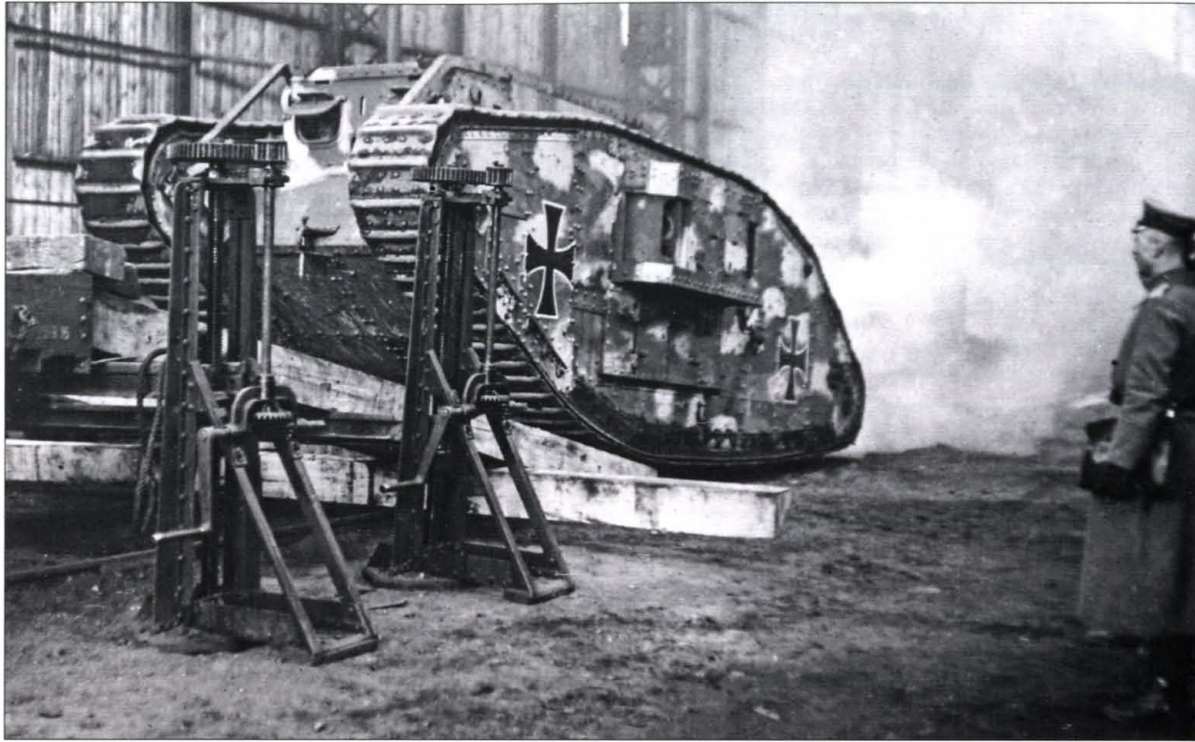
A refurbished Mark IV Female tank is driven on to a railroad flatcar at the Charleroi plant. (NARA)

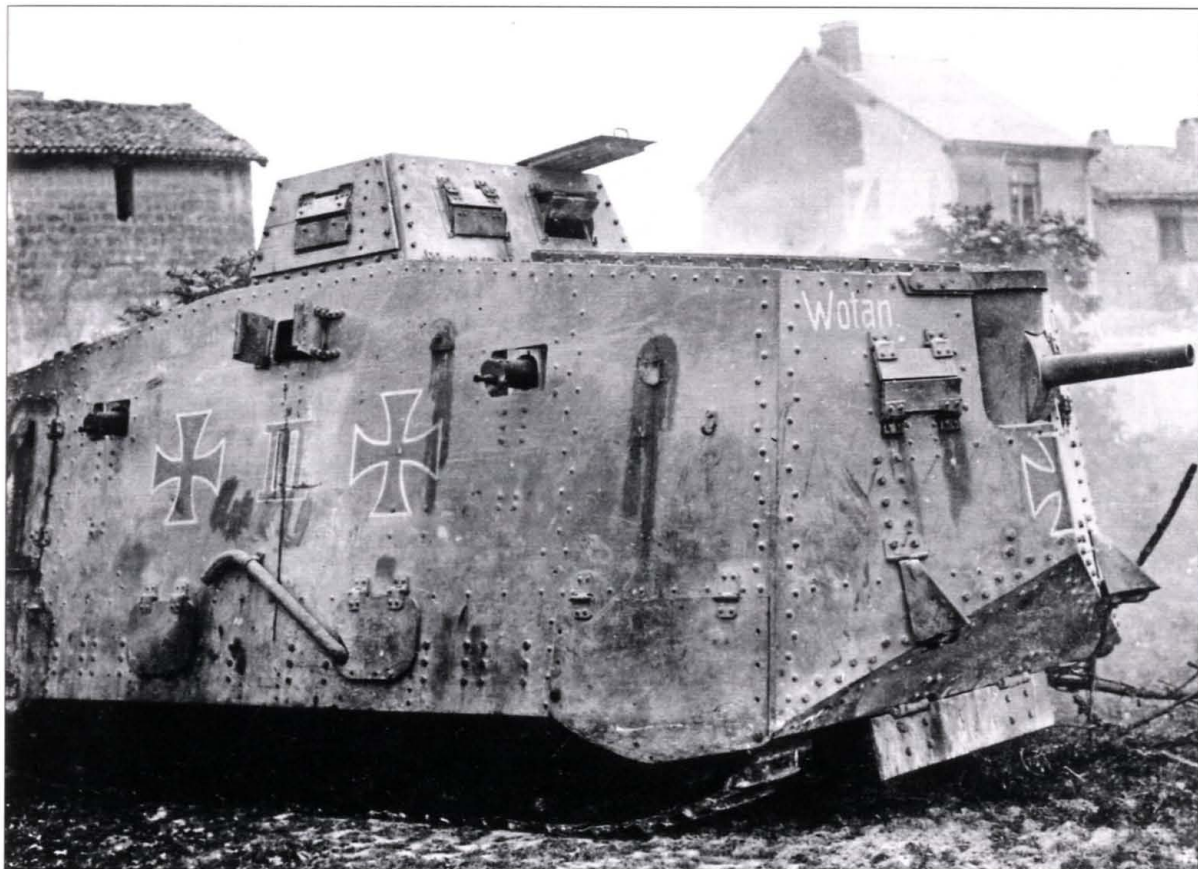
Panzer 563 "Wotan" was the penultimate production example of the A7V and a good example of the final production batch, designed from the outset for the pedestal mounted 57mm gun. (NARA)
