Armor Battles on the Eastern Front

(1) The German High Tide 1941-1942

Robert Michulec

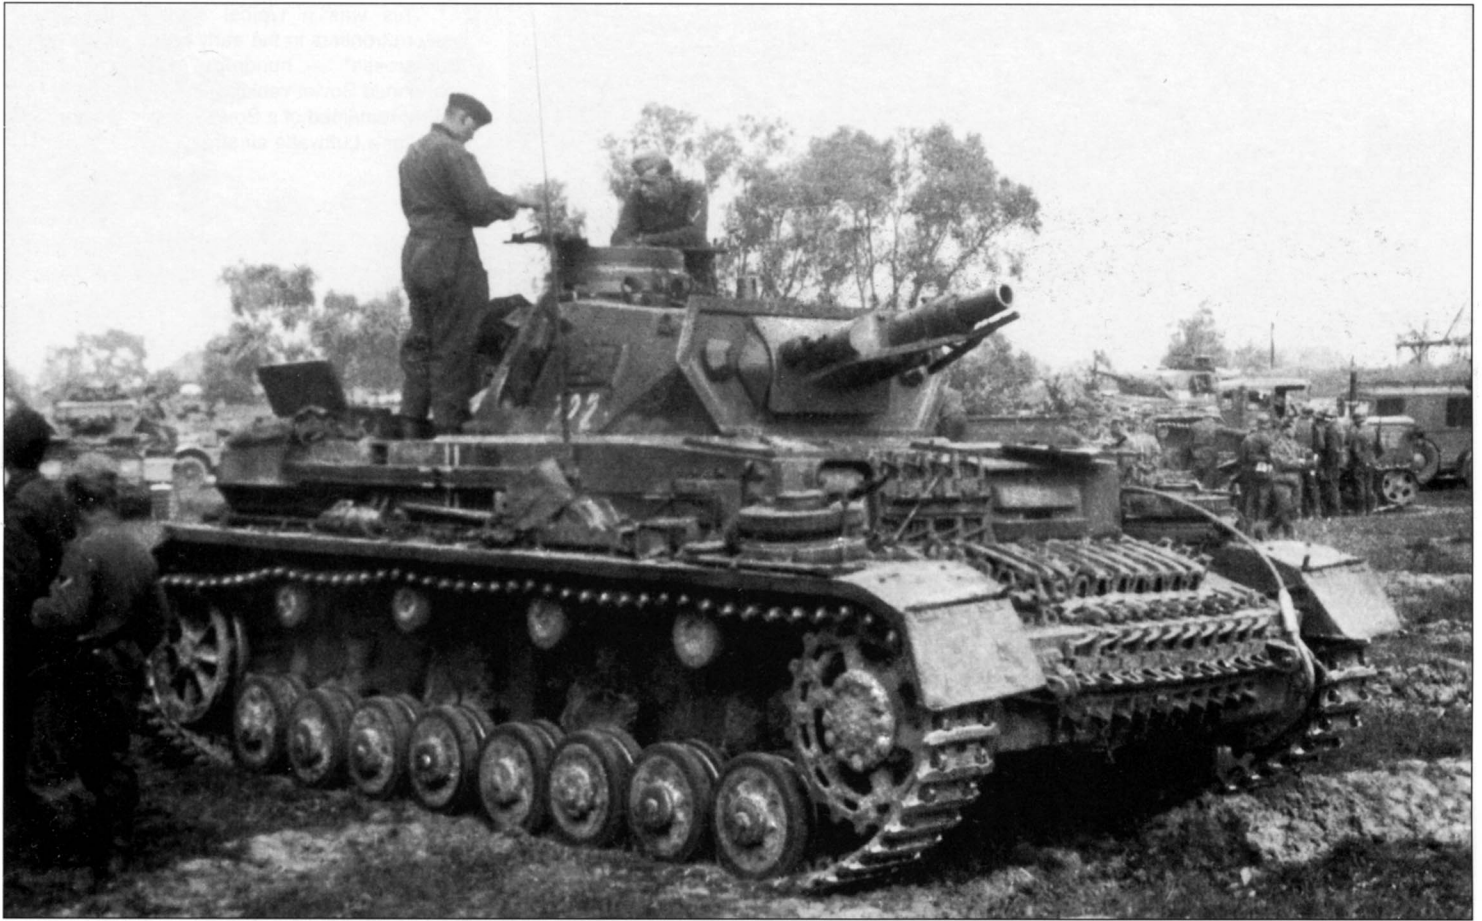
A Pz.Kpfw. IV Ausf. D in the so-called "U-bootpanzer" (Tauchpanzer) configuration, which permitted the tank to submerge in water up to 15 meters (16.5 yards) deep. These Tauchpanzer IVs were originally developed for the preparation of Operation "Sea Lion", the invasion of England, but were eventually used to cross the River Bug in June 1941 during Operation "Barbarossa". Note the frame around the turret front; this is the mounting frame for the waterproof fabric cover. The Tauchpanzers were mainly used by 18.Panzer-Division of Guderian's Panzergruppe 2.

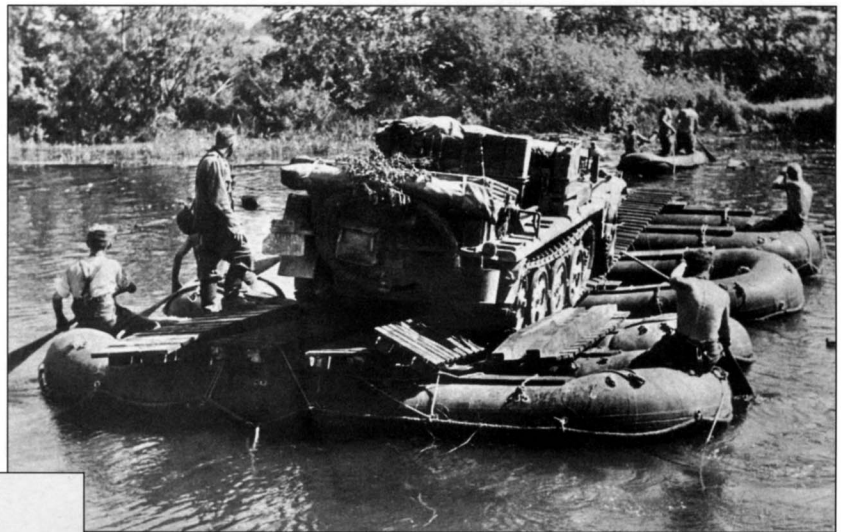
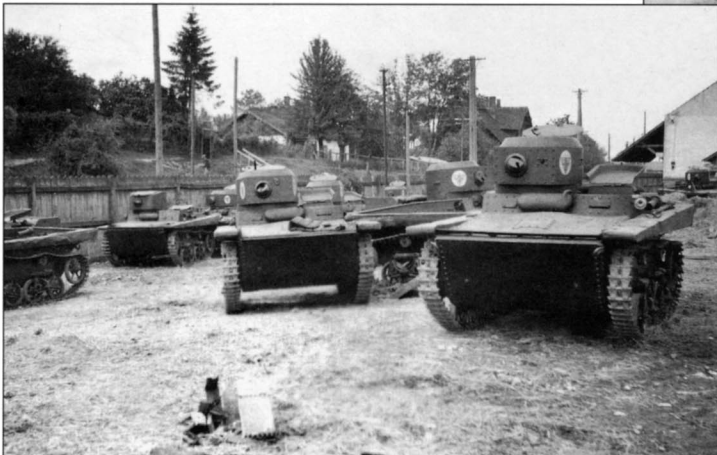
The vehicles that could not travel through water were transported across rivers by the use of pontoons. Here we see an example of such a river crossing. Four large rubber rafts have been used to form a pontoon to ferry a Sd.Kfz. 10 that is overloaded with supplies. This was probably the simplest way employed by the Panzerwaffe to execute a river crossing.

When the Germans reached the first Soviet areas of troop concentrations, they saw astounding sights — hundreds of vehicles destroyed by Luftwaffe air strikes or abandoned by retreating Soviets. Here is a group of no less than ten T-37 amphibious tanks abandoned by a Soviet reconnaissance troop during a wild escape after being taken by surprise. None of them has even a trace of battle damage. Note the unit markings painted on the turret sides.

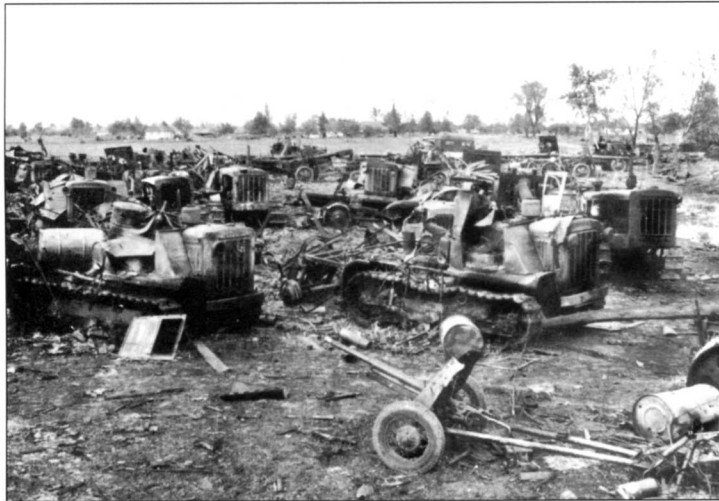
The field concentration of vehicles belonging to an anti-tank unit was photographed following an air strike. All visible tractors are the ChTZ-65 "Stalinet" artillery tractor, which was designed on the base of the agricultural tractors, like American "International TD", for example. Factories could produce them for both military and civil duty without any troubles, but this civilian machine was not popular with the military crews. The guns are the two main types at that time: the 45mm model 1937 (designed on the base of the German 3.7cm PAK 36/37 gun) and the 107mm model 1910/30 and model 1940.

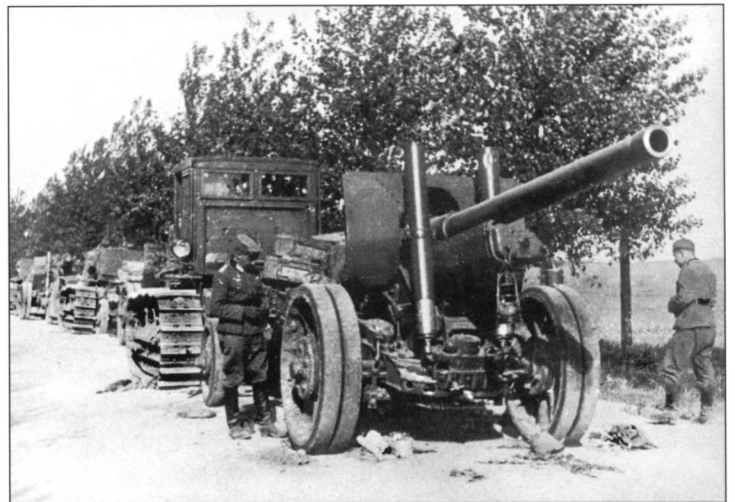
Hundreds more vehicles and guns were captured by the Germans during their advance when they found an entire military column abandoned due to either a lack of fuel or desertion by the Soviet soldiers. The S-65 tractors seen in the background are the modified version with a cab. The artillery pieces are heavy 122mm A-19 model 1931/37 guns.

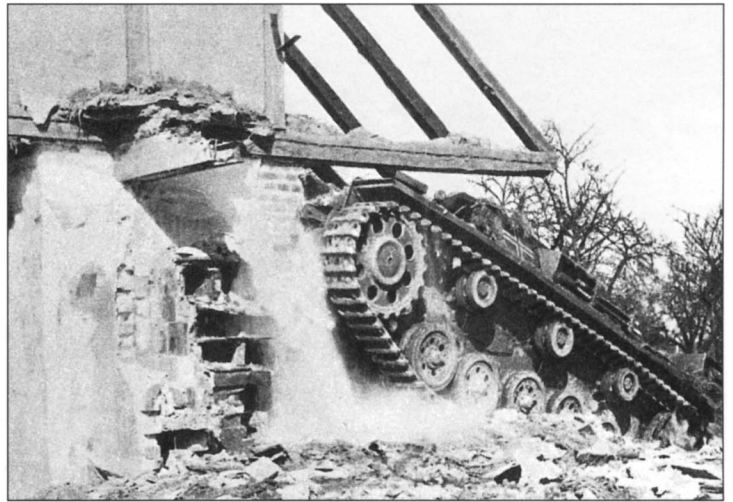
A StuG III at work. This type of vehicle proved to be the most successful German AFV during the first Russian campaign. It was fast, mobile, and quite well armed and armored. Both sides were impressed by its capabilities and began larger production of it (Germany) or started developing its own similar vehicle (Soviet Union).

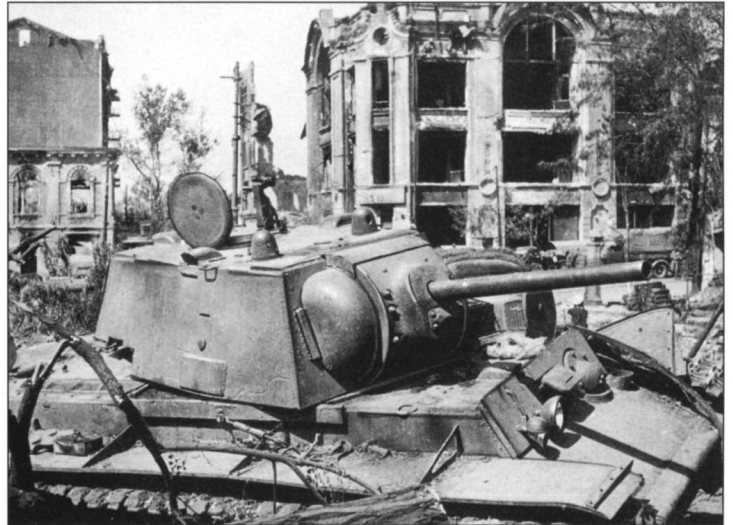
A knocked-out KV-1 on the street of an unknown Soviet city. Note the many details of the construction of this tank. In the first days of the war the Red Army units had 508 KV-1 tanks out of a total of 636 vehicles of the KV family that were produced. Just as in the previous decade, when the BT and the T-26 tanks had been armed with the same gun, the new Soviet tanks, the KV-1 and the T-34, were again armed in the same way, i.e., with a 76.2mm gun, but they were produced by two different manufacturers.

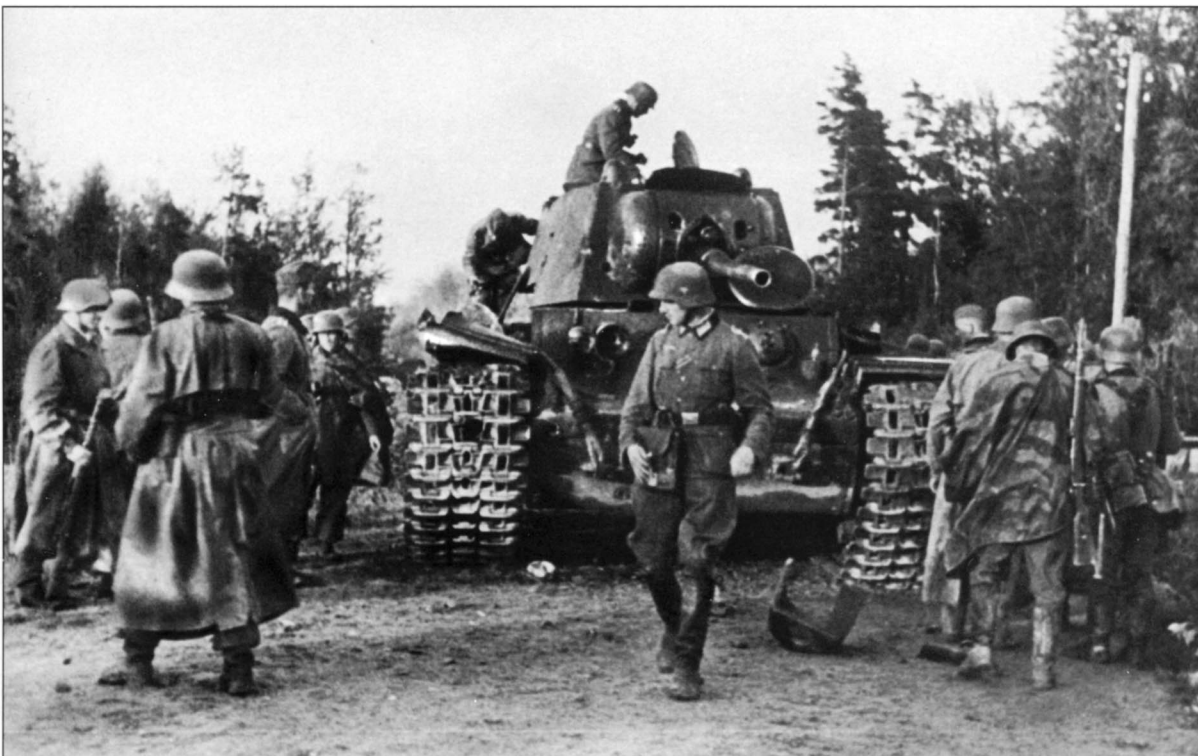
One of the greatest surprises to the German High Command was the KV-1 heavy tank, which was so strongly built that it excited curiosity from every soldier that encountered it. Here we see a good view of a typical KV-1 Model 1940 series whose L-11 gun is being carefully examined by soldiers and NCOs of Herresgruppe Nord after knocking it out of action on a forest road. KV tanks overwhelmed all German tanks, therefore they were usually eliminated not by tanks or anti-tank guns of the Panzertruppen, but by the Luftwaffe or 8.8cm Flak guns.

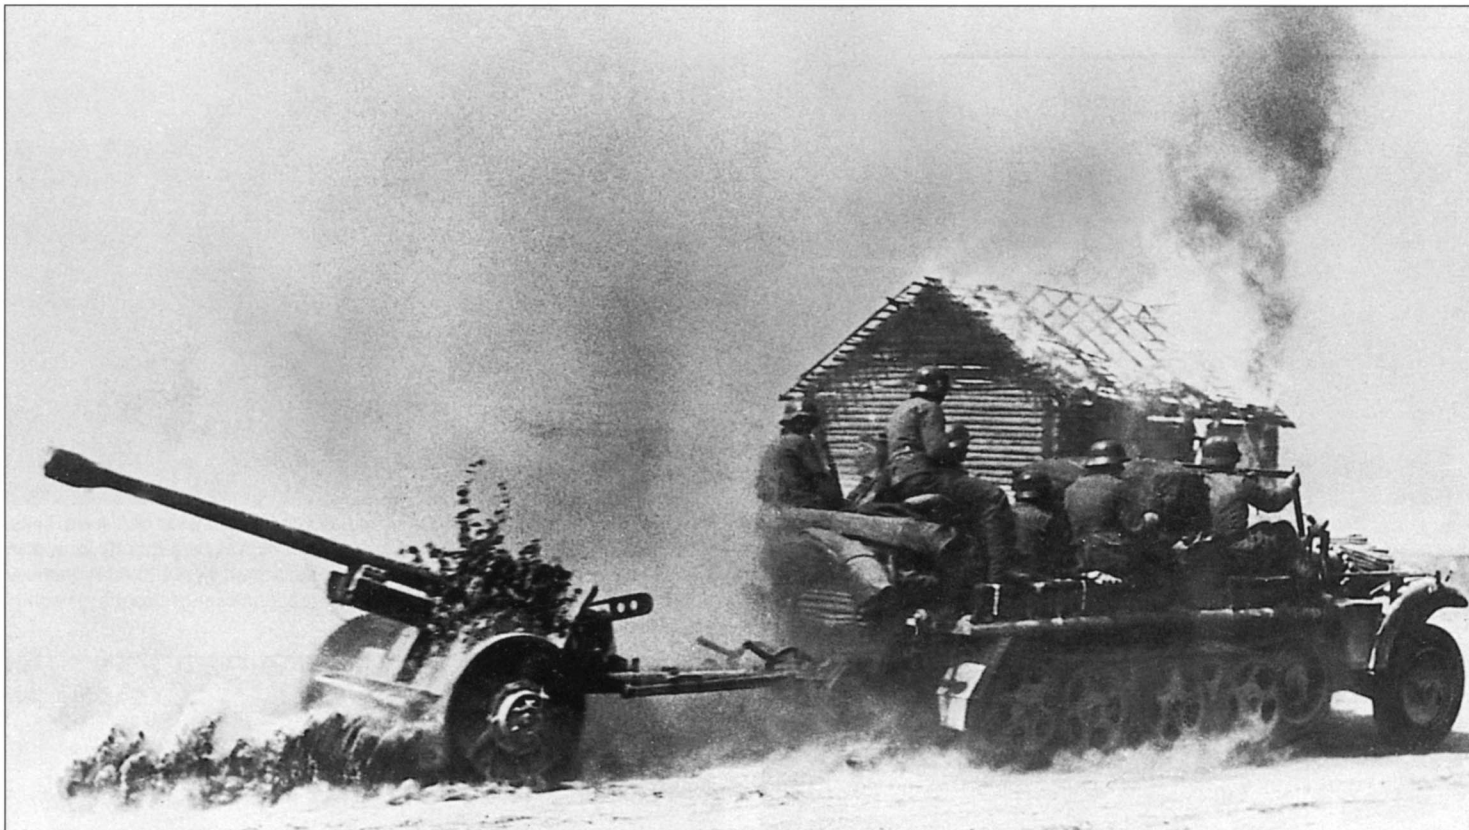
A Sd.Kfz. 10 with a 5cm PAK 38 anti-tank gun in tow passes through a Ukrainian village amidst a cloud of dust and smoke. The PAK 38 was a very useful weapon against Soviet armor, especially when firing the Pz.Gr.40 shells, but it did not guarantee superiority to its crews, so it was not appreciated by the Germans. On the other hand, the Sd.Kfz. 10 was one of the most popular vehicles of this period and was very commonly used in all motorized divisions.

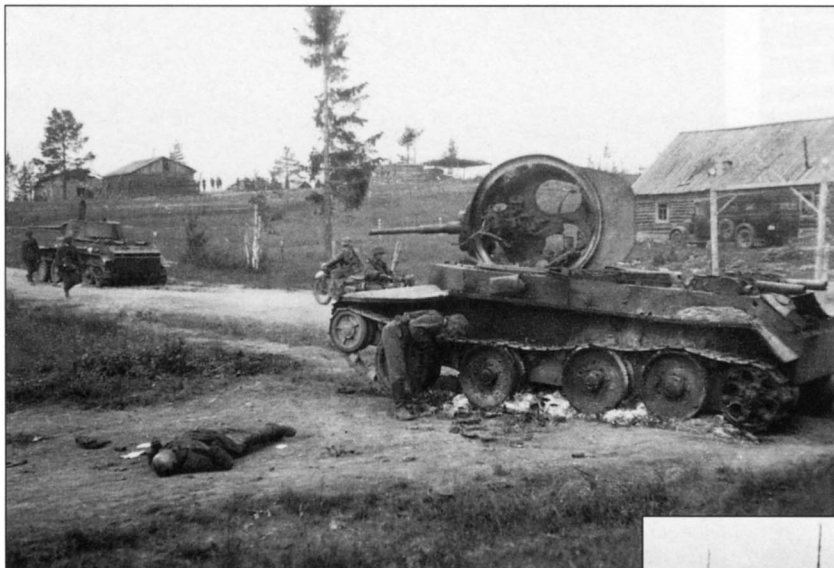
The 3.7cm PAK 36/37 gun was not completely useless. This photo shows that it was useful during the summer of 1941, especially when the Soviets employed only light armored tanks in their assault units. These two BT-7 tanks were destroyed by a Waffen SS Panzerartilleri Abteilung (Pz.Art.Abt.) equipped with 3.7cm guns. Note the interior details of the blown-off BT-7 turret.

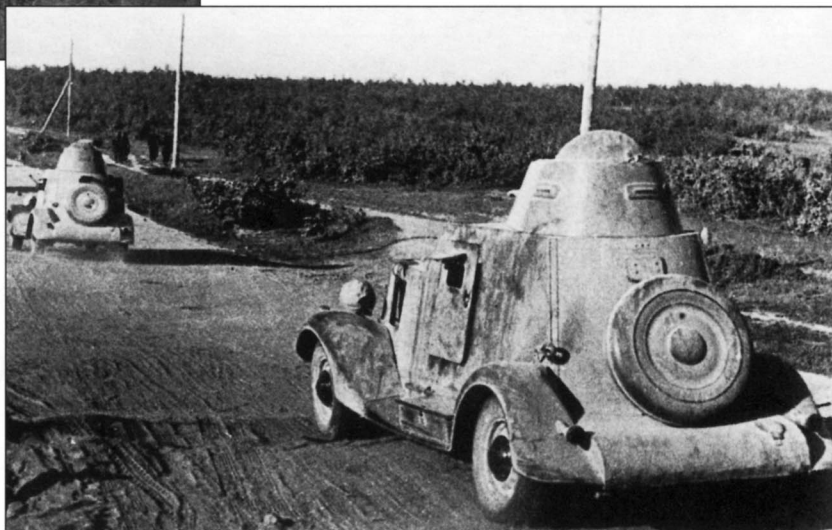
Soviet armored units were very well equipped with armored cars, which still played a major role in armored units. In this photo we can see the most popular light armored car used by the Red Army, the four-wheeled BA-20. Note the colors of these vehicles — all BA-20s are covered by a solid coat of dust, so the original camouflage color is not visible at all.

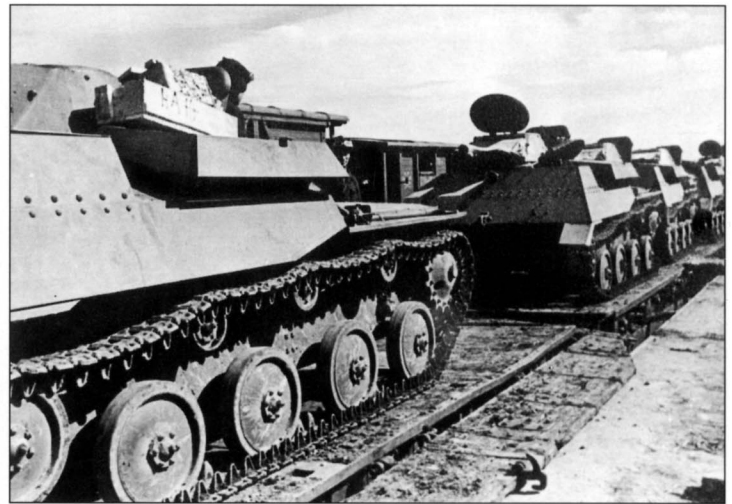
From the beginning of the war the Soviets sent to the front lines hundreds of trains carrying vehicles for the fighting troops. This scene shows the transport of T-40 amphibious tanks armed with 12.7mm machine guns. These vehicles were used by the reconnaissance troops of some divisions in place of the T-37/38 tanks.

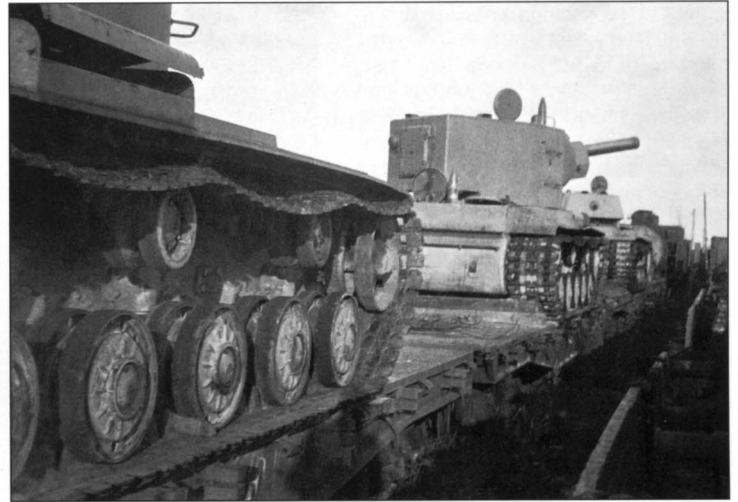
The two giants of the Red Army, the KV-2 heavy tank and the KV-1 tank (in the background), are visible in this photo. The KV-2 came as a surprise to the Germans in the early days of the war. It was invulnerable to any tank or anti-tank gun at that time and could only be stopped by heavy artillery or 8.8cm anti-aircraft guns. However, the KV-2s were prone to mechanical breakdowns.

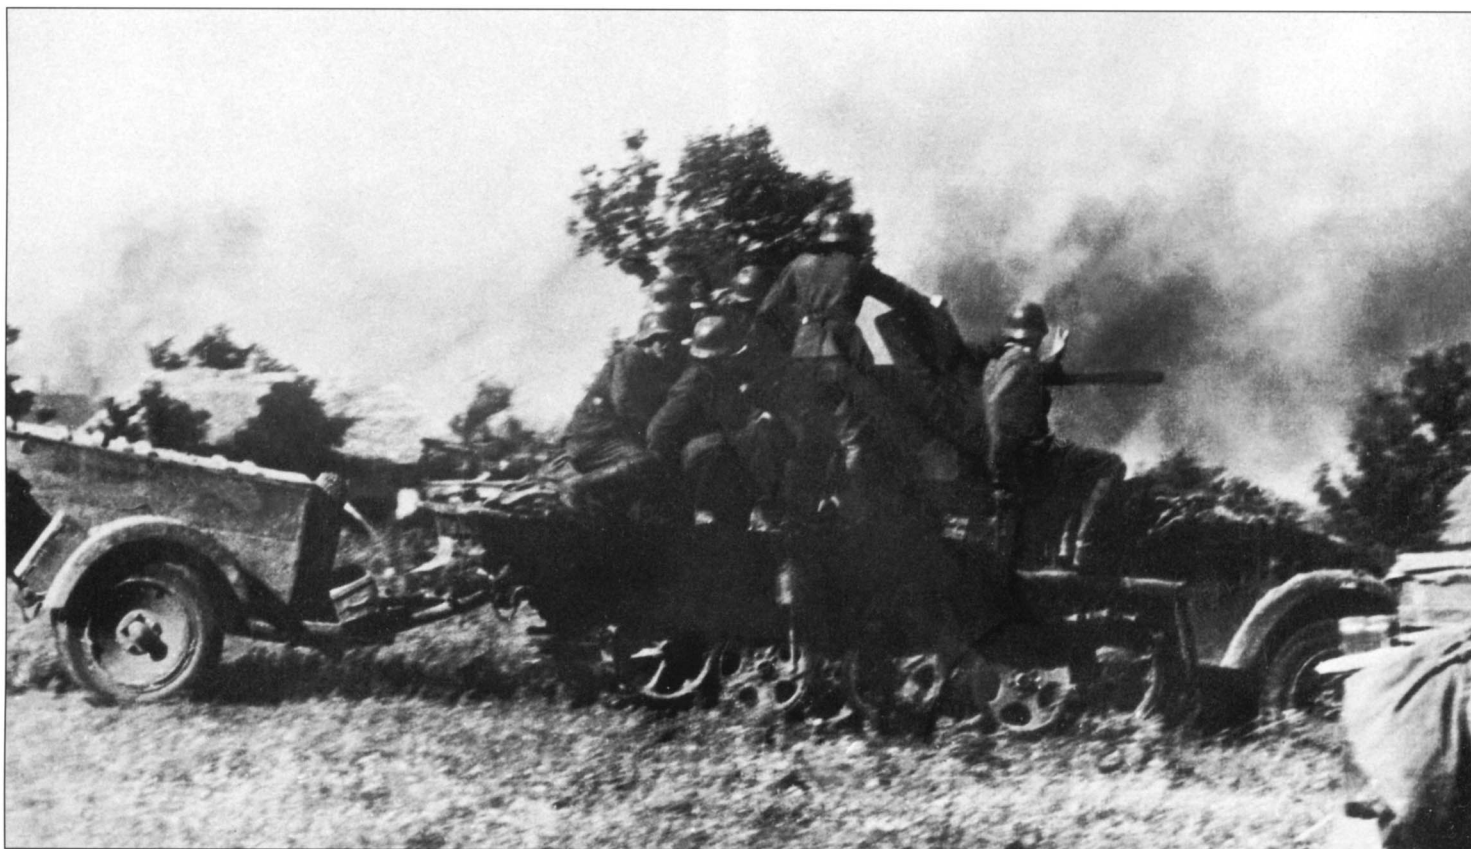
A Panzerabwehrabteilung (anti-tank gun battalion) vehicle in action in a village. This Sd.Kfz. 10 is fitted with a 3.7cm PAK 35/36 anti-tank gun and tows a trailer with additional ammunition. Usually the complete gun with its field carriage was carried, thus offering the Panzerjäger units great mobility. About 35% of all independent anti-tank units used in Operation "Barbarossa" were equipped with such composite vehicles.

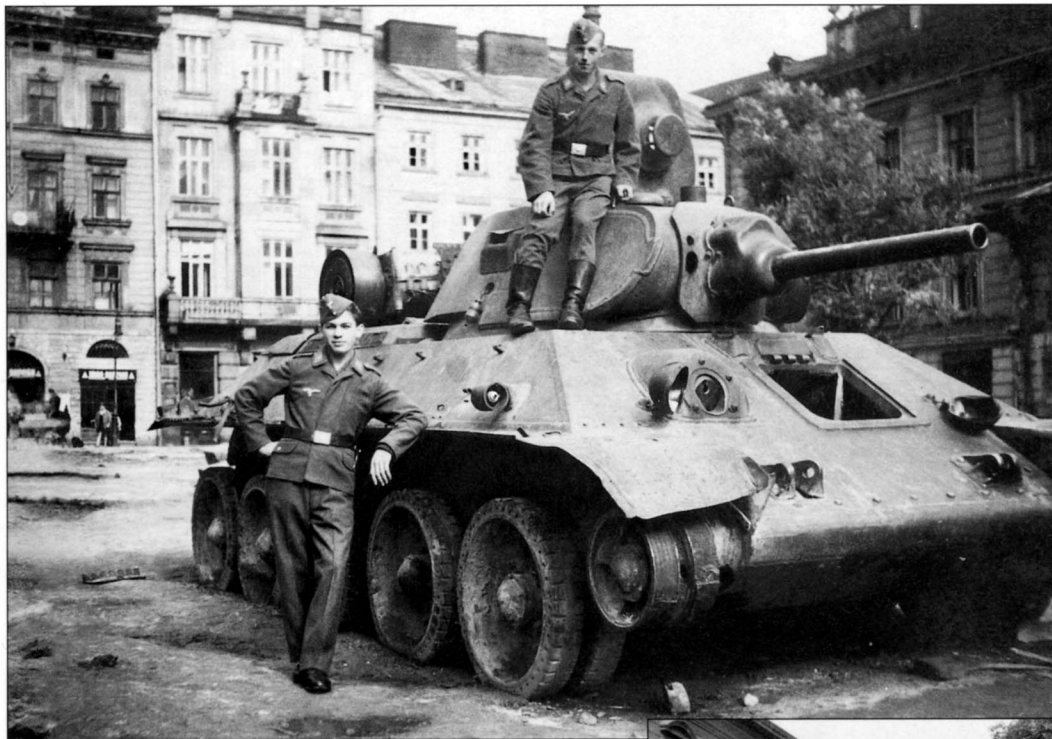
A souvenir photo from a "trip" to Lvov in July 1941 taken by Luftwaffe personnel, showing two of them and a knocked-out T-34 Model 1940 from 4th Mechanized Corps. Clearly visible in this photo is the ventilation on the turret hatch and an extra transmission lashed to the engine deck. Also abandoned on another street was at least one T-34 from the same unit with a similar transmission on the rear deck.

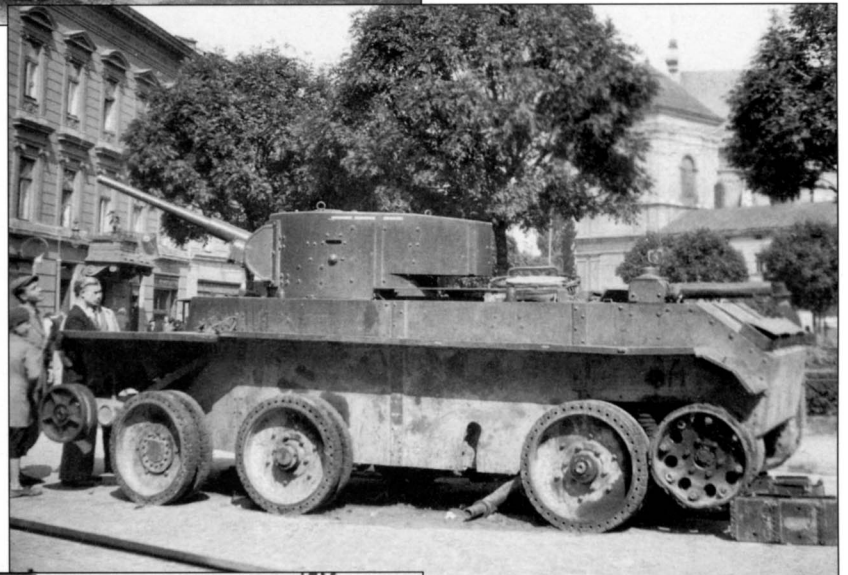
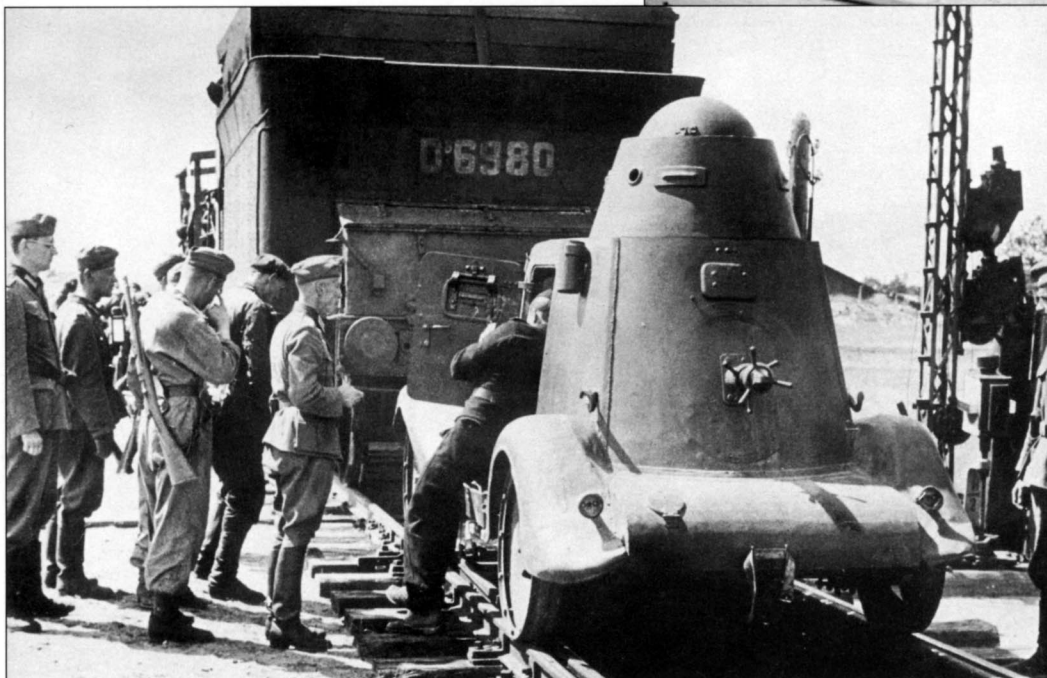
A few dozen BA-20 armored cars were modified to the BA-20 ZhD railway version and adopted for use by railway protection forces. Here we see one of the captured vehicles being inspected by the Germans, who named this type of vehicle the Pz.Sp.Wg. BA-20 2(r).

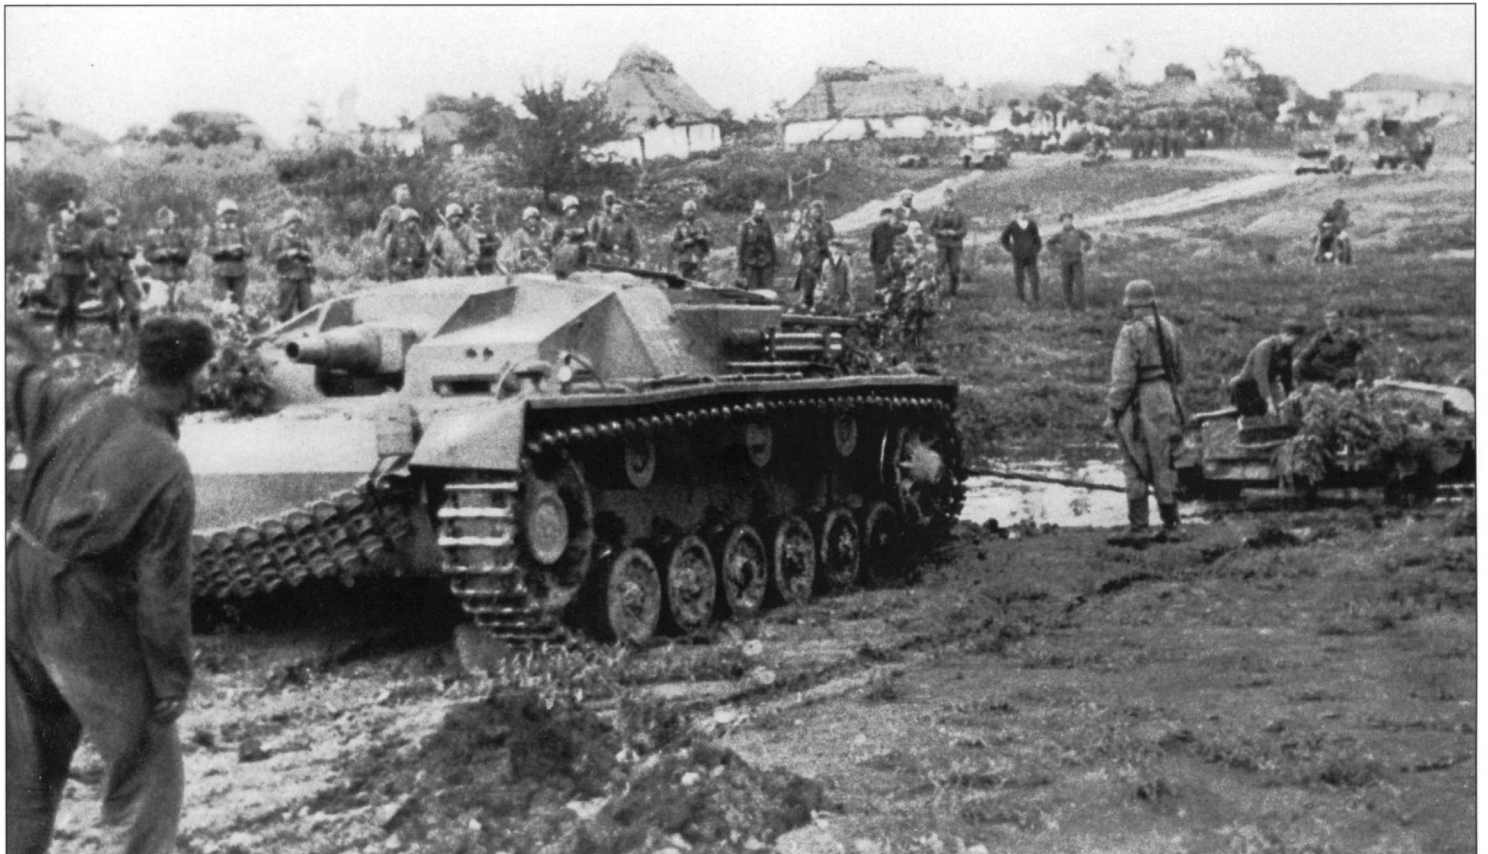
German tank crews sometimes had rotten luck. Here a friendly StuG III Ausf. D hauls another StuG III out from a muddy pool. This work would normally be done by a strong, half-track tractor. Since there were not too many of them available during the early weeks of fighting, they had to be replaced by combat vehicles.

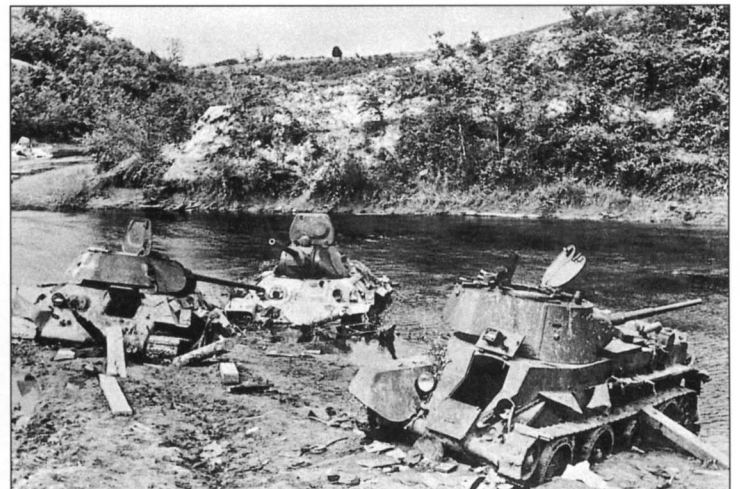
A similar situation, but this time the Soviet tank crews are in trouble. The vehicles crossed the river without much difficulty, but the muddy bank was too soft for them, especially the T-34 at the left. Both T-34 tanks are the 1941 model series, without ventilation on the turret hatch, but with thicker armor on the front of the turret.

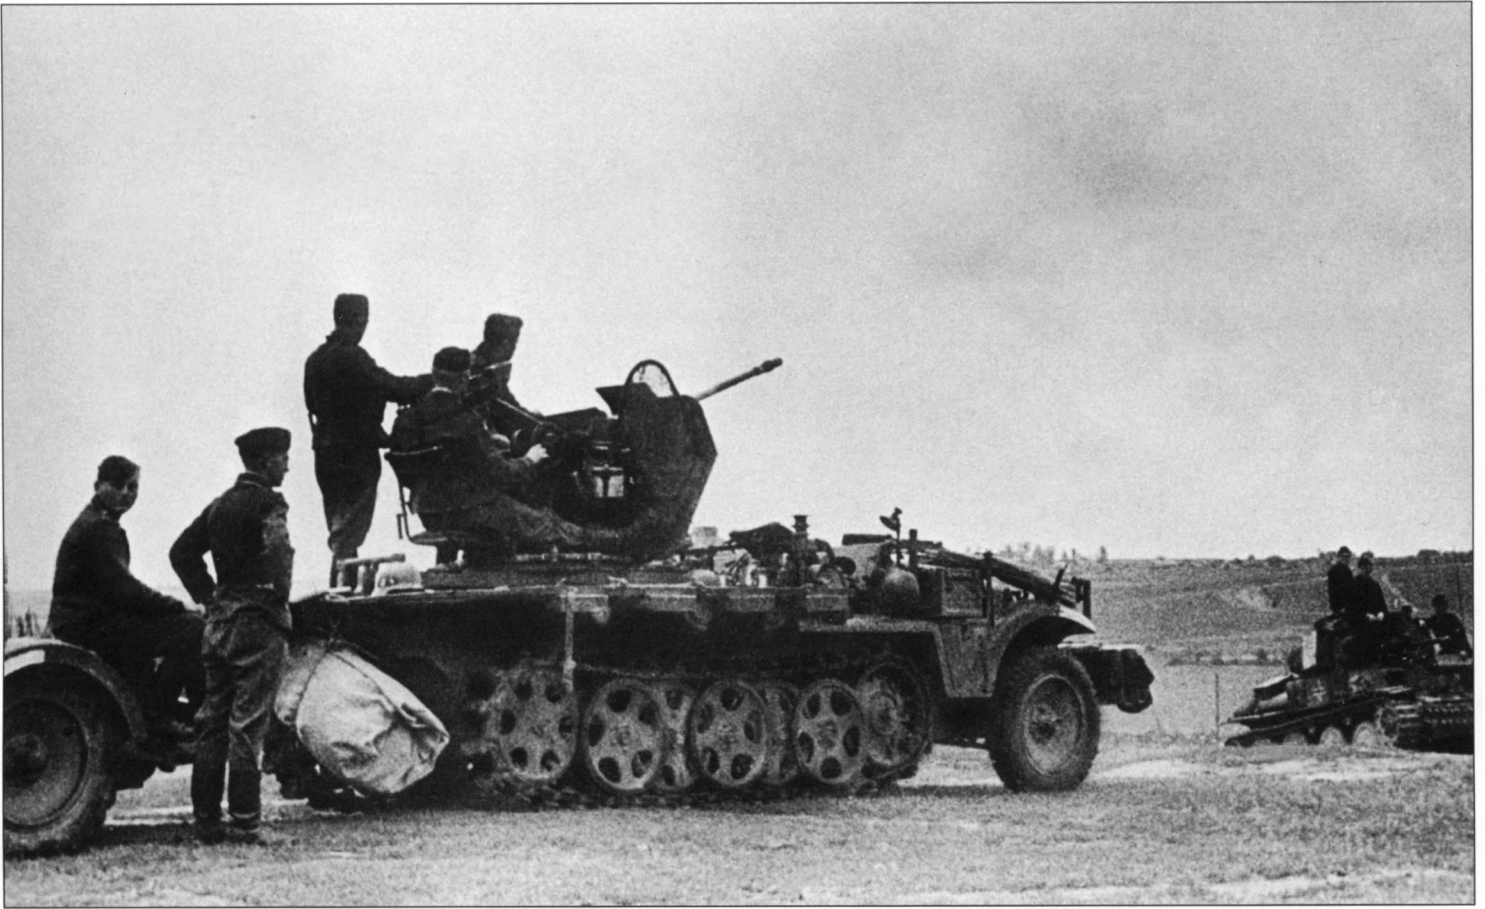
The crew of a Sd.Kfz. 10/4 is ready to provide cover fire on a road used by an advancing armored unit. The 2cm Flak gun was an effective anti-aircraft weapon. This vehicle has all its sides folded down to permit full traverse of the gun. Note the missing mudguard on the half-track.

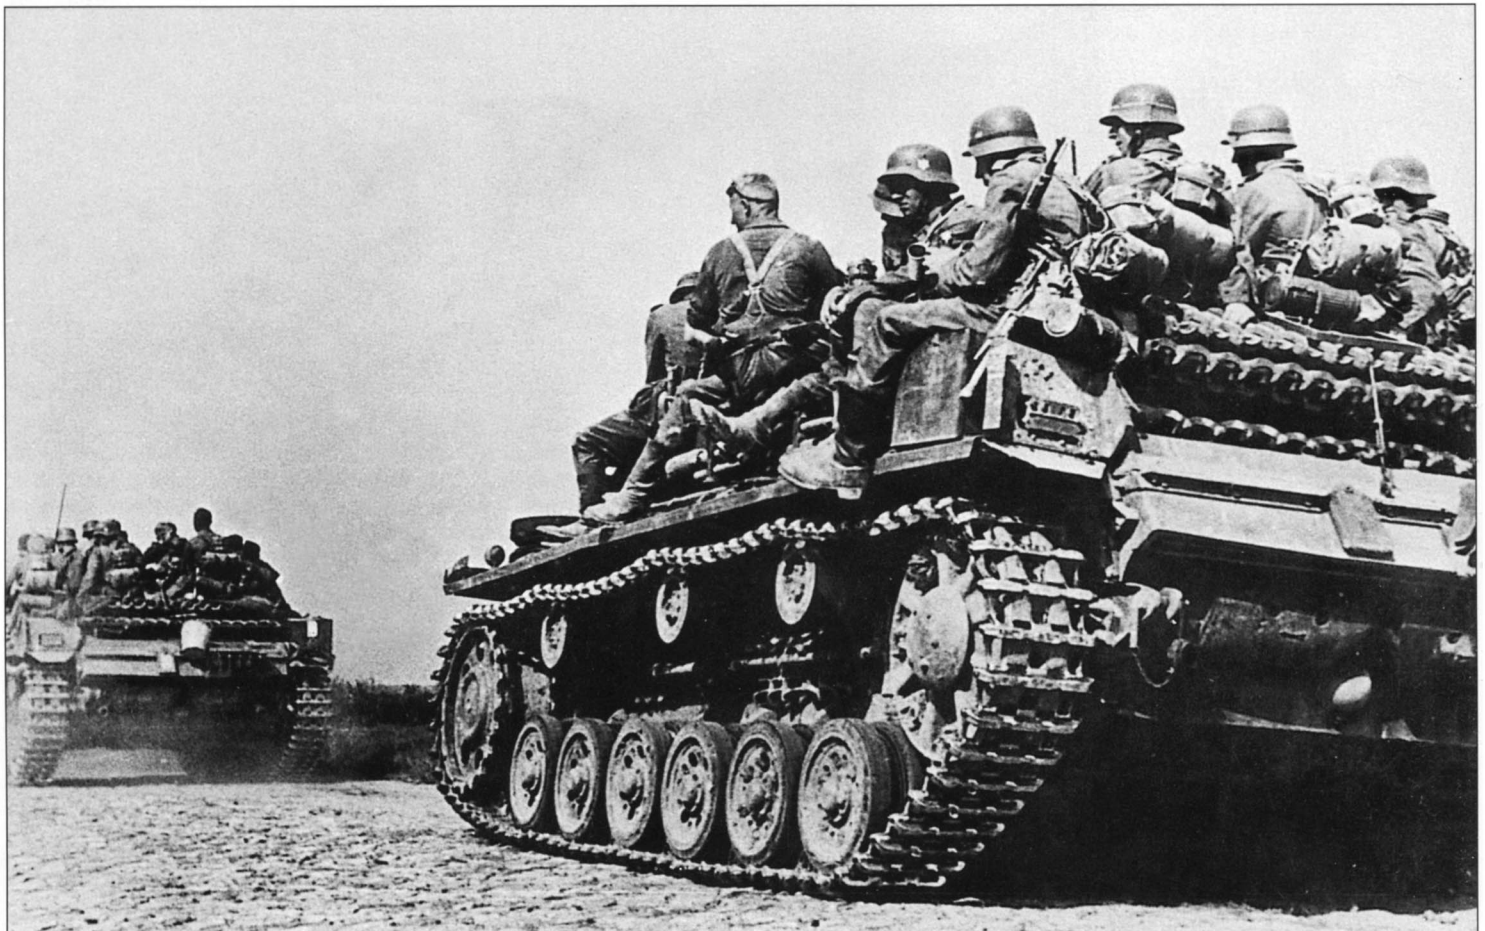
This photo of a pair of Pz.Kpfw. IIIs was taken during the pursuit of the retreating enemy. They are both fully loaded with infantrymen, who are carried for support in the upcoming battle and as protection against enemy infantry action.

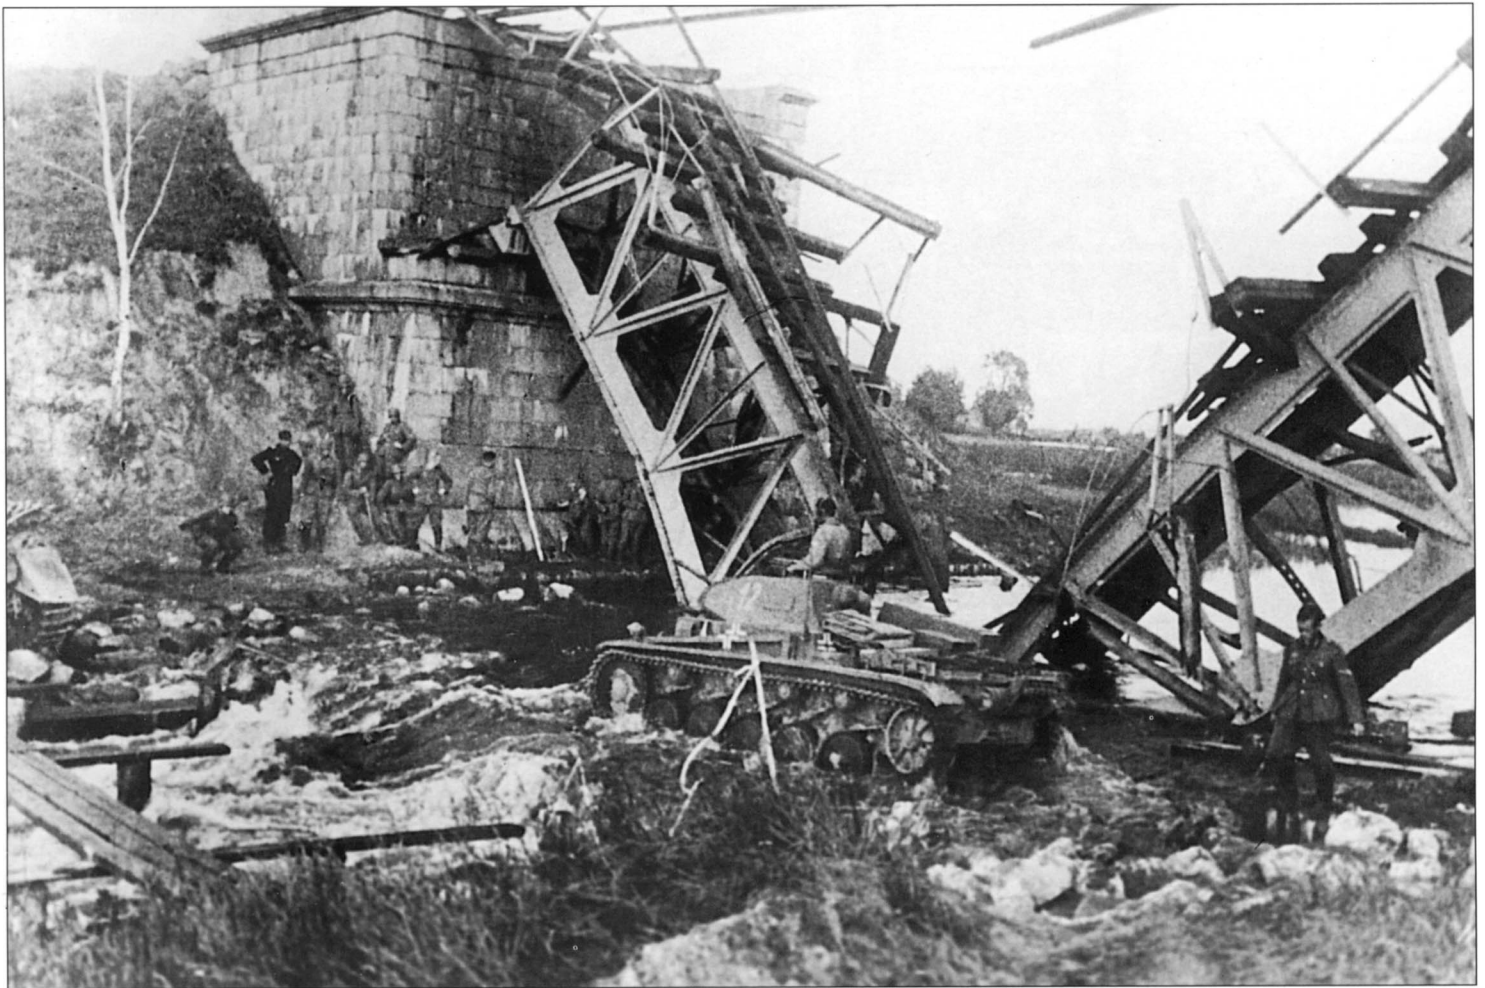
A Pz.Kpfw. II crosses a river near a blown-up bridge in the southern part of the front in July 1941. The tank carries the full set of markings, including the national cross on the rear superstructure just under the turret. The two-digit number is unusual, and the meaning of the black and white sign, visible on the superstructure to the left of the national cross, is unknown.

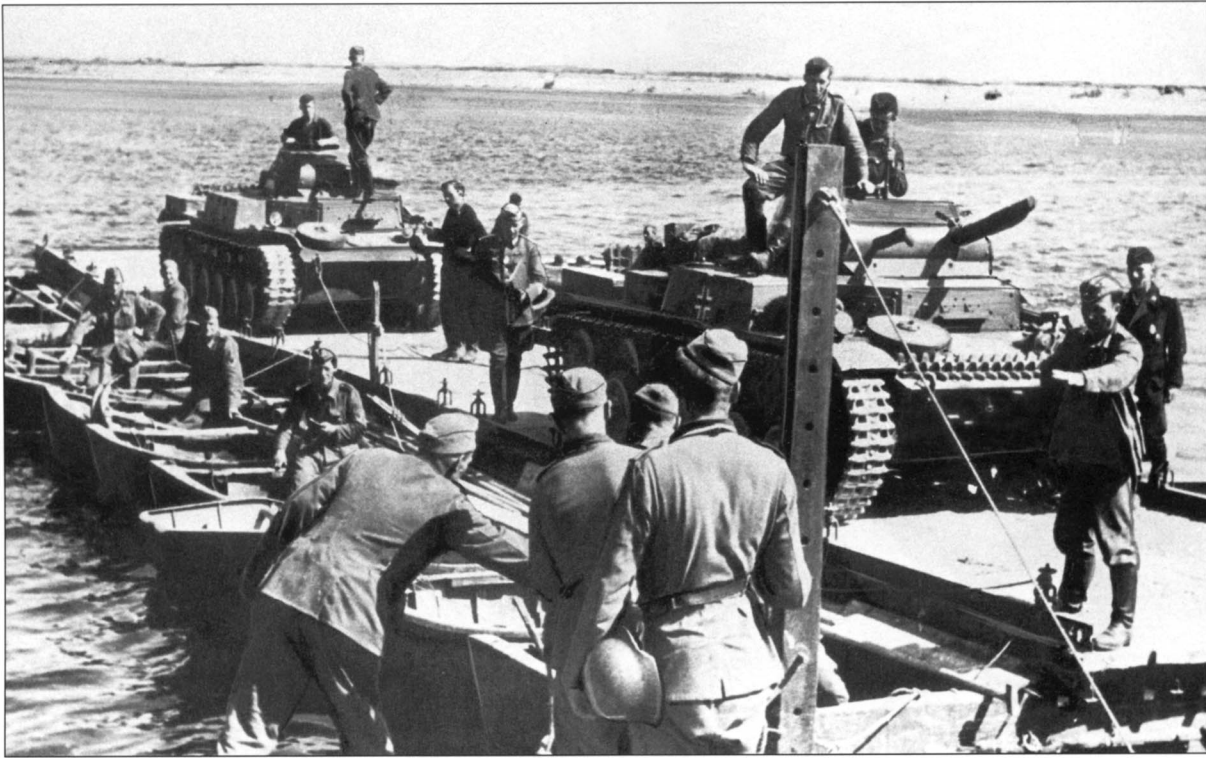
Unlike the Soviets, the Germans had no major difficulty crossing rivers, mainly because they often had more time to make preparations. They used many sorts of ferries, including parts of propelled pontoon bridges, as is seen in this photo. Note the colors of the second Pz.Kpfw. II: its frontal plate on the hull is painted in two colors, and it has old-style markings on the side of the turret — a white "2" with a rhomboid marking under it.

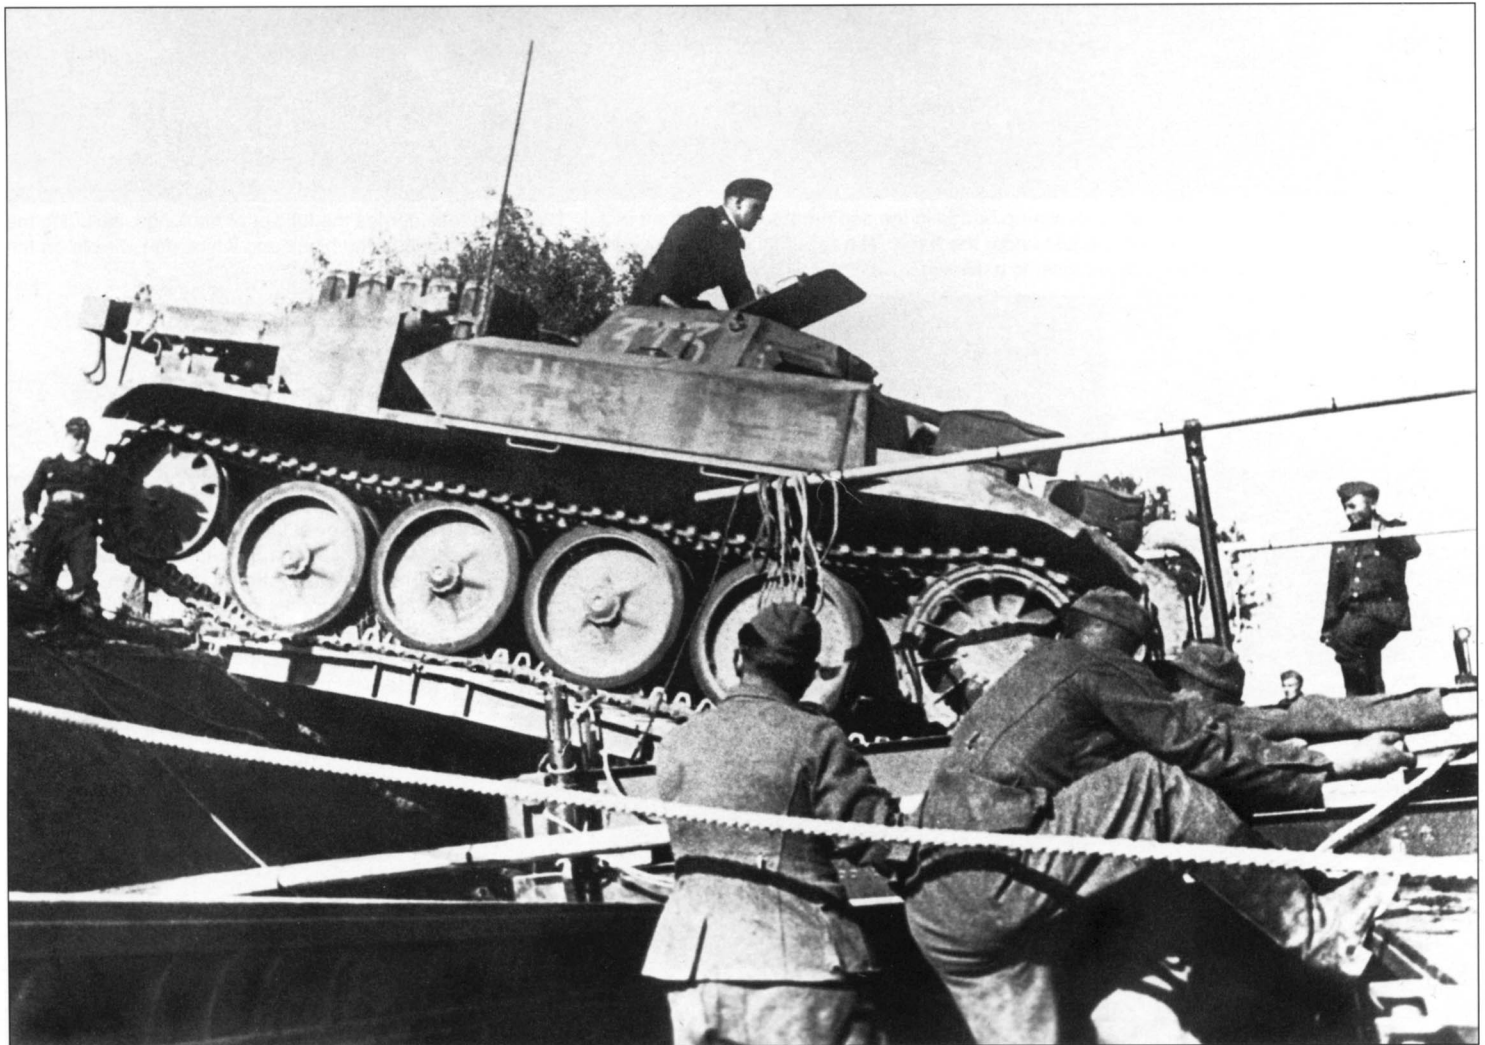
One of about 120 Flammpanzer IIs sent to the Soviet Union in three battalions, Pz.Abt.(F) 100, 101 and 102, crosses the Dniepr river during the German assault toward Smolensk in July 1941. There were two battalions of Flammpanzers used in Heeresgruppe Mitte, including Pz.Abt.(F) 100 in Pz.Gr.2, which attacked the city of Smolensk, providing great support to the attacking infantry. The tanks carried the same kind of markings (except the unit emblem), so the yellow number seen on the turret indicates the 3rd vehicle from 1st platoon in 3rd company. Each company was composed of 14 Flammpanzer IIs and 7-8 standard Pz.Kpfw. IIs. The total number of tanks in each such battalion was 73-80 tanks, a very strong force indeed.

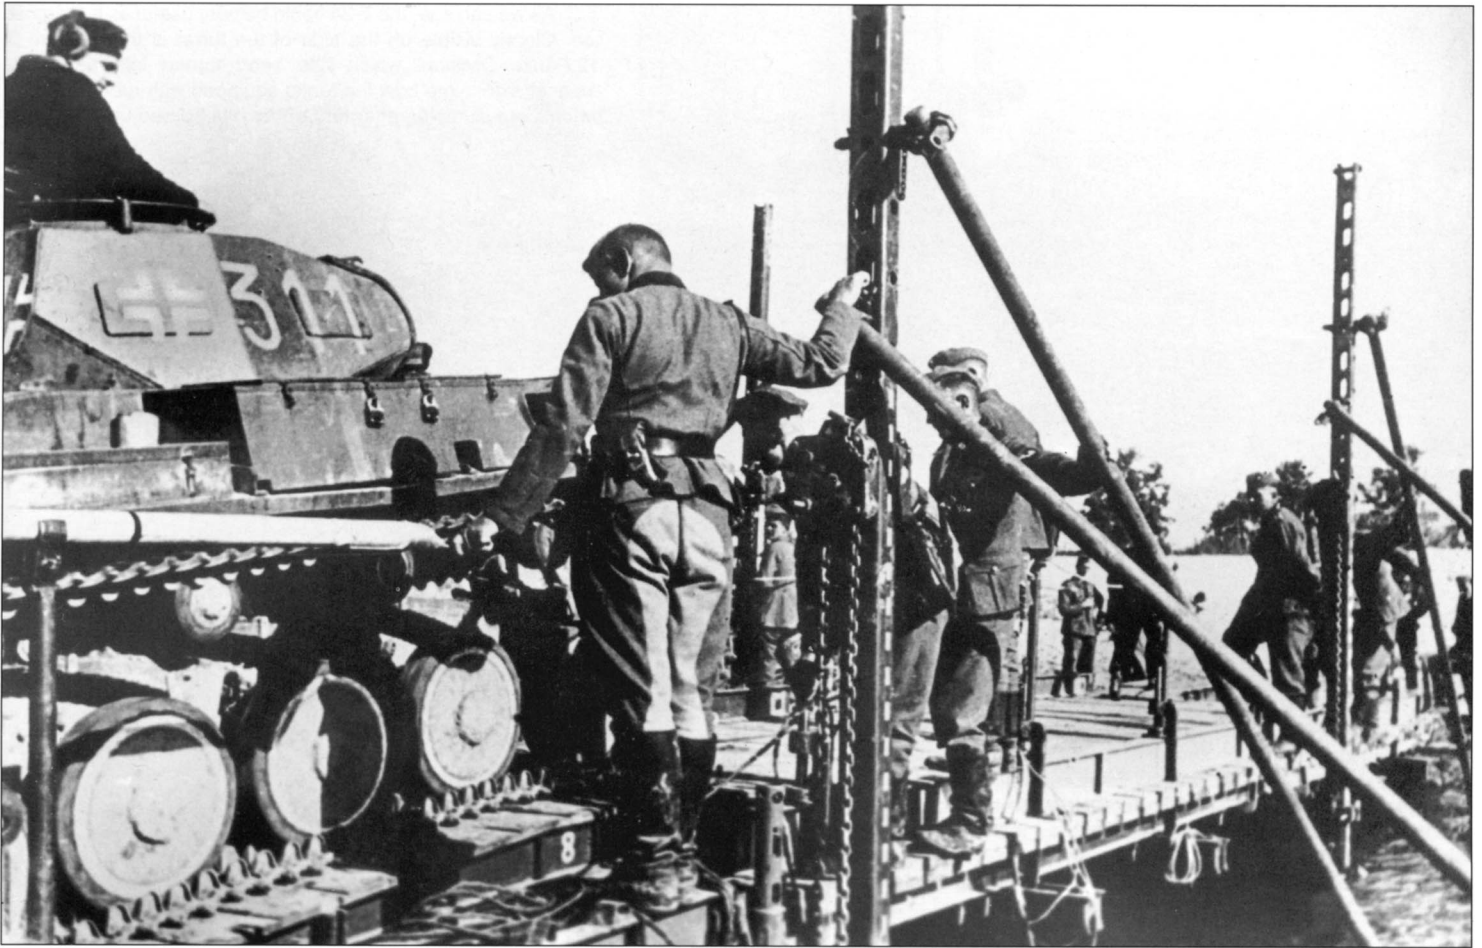
A Pz.Kpfw. II crosses the Dniepr river courtesy of a light bridge built by an engineer battalion in July 1941. The material under the tank tracks is a piece of light assault bridge used by motorized engineer troops in Panzer divisions, usually transported on the Sd.Kfz. 251/7. Of special interest are the markings on the turret, composed of white national cross and the yellow tactical number "311" on all three sides. The tank probably belonged to Pz.Abt.(F) 100 or 101.
