Armor Battles on the Eastern Front

(1) The German High Tide 1941-1942

Robert Michulec

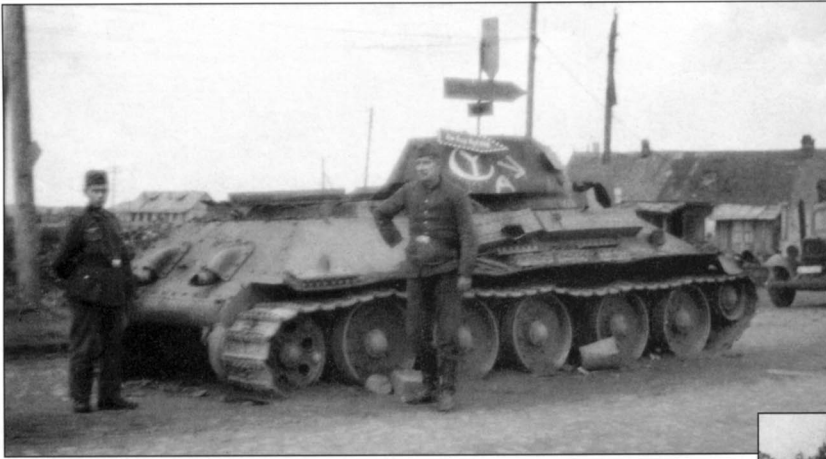
As we can see, the T-34 could be very useful as a signpost, too. Clearly visible on the side of the turret is the emblem of 12.Panzer-Division, which has been turned into a kind of “peace” sign. Note how the tanks equipped with rubber-rimmed wheels are slumping after the rubber has burned up.

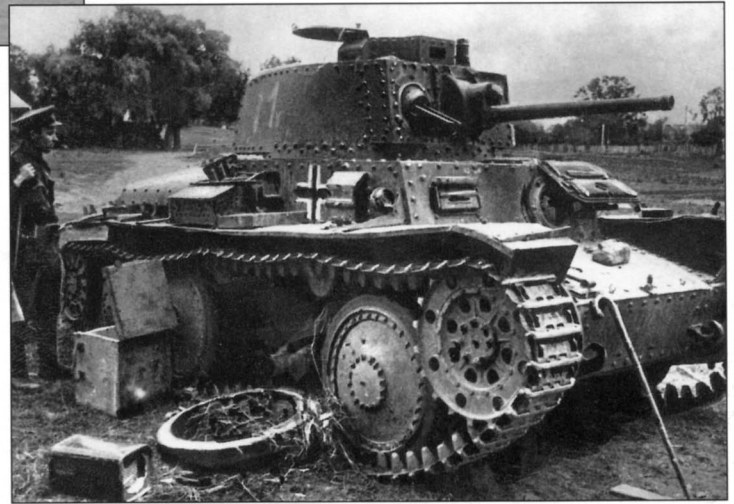
The road taken by Generaloberst Erich Hoepner's Panzergruppe 4 to Leningrad was difficult and long. Enemy resistance was very strong and caused Hoepner's Panzer divisions to suffer many casualties. Here is an example — a Pz.Kpfw. 38(t) from 8.Panzer-Division, which was knocked out of action and captured by the Soviets. Note the markings on this tank. On the turret is a yellow number “1”. Adjacent to it is the emblem of the division, also in yellow. However, the number on the turret is not the tactical number of the vehicle. This number— a white “115” — is just visible on the special plate under the markings on the turret.

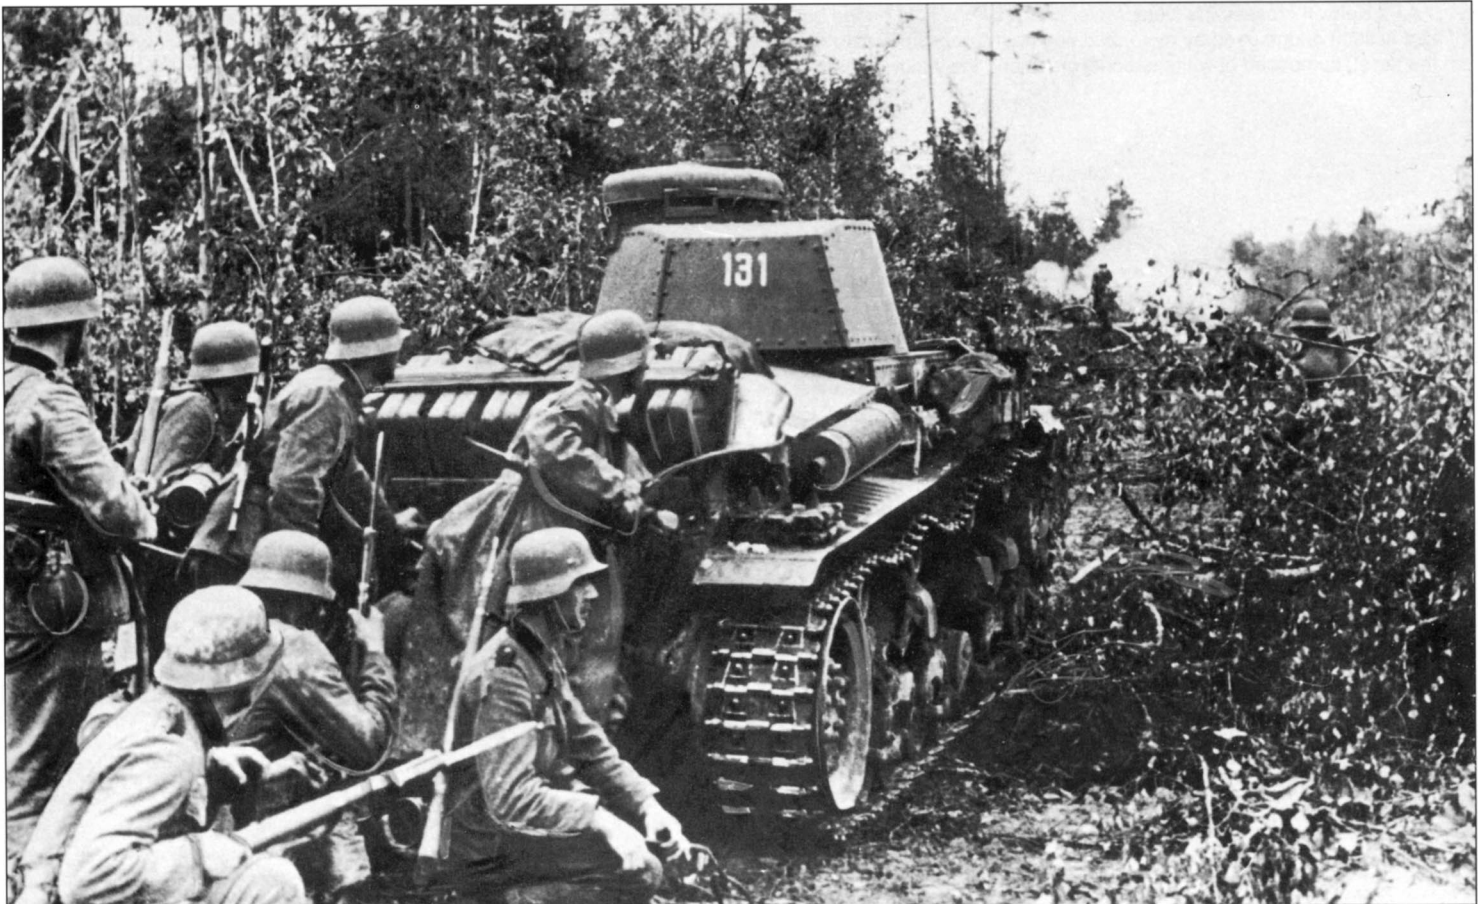
One of the reasons for the difficulties endured by Pz.Gr.4 was the weakness of its armament. One of its divisions, 6.Panzer-Division, was mainly equipped with outdated Pz.Kpfw. 35(t)s, so it is hard to say that it was a powerful unit, even though it did have 232 tanks. These Czechoslovak tanks were armed with weak 3.7cm guns that fired anti-tank rounds that could penetrate 30mm-thick armored plates only at a range of 500 meters. In this photo we see one of 6.Panzer-Division's Pz.Kpfw. 35(t)s during action in a Russian forest. Note the tactical number on the turret — quite unusual by German standards.

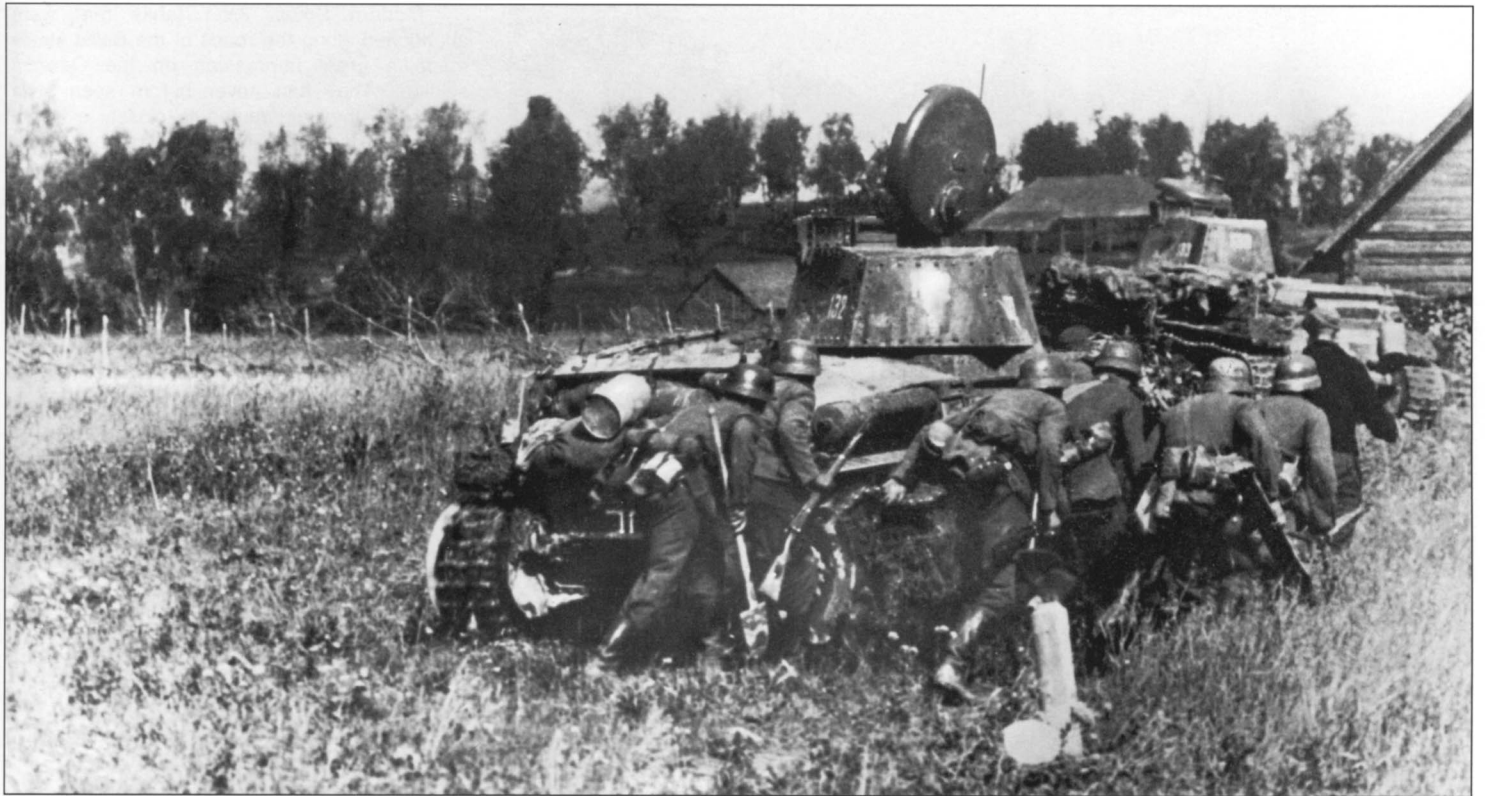
An infantry squad takes cover behind a Pz.Kpfw. 35(t) from 6.Panzer-Division, which was employed by XLI Pz.Kp. attached to Pz.Gr.4 of Heeresgruppe Nord. There were 232 tanks in the division on 22 June 1941. Though the division was strong on paper, the majority of its tanks were 155 Pz.Kpfw. 35(t)s supported by five command vehicles. Both Pz.Kpfw. 35(t)s in the photo have standard camouflage and markings, including closely spaced tactical numbers repeated on the three sides of the turret. The rear tank has the tactical number "132", while the lead tank has "133".

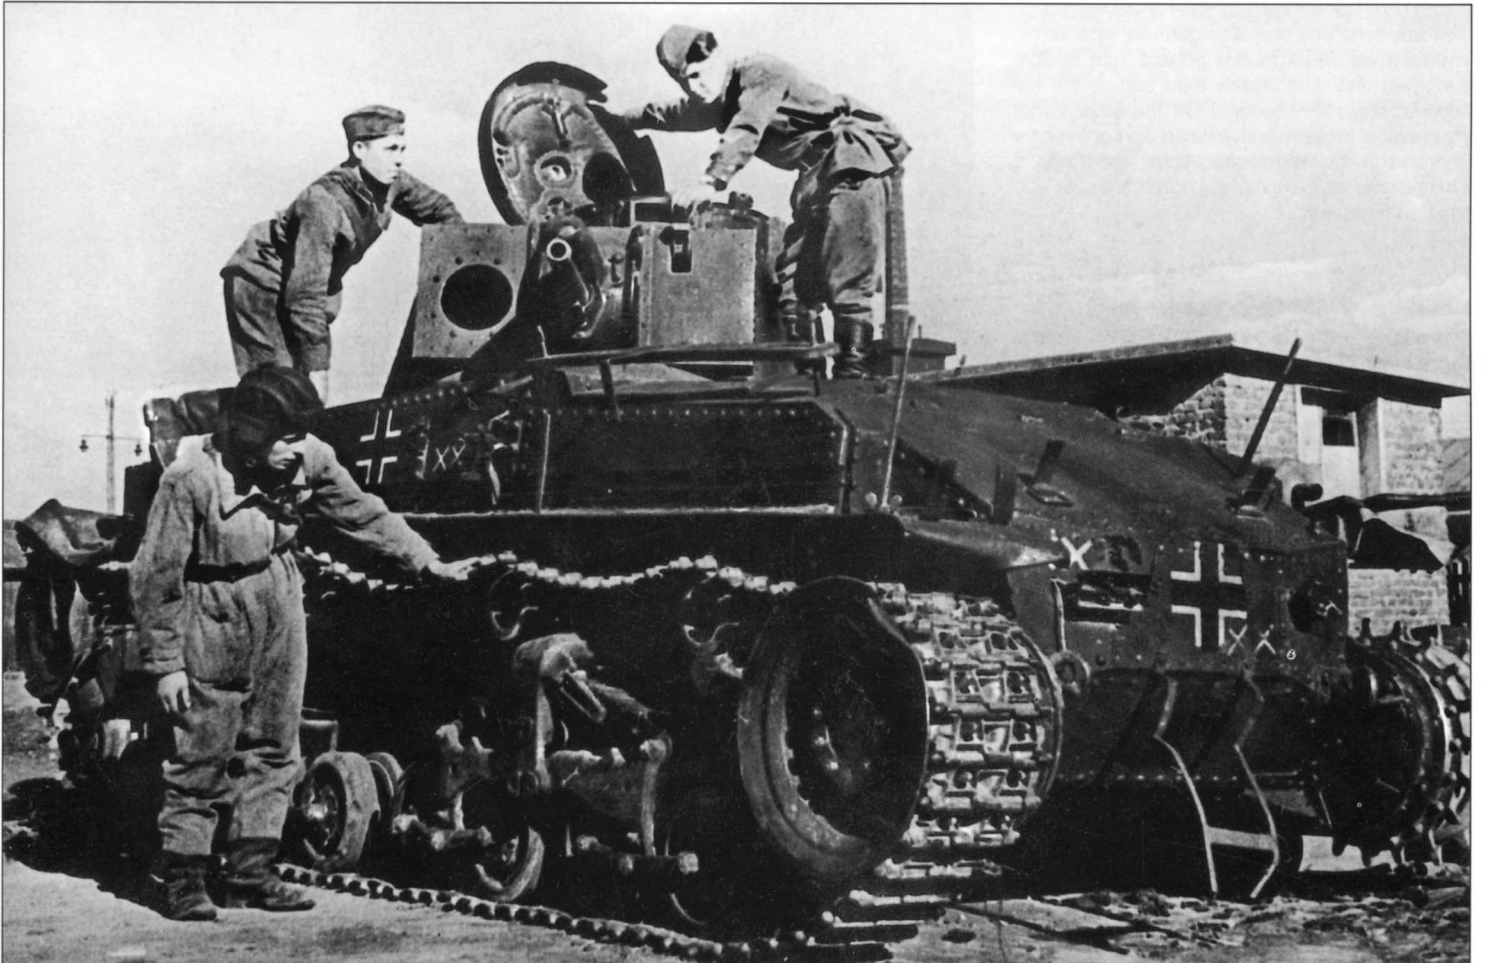
Soviet soldiers inspect a captured Pz.Kpfw. 35(t) from 6.Panzer-Division. Note the divisional markings — XX — on the side of superstructure, as well as another set on the rear hull plate. By the end of August 1941, 6.Panzer-Division had lost 35 tanks, and another 33 had been damaged. By the winter of 1941/42, almost all of the division's tanks had been lost in the fields or forests of northern Russia, mainly due to breakdowns.

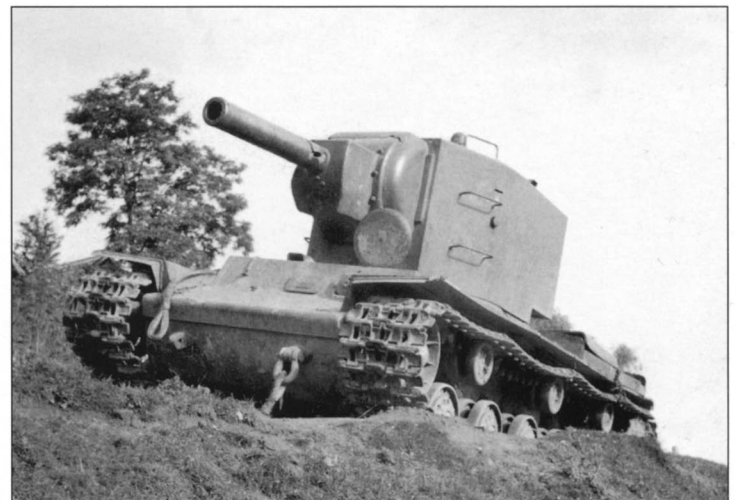
Most of the KV tanks the Germans came across in Lithuania were abandoned due to mechanical breakdowns, lack of fuel or minor combat damage. This KV-2 is a victim of one of these problems. Note the hole in the gun barrel near the mantlet.

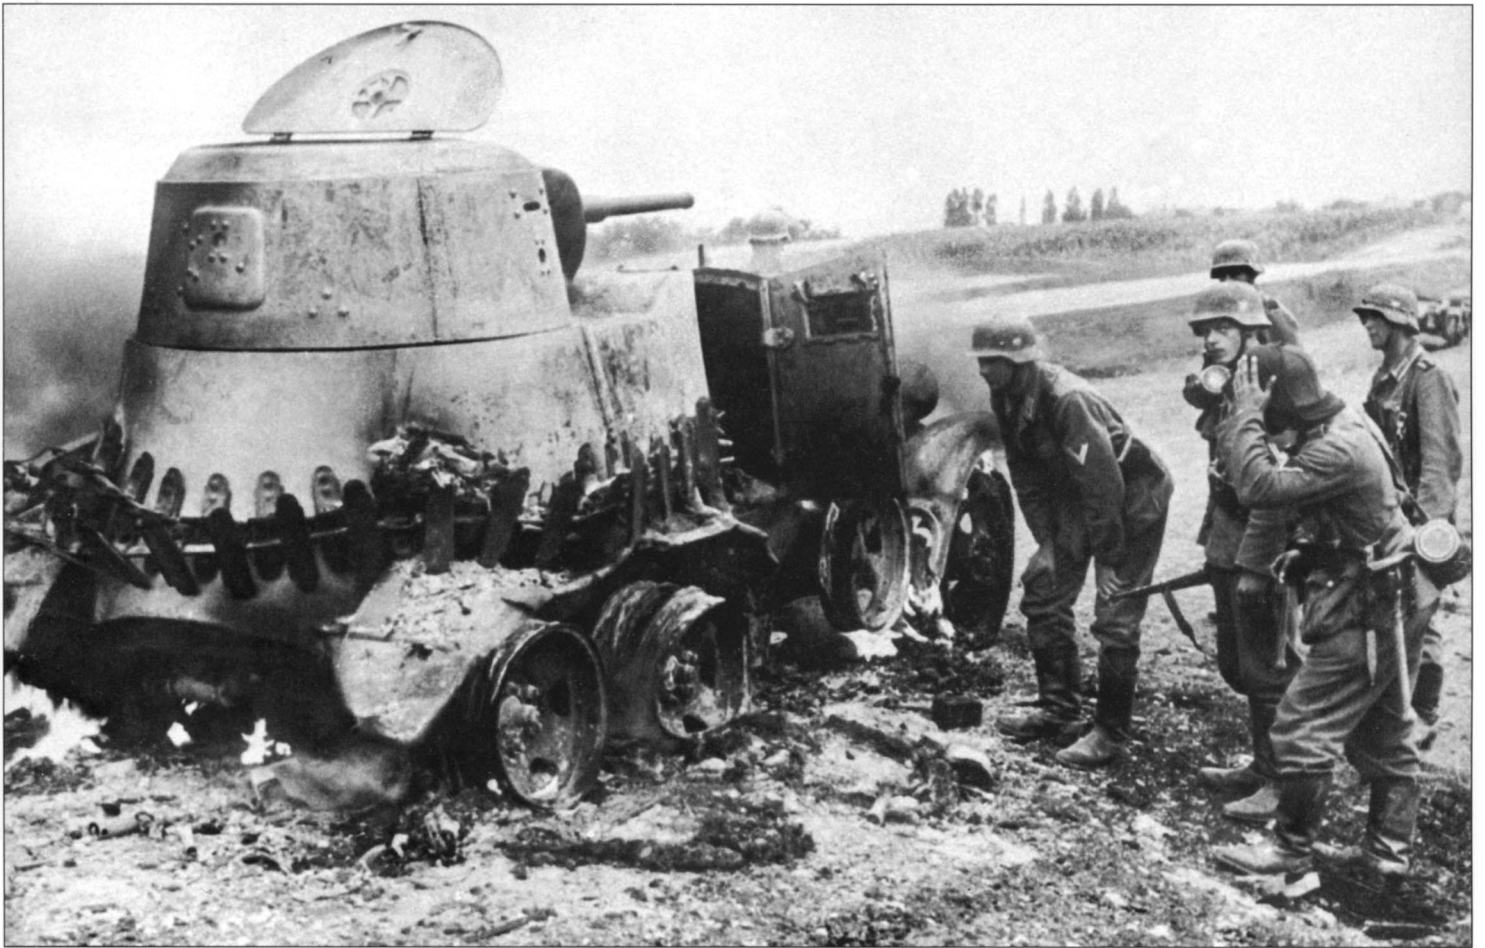
The gesture of the soldier nearest to the camera indicates his amazement at the total destruction inflicted on this BA-10. The armored car was totally demolished by a direct hit to the fuel tank. Supplementary track was strapped around the hull, which could be placed over the rear wheels to convert it into a half-track to help negotiate difficult terrain. Note the turret details: the hatch in its rear and the interior elements of the ventilation mushroom on the top hatch.

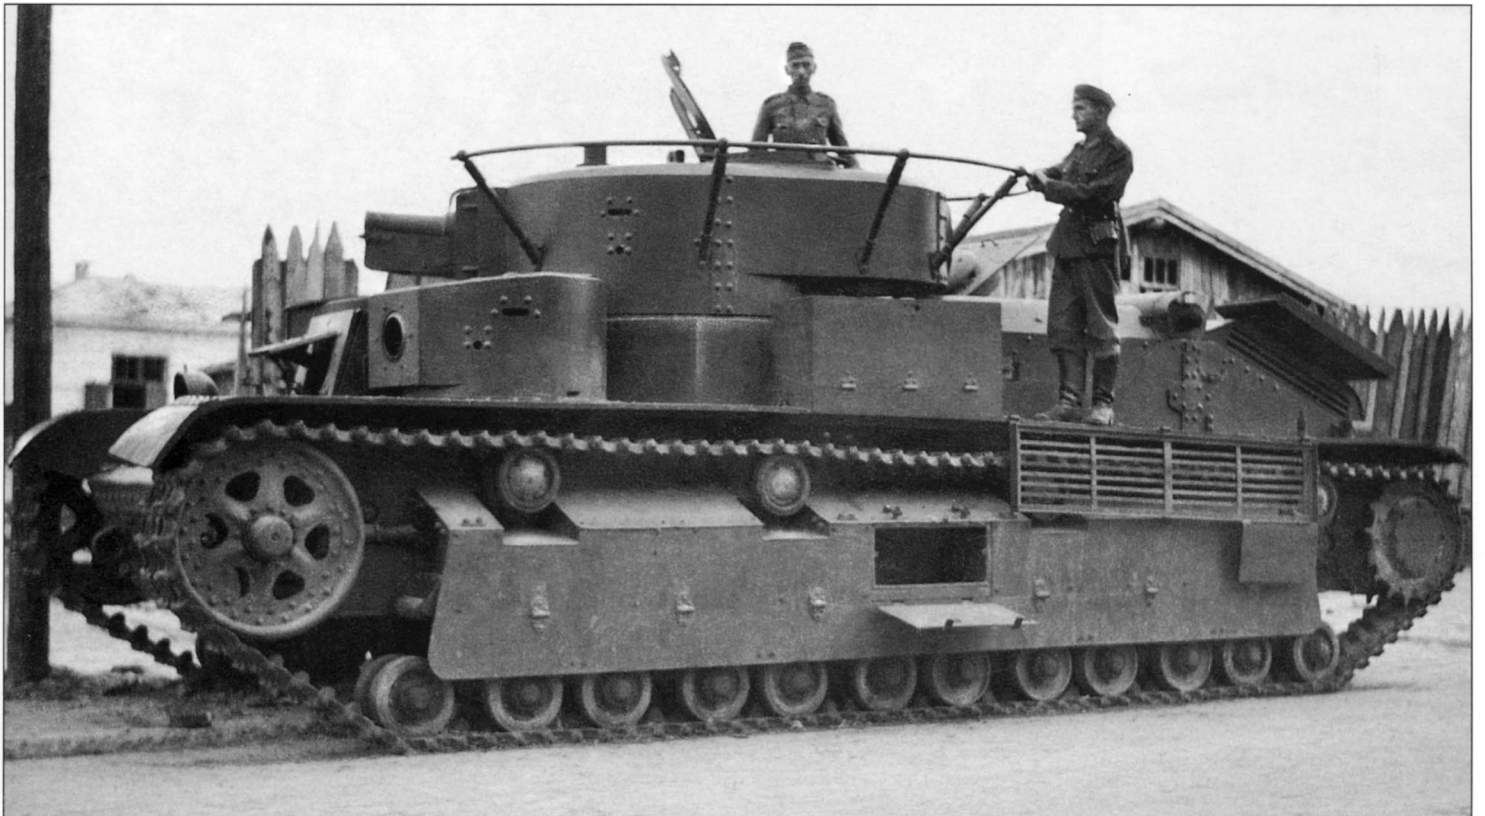
The Soviet medium tank of the 1930s, the T-28, was big, slow and had thin armor. There were 490 of these tanks produced between 1932 and 1939, and about 400 of them were in service at the beginning of Operation "Barbarossa", mainly in the 3rd, 5th, 8th, 10th, and 15th Tank Divisions. This is a command version of the T-28, apparently abandoned due to a mechanical breakdown or fuel shortage. Note the short-barreled KT-28 76.2mm gun.

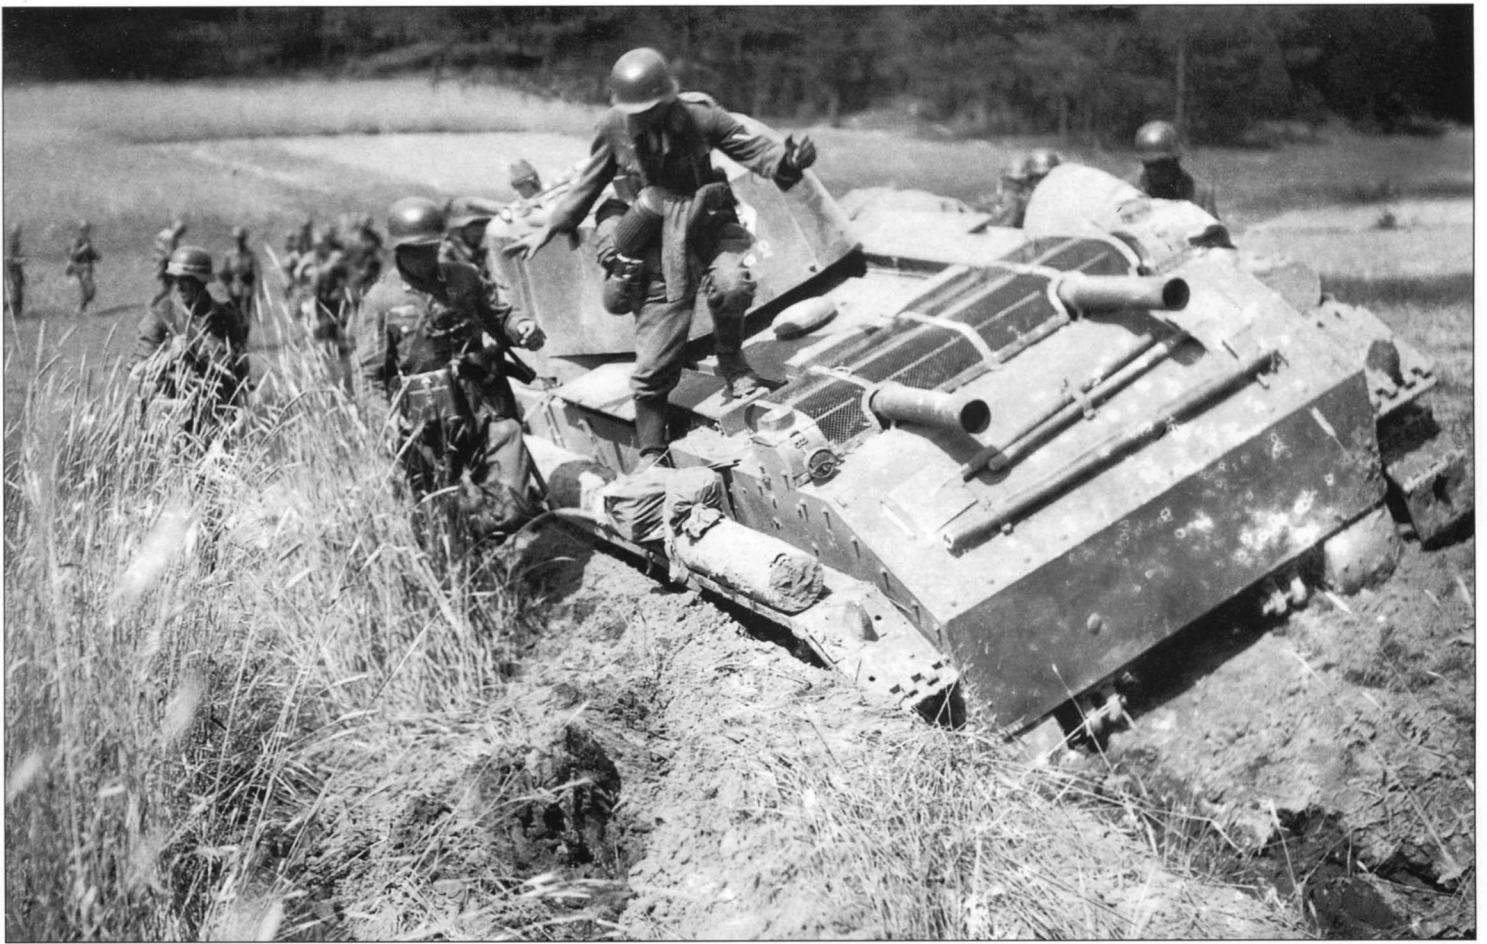
German soldiers enjoy looking at another tank found along their way. This one is a BT-7 bogged down in the soft ground of a corn field. The photo shows many details of the upper surface of the rear portion of the tank. The unit emblem on the rear of the turret is partially blocked by a soldier.

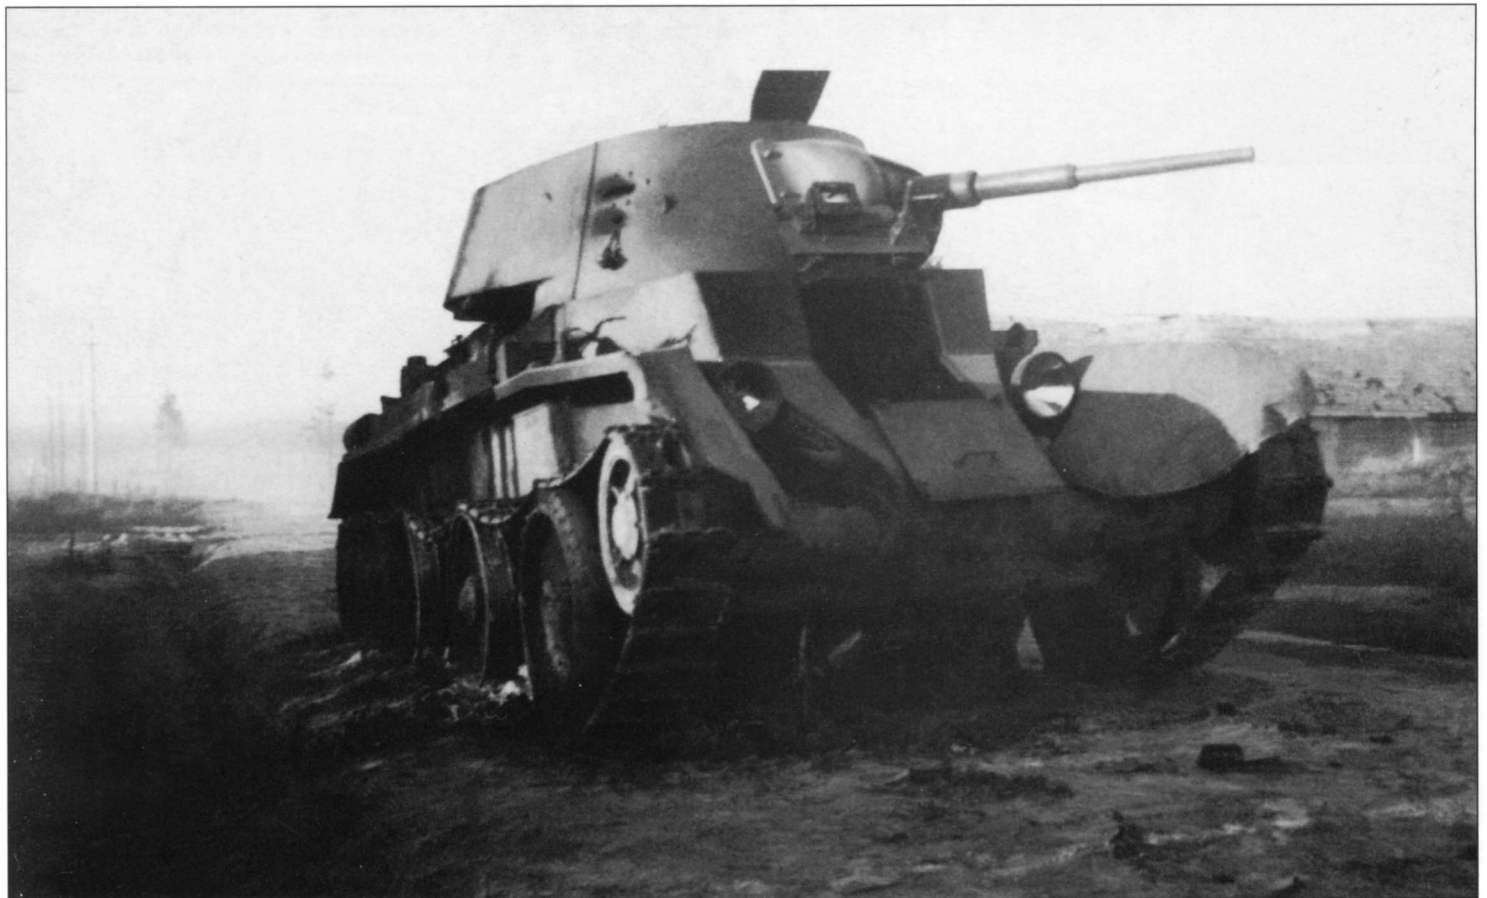
Another BT-7 abandoned on a road in a village. This tank was hit hard during a duel and was destroyed mainly by internal fire. Note the areas on the turret that have been blackened from smoke. The crew of this tank was probably lucky and escaped, a conclusion drawn from the open driver's hatch.

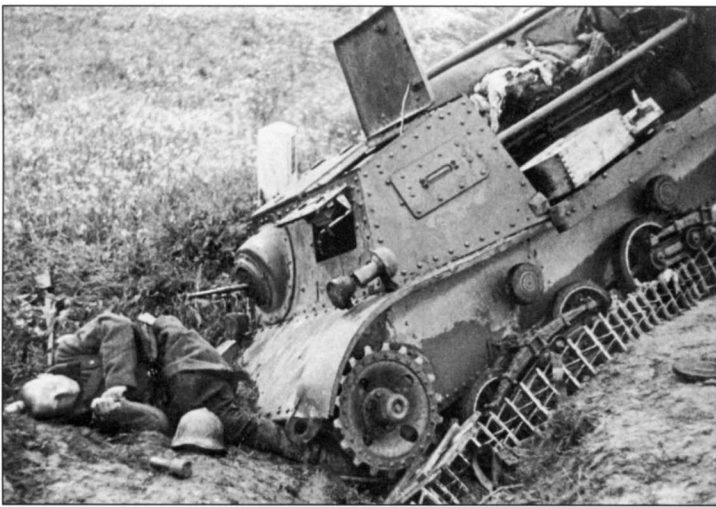
The soldier seen here had no luck at all — after being killed his legs were crushed by a Komsomolets artillery tractor used for towing anti-tank guns. This is probably a late production version with an enlarged machine gun position. This type of vehicle was very unusual because it was fully tracked, very small, armed with a machine gun, and the compartment for the gunner and driver was covered with 7-10mm armored plates. It was more of a combat vehicle used to support infantry or an anti-tank battery than simply a tractor for a gun crew.

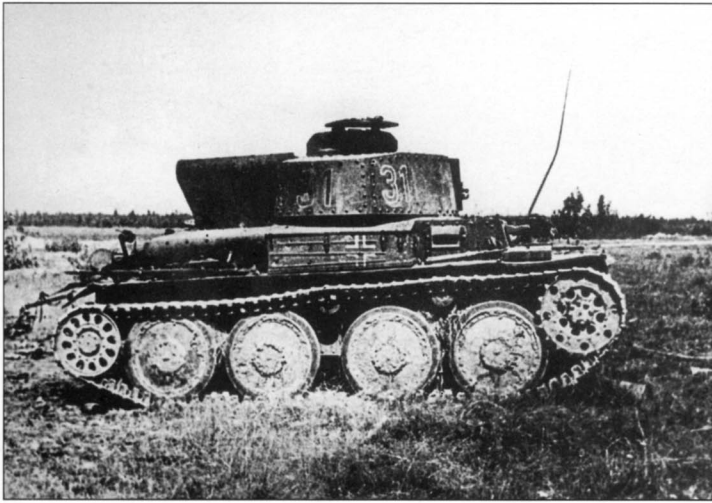
The German 20.Panzer-Division was involved in heavy fighting northeast of Smolensk, where the division had to battle against Soviet counterattacks. The 20.Panzer-Division repulsed all the Soviet attacks and retained its front line, but it suffered heavy losses due to the Soviet gunners and the breakdowns of tanks. Because the Soviets regained some terrain, all these tanks were lost. This Pz.Kpfw. 38(t), marked with the tactical number "31", is from 3rd company of Pz.Rgt.21. The number on the rear of the turret is painted in two colors, while the other one, painted only on the side, is just a white outline. The national cross was painted on the box in the same way.

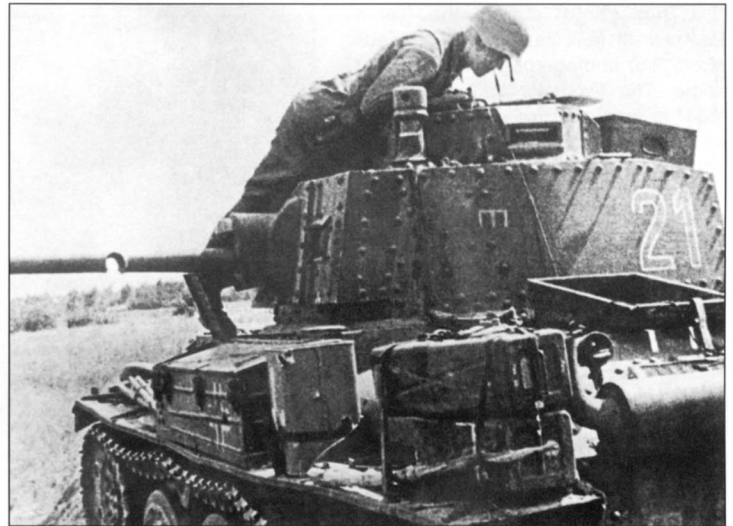
Another derelict Pz.Kpfw. 38(t), tactical number "21", is inspected by a Soviet soldier. Note that the barrel of the 3.7cm gun is pierced with a hole made by a Soviet 47mm round. The tactical sign of 20.Panzer-Division is painted in yellow on the turret.

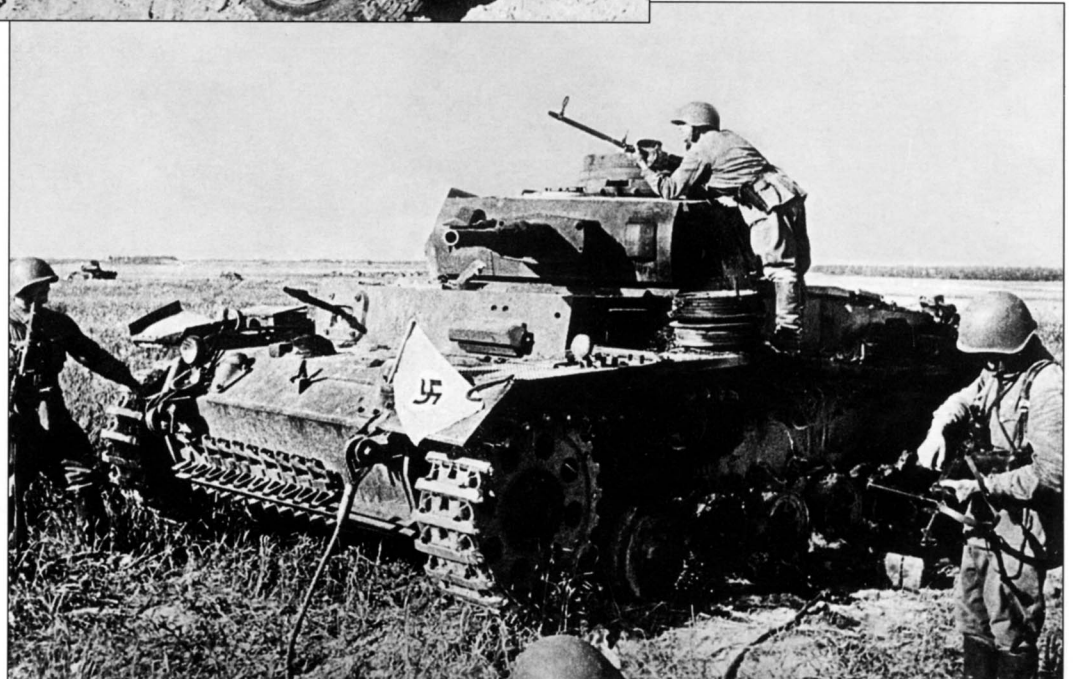
Another Pz.Kpfw. III, this time an Ausf. G from the early series, with the old type of cupola, but with an MG15 installed for anti-aircraft duty. Unlike tank number "531", this one is devoid of the additional 30mm armor on the hull and superstructure frontal plates. Notice that the tank was hit by a round in the left side of the hull, which ignited a fire. In the background is another knocked-out Pz.Kpfw. III.

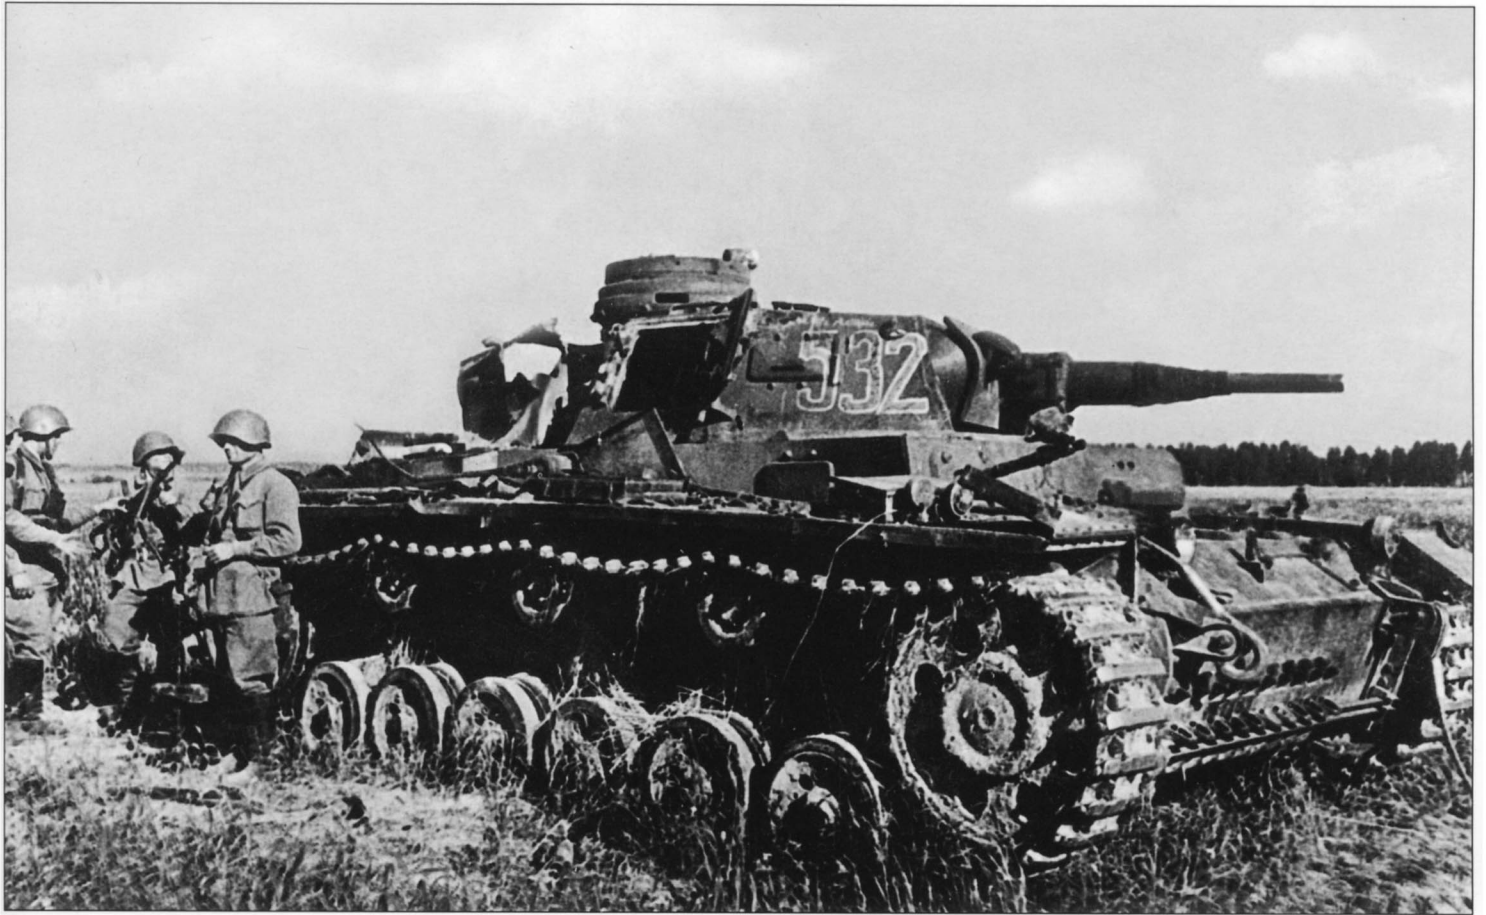
The same Pz.Kpfw. III tank photographed from the other side. This vehicle has a smaller tactical number "532" painted in red with a white outline. Note the damage to the stowage box — it shows where a round tore through then ripped off part of the door of the turret's hatch.

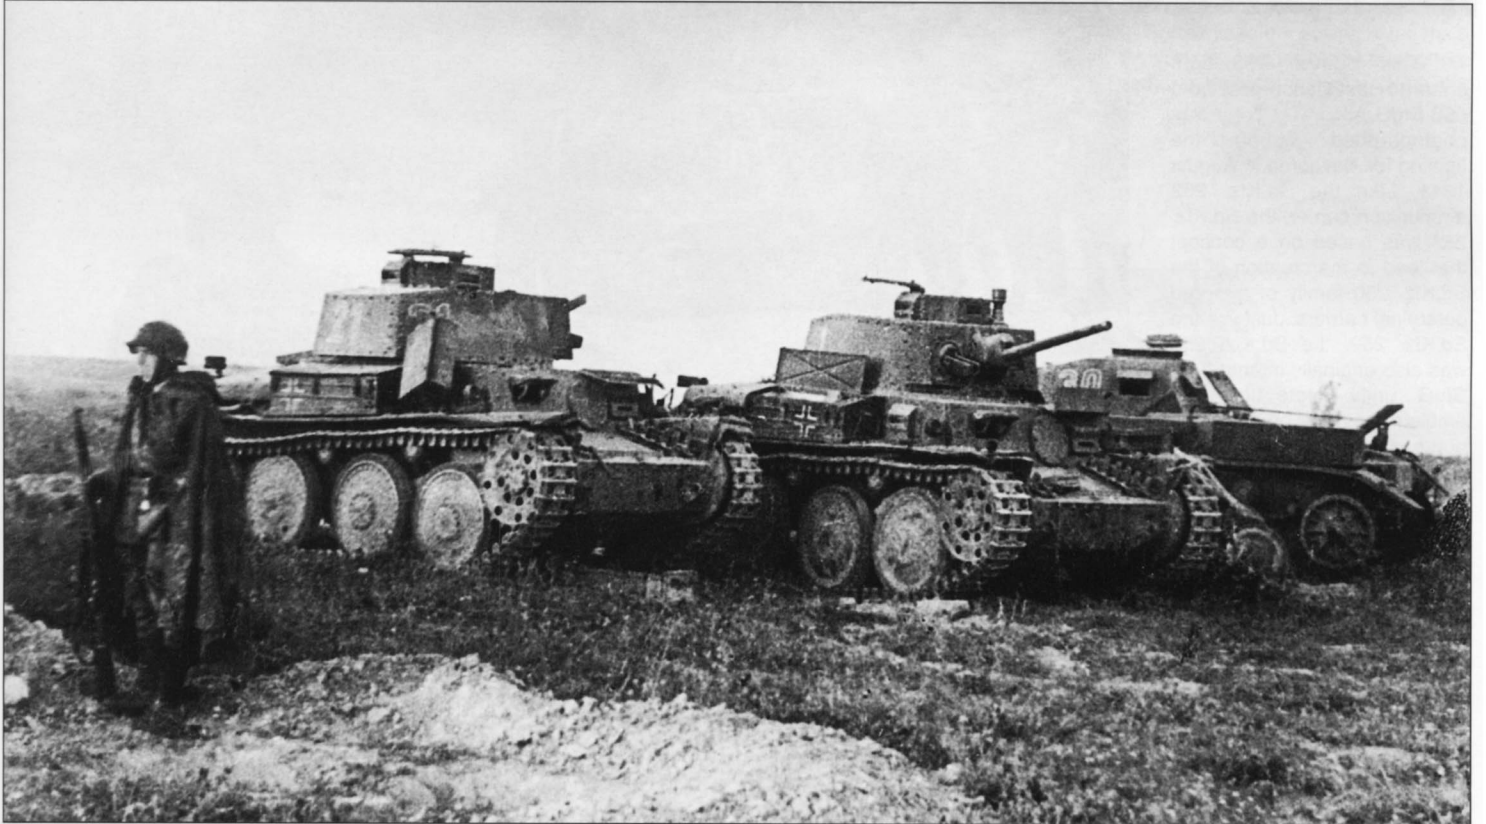
Another group of German tanks captured by the Soviets. These two Pz.Kpfw. 38(t)s and the Pz.Kpfw. II, which belonged to 7.Panzer-Division, were lost during the long, stubborn battle at the Smolensk-Moscow highway near Yartsevo in July 1941. Note the markings on the Pz.Kpfw. 38(t) at the left and the Pz.Kpfw. II at the right — they have numbers of only two digits painted in red with a white outline. The previous number of the second Pz.Kpfw. 38(t) was probably painted over. General Hermann Hoth's Panzergruppe 3 tried to finish off the Soviet troops northeast of Smolensk, but its most advanced division was stopped and counterattacked by strong enemy forces in the Yartsevo area. The fighting for Yartsevo lasted for seven days, and the town was taken and re-taken two or three times a day by the opposing forces.

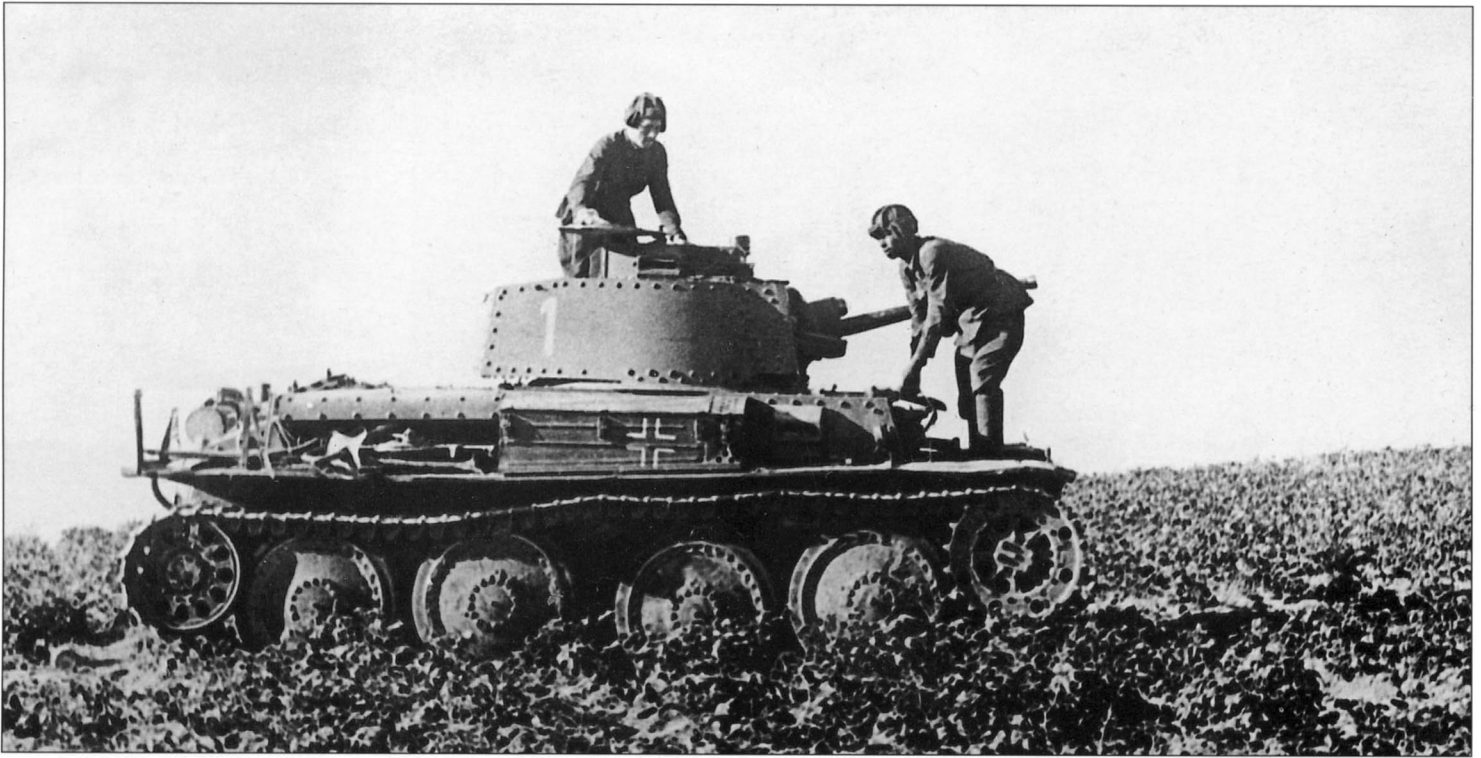
Another Pz.Kpfw. 38(t) abandoned in the Yartsevo area is inspected by members of a Soviet tank crew. The only serviceable tank captured there, it was later used by the Soviets. Note the one-digit number painted in white or yellow. The German forces at the battlefield of Yartsevo were represented by 7.Panzer-Division, while the Soviets were represented by the 69th, 101st and 110th Tank Divisions, and also by a group of 3,000 infantry and 300 different guns, which defended the town.

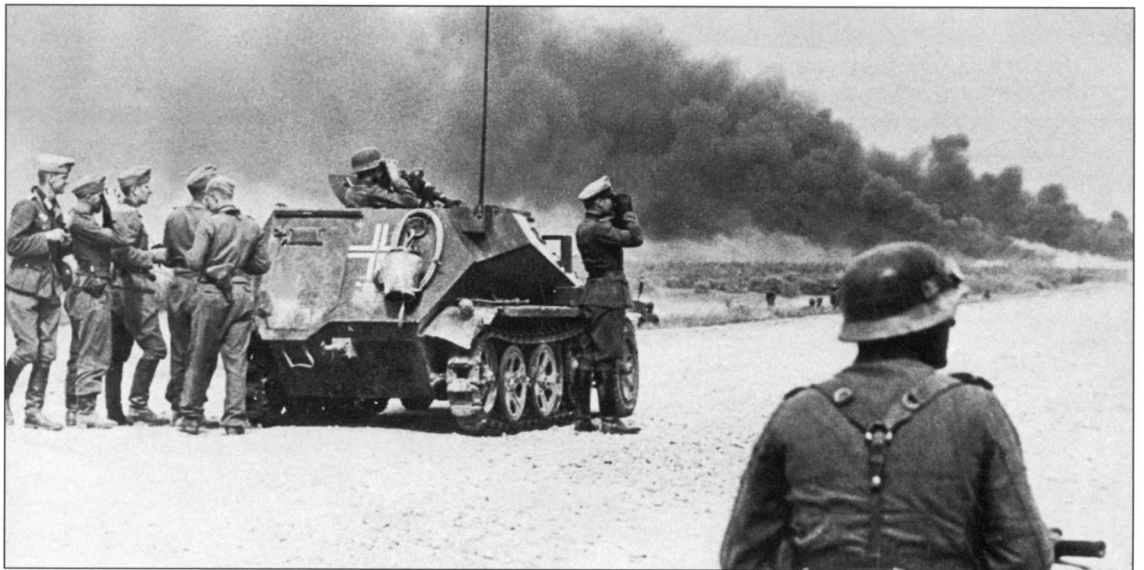
This Sd.Kfz. 253 light armored observation post from 666.StuG.Abt. was photographed during the fighting for Novgorod in August 1941. Like the Sd.Kfz. 252 ammunition carrier, the Sd.Kfz. 253 was based on a concept that led to the creation of the Sd.Kfz. 250 family of armored personnel carriers. Just like the Sd.Kfz. 252, the Sd.Kfz. 253 was also originally intended for StuG units. Note the unit emblem painted on the rear doors of the vehicle.

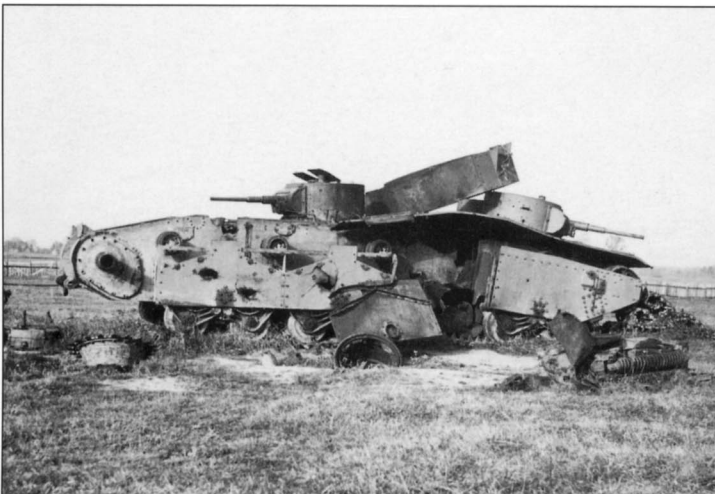
Although only 59 pieces of the T-35 heavy tank were produced, it was the most famous tank of the summer season of 1941, especially to the German soldiers serving in the rear, who were impressed by the huge size of this vehicle. During the beginning of "Barbarossa", almost all the T-35 monsters (there were 48 of them operational in western Ukraine) were used by 34th Tank Division from 8th Mechanized Corps, which was involved in the great armored battle in Ukraine. One of the regiments in this division, the 67th Tank Regiment commanded by M.D. Bolkhovitin, suffered heavy losses from air assaults on the first day of war and was almost completely wiped out. The first three T-35s were damaged by aircraft and blocked a road. Other tanks that tried to avoid them were lost in just a few minutes due to mechanical breakdowns in the fields near the road or in roadside ditches. This T-35 was destroyed by one of the Luftwaffe's bombs.

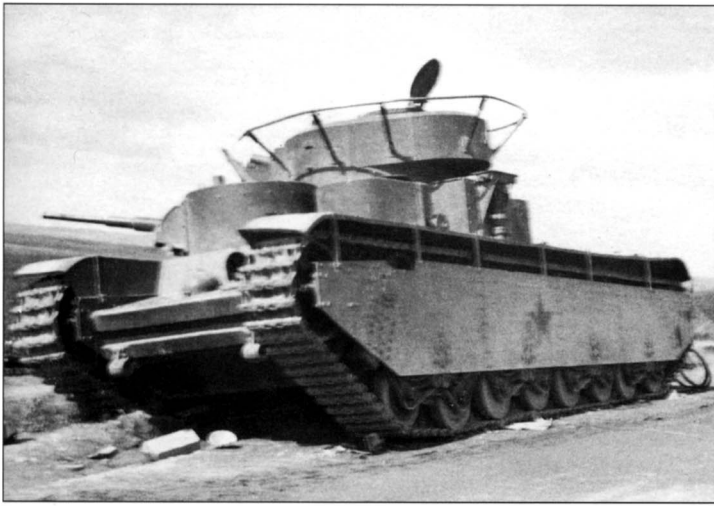
A T-35 from the 1934-1937 production series, which is equipped with a frame antenna, lies abandoned in a ditch. Note the Soviet red star on the side of the armor.

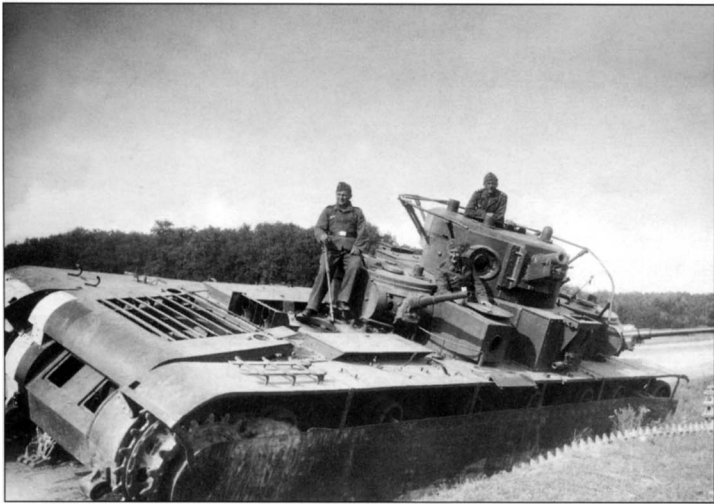
Another T-35 of 34th Tank Division that ended up in a ditch following a mechanical breakdown. Note the details visible on the deck. The Germans painted the white road markings for the safety of their drivers who were driving at night. They also removed the track, which was probably used to up-armor their tanks.

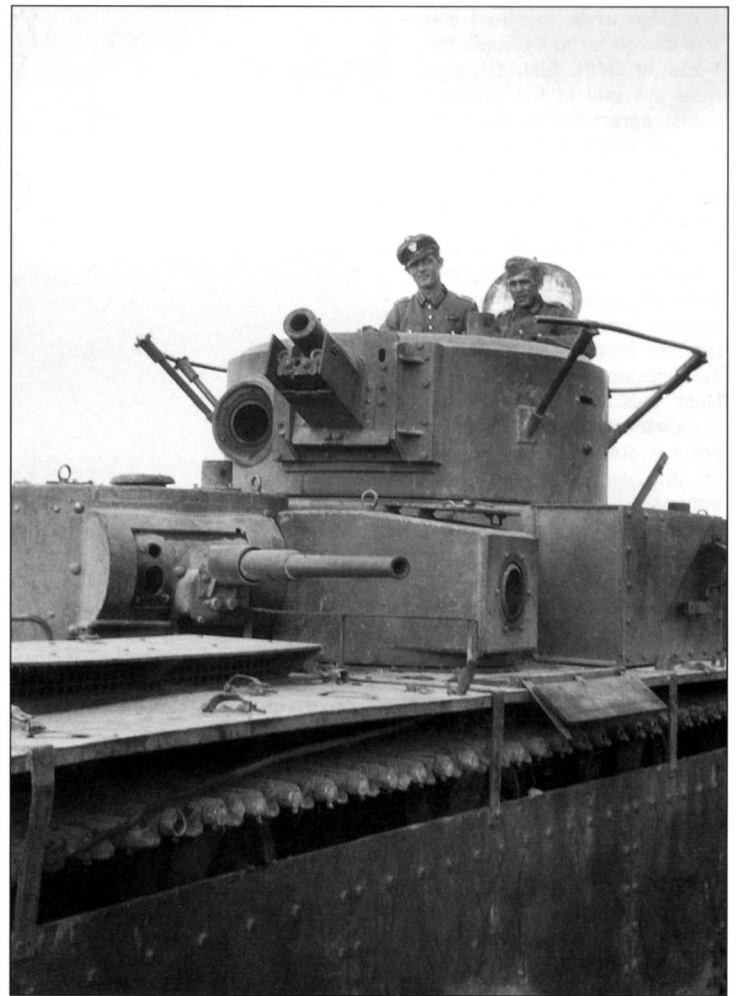
Close-up view of a T-35 tank with its German captors posing in the main turret. Note that the tracks are still on the vehicle. Just visible at the bottom right-hand corner of the photo is the red star national insignia. Note the many details of the turret construction.

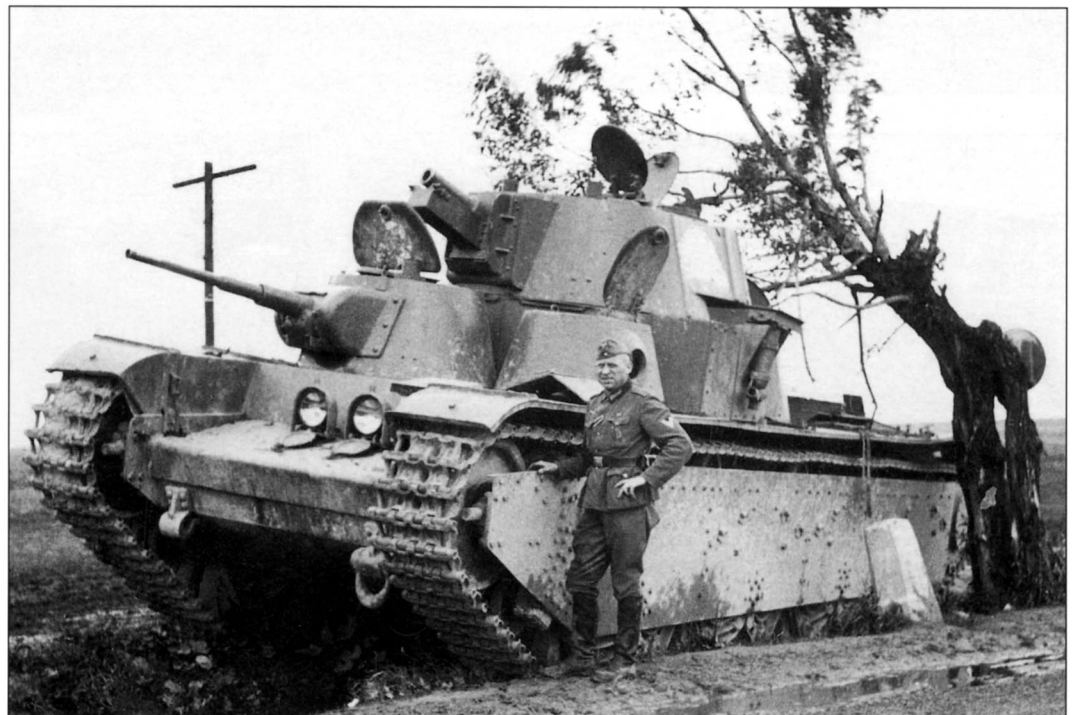
This T-35 from the 1938 production series (which produced 11 vehicles in all) suffered damage while crossing a ditch. Note the unit markings on the side of the main turret and the pattern of rivets on the hull armor.
