Armor Battles on the Eastern Front

(1) The German High Tide 1941-1942

Robert Michulec

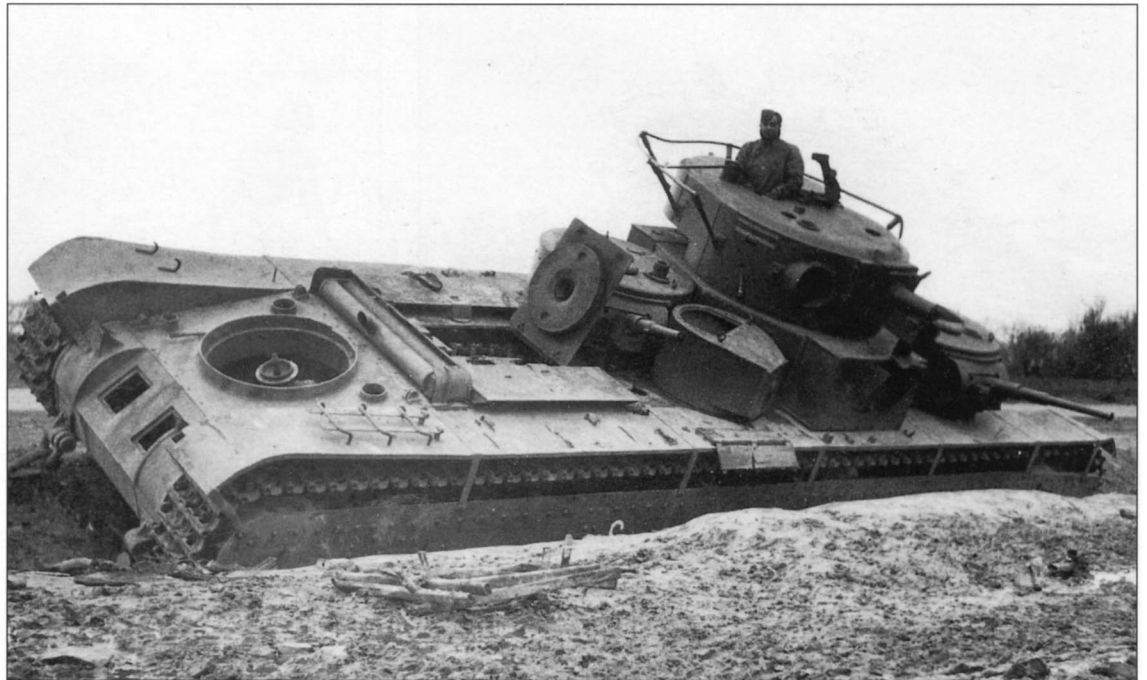
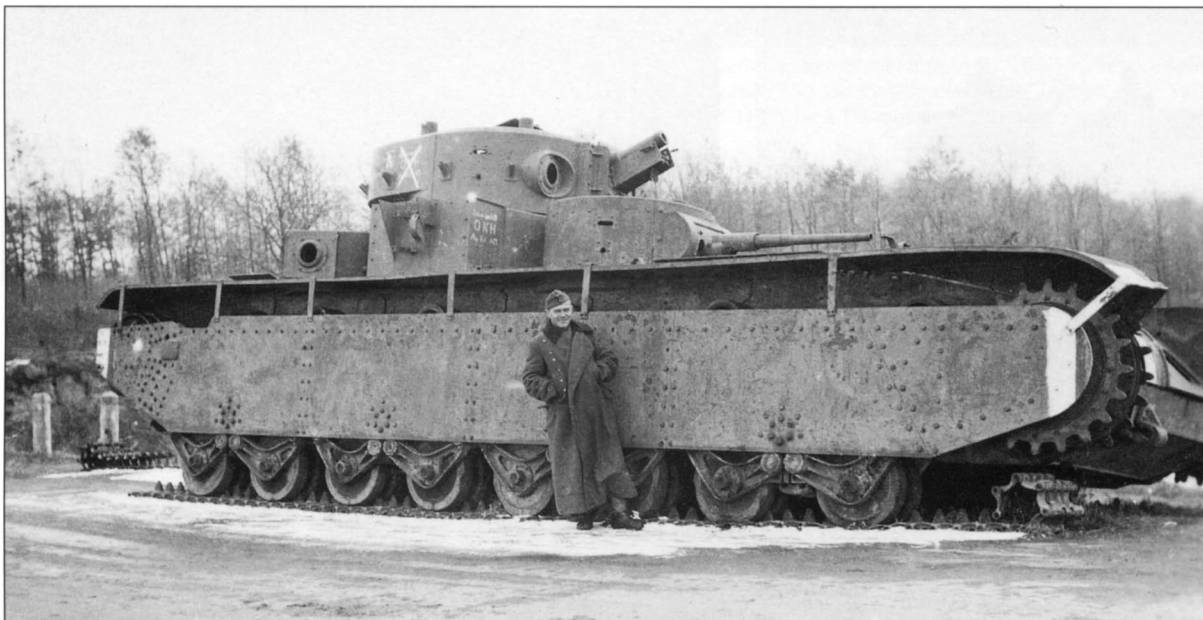
This T-35 was a hit with the tourists in the winter 1941/42 season. The largest section of track was "borrowed" by the German tank crews. Again, road markings have been painted for traffic safety. Note the inscriptions painted on the main turret and superstructure.

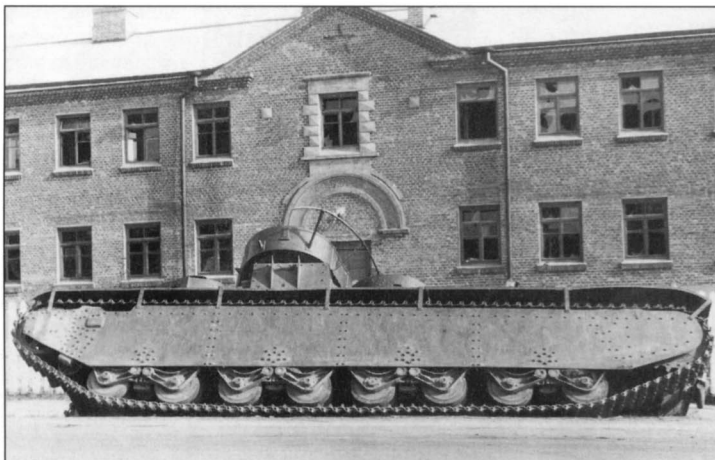
This T-35 self-propelled "fortress" became lodged in a ditch, this time in the center of a small town in front of a public services building. This is the command version from the 1936-1937 series. The massive dimensions of this tank, a length of almost 10 meters (12 yards), is shown well here. For some unknown reason all the turrets are turned in the direction of the ditch.

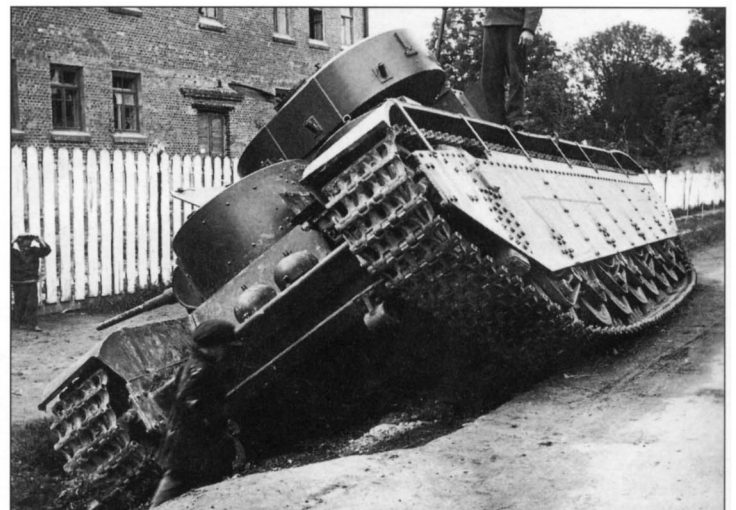
The same T-35 viewed from the front. Notice how the lights are lowered to combat position. There are known photos showing no fewer than 13 different T-35 tanks of 34th Tank Division abandoned on roads or in ditches.

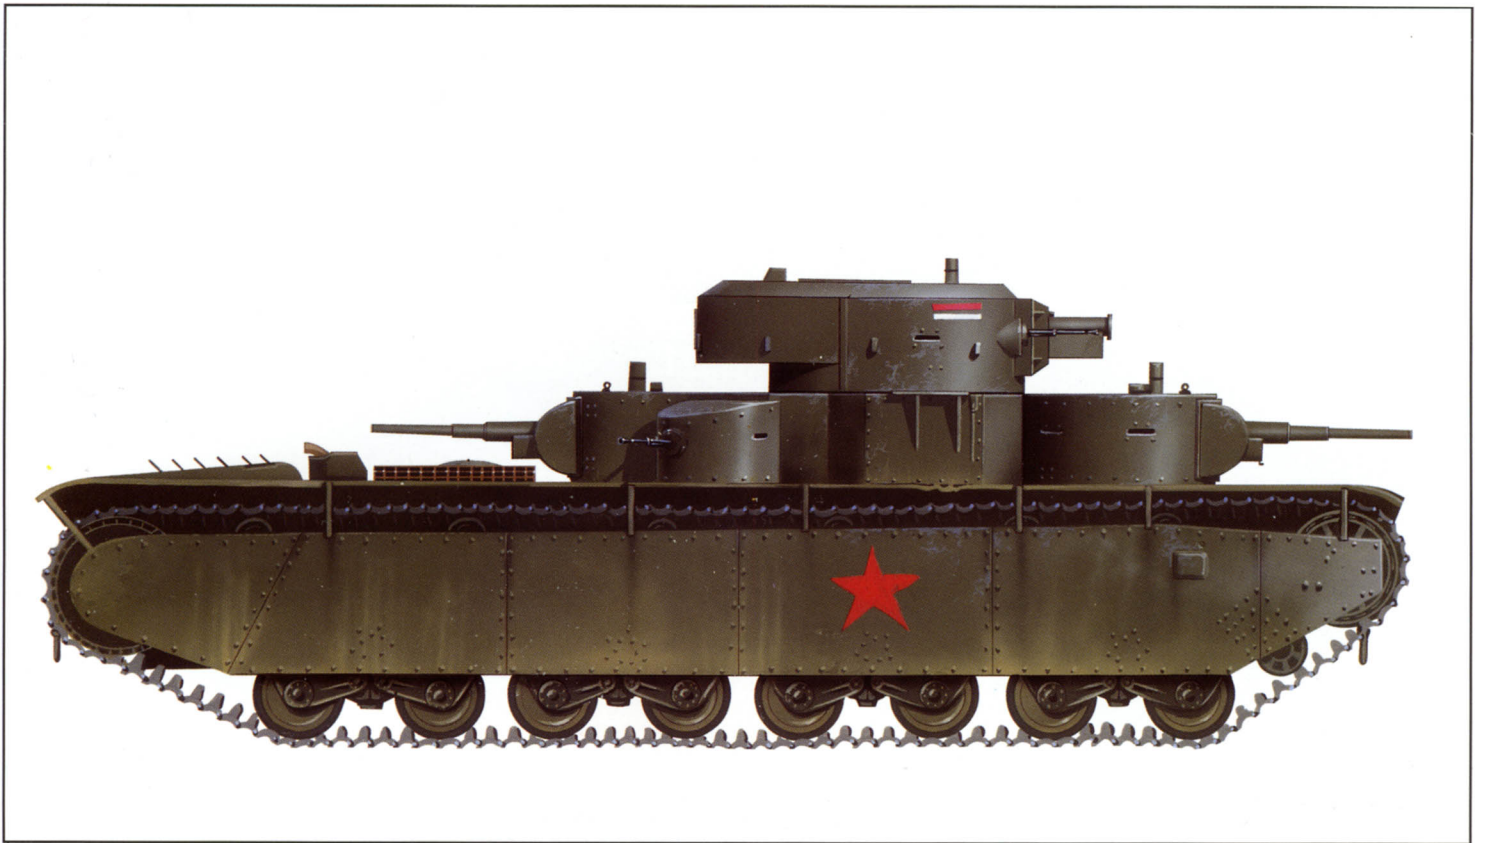
T-35 Model 1935, 34th Tank Division, 8th Mechanized Corps, southern sector of Eastern Front, July 1941

The T-35s were probably the only tanks in the Soviet Army during the summer of 1941 that carried the red stars on the side of the hull as a national marking. All of these vehicles were painted in the same way, i.e., with dark olive-green on all surfaces. Some of them still carried remains of the pre-war marking system, which indicated the battalions and companies within regiments. In this case, the tank has two small bars painted on the turret in red (top) and white (bottom), indicating 2nd Company of 1st Battalion.

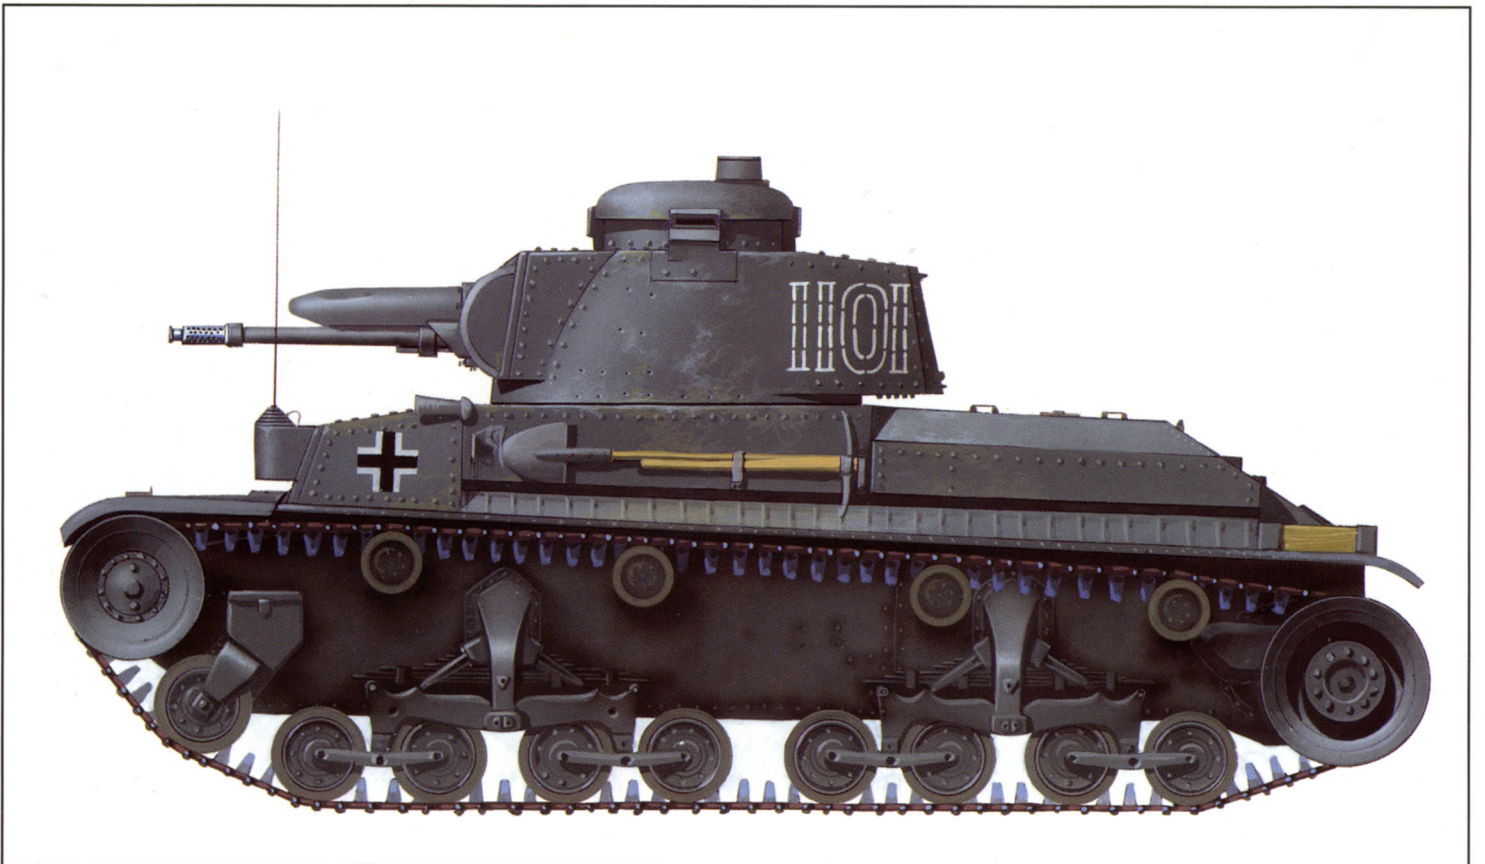
Pz.Kpfw. 35(t), staff company of II/Pz.Rgt.11, 6.Panzer-Division, Baltic states, summer 1941

The number '01' indicates that the vehicle belongs to the 2nd Abteilung (Roman letter 'II') commander. The tactical markings were applied in white over the standard dark gray color of the German armored fighting vehicles throughout the first two and a half years of the war.

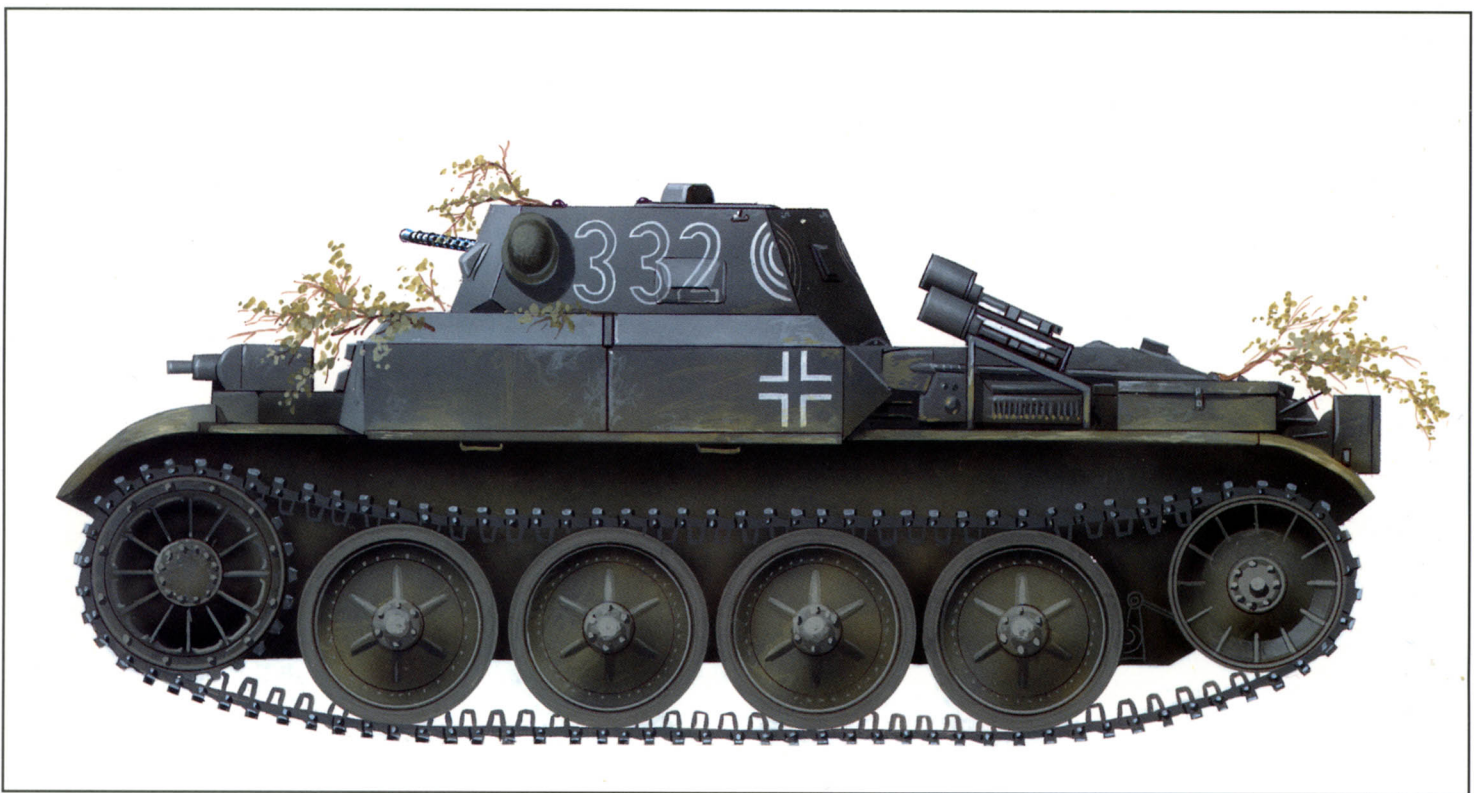
Pz.Kpfw. II (F1), Pz.Abt.101, central sector of Eastern Front, late summer 1941

The Flammpanzer II was also known as the "Flamingo". The tank carried standard camouflage, markings and numbering. The camouflage, which was typical of German tanks during this period of the war, was composed of dark gray on all surfaces of the tank. Markings were composed of three concentric circles painted at the corners of the turret rear, which sometimes had the appearance of the ace of spades. The three-digit tactical number is a typical one that indicates a specific tank in a platoon of a company. There were four Flamm Pz.Abt. numbered 100-103, and all of them were used during Operation "Barbarossa", with Pz.Abt.100 and Pz.Abt.101 fielded in the central sector of the front.

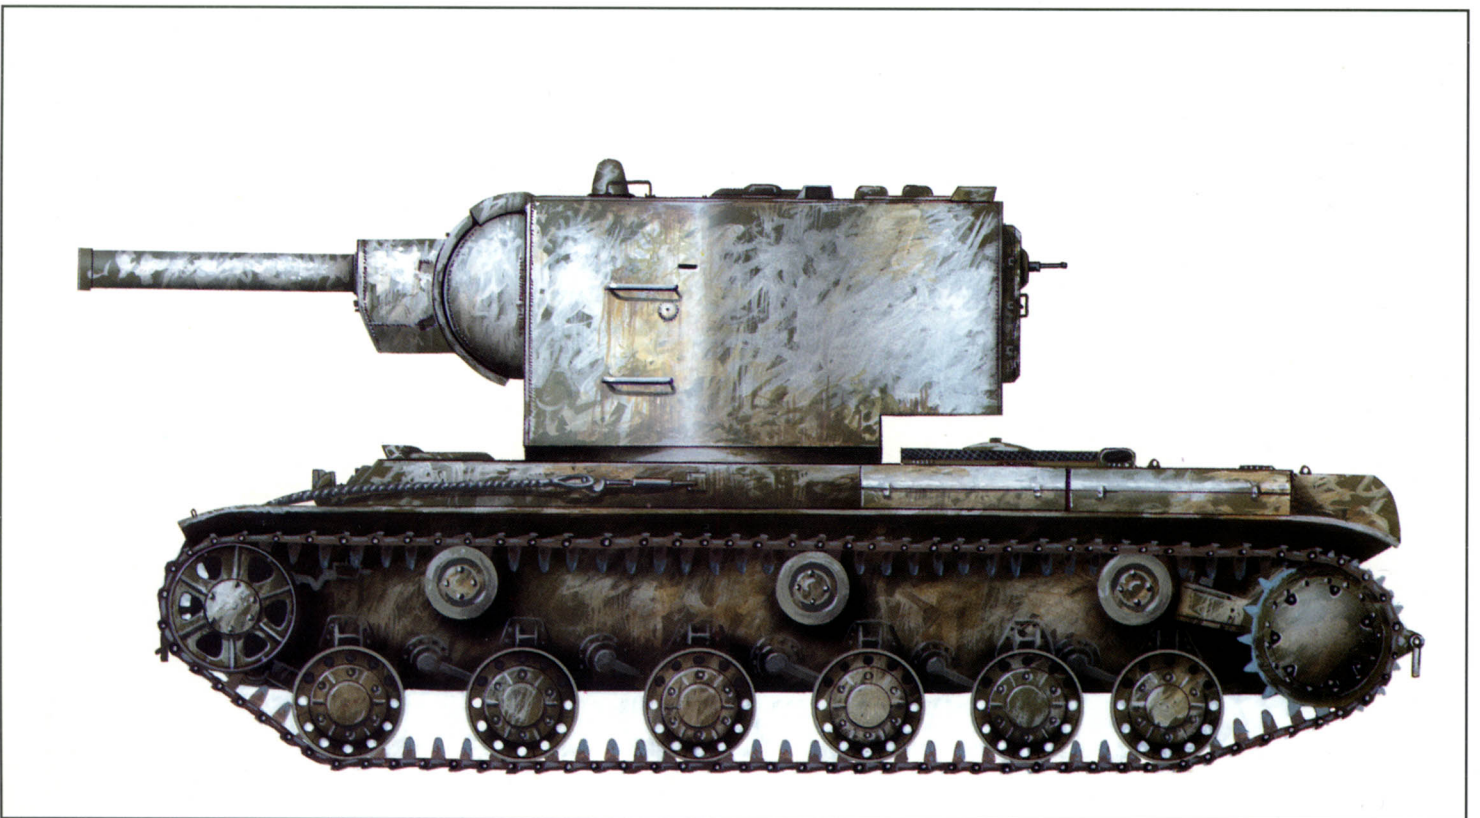
KV-2, unknown unit, Moscow area, late 1941

KV-2 tanks were used in several battalions in the opening phase of the German-Soviet war, and most of them were lost during the first two months of the conflict. A small number survived this period and experienced limited-scale combat in the final weeks of 1941, during the great battle for Moscow. One of these tanks, part of an unknown unit, is seen here. It carries very unusual camouflage for KV-2 tanks that is composed of a white coat of winter camouflage applied over the standard dark olive-green background. KV-2 tanks had no unit markings at all.

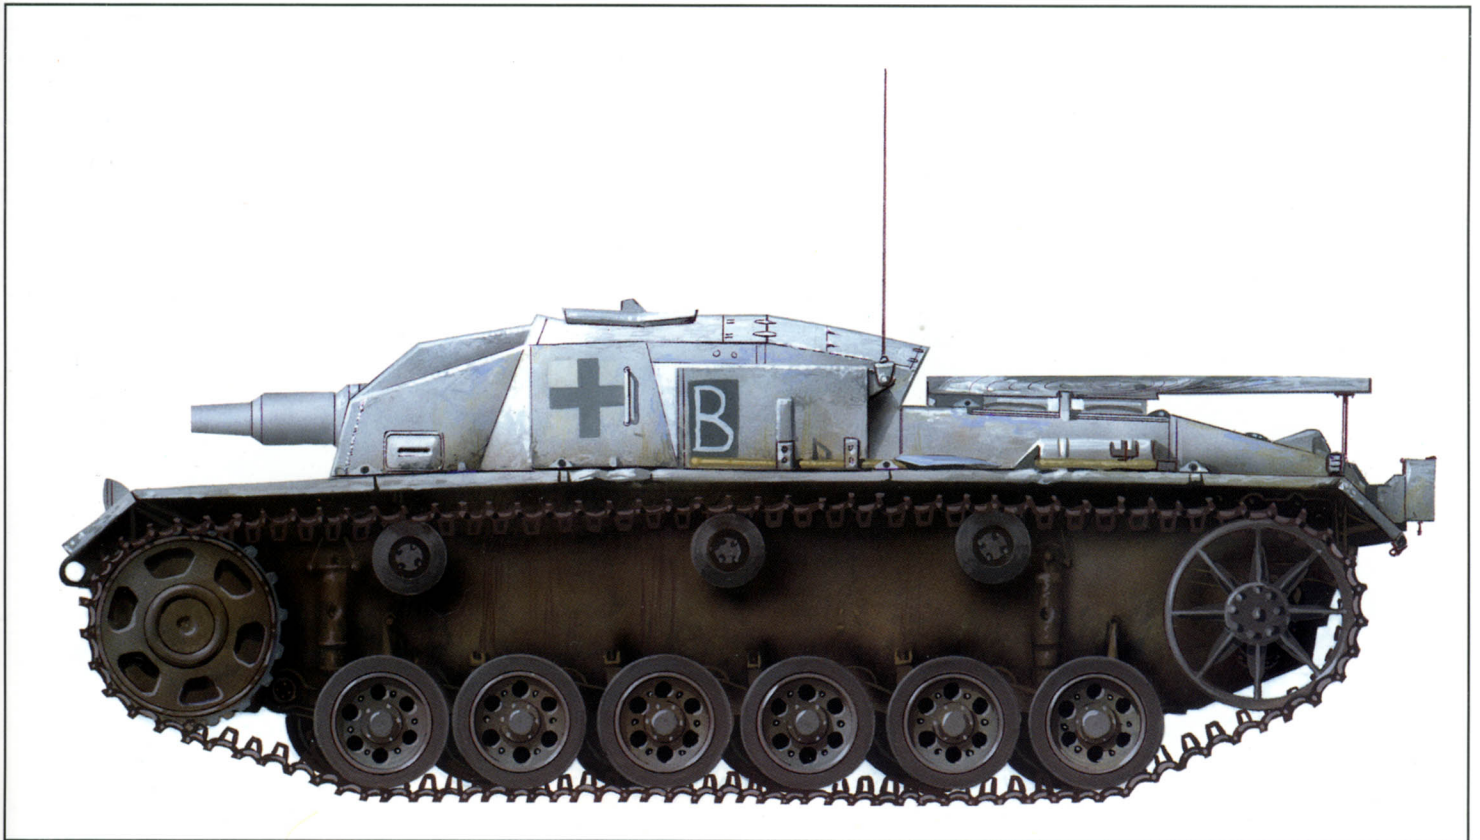
StuG III Ausf. C/D, 6.Panzer-Division, Sychevka, early 1942

A battery of StuGs was formed when all the tanks of the division were lost during the last weeks of 1941. This StuG has a white winter coat over a standard dark gray background. The national marking is painted over the white, while the individual letter of the vehicle -- "B"-- is isolated on a dark gray square. The sides of the hull and the undercarriage are still the basic gray color (though covered with dirt), while the frontal portions of the hull are painted white.

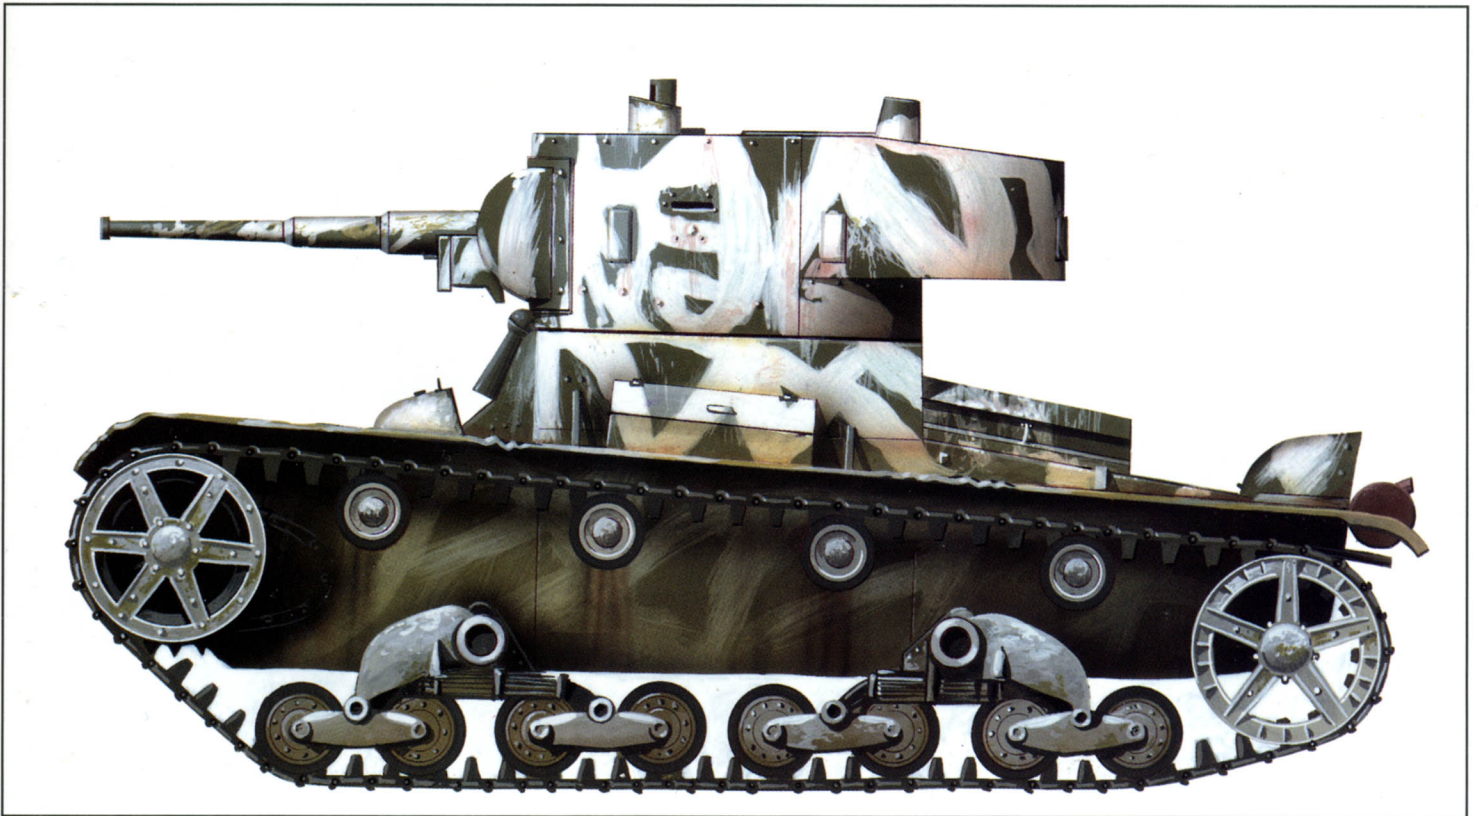
T-26 Model 1933, unknown unit, Leningrad Front, spring 1942

This T-26 was employed by the Soviets on the Leningrad Front during the fighting near the Neva river in the early spring of 1942. The Model 1933 was in production from 1933 to 1937, as were numerous variants of the T-26. This tank carries standard dark olive-green camouflage with a whitewash pattern for the winter season. White camouflage was applied to all sides of the upper part of the tank, as well as partly on the top surfaces. The turret top was painted entirely in white, the engine deck partly in white, while the glacis was covered with mud and sand.

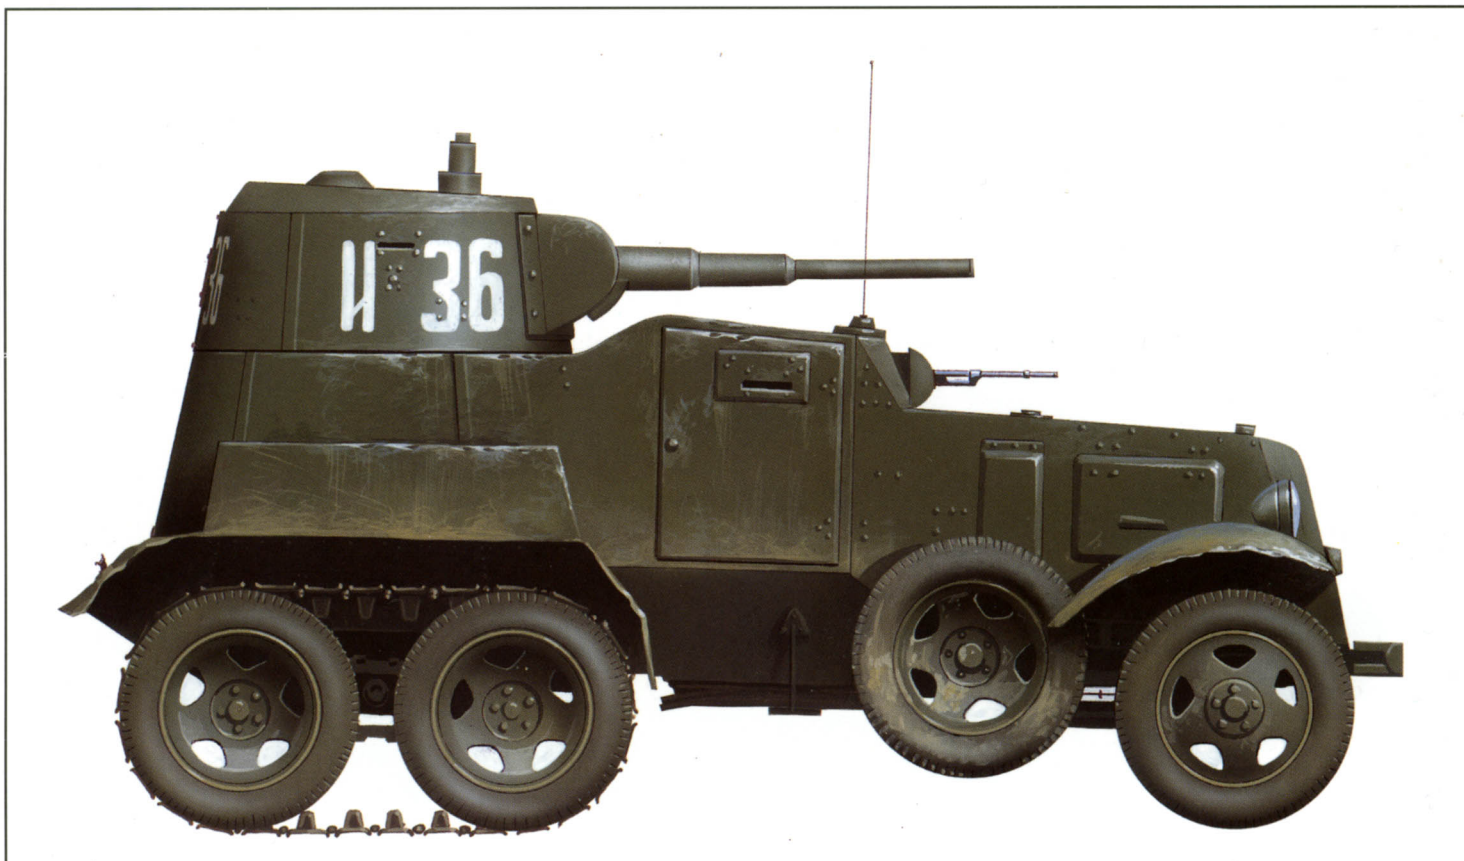
BA-10 heavy armored car, Leningrad Front, spring 1942

The BA-10 was the standard Soviet armored car, though the BA-6 and BA-20 were also used. Many BA-10s were transferred from the Far East to western Russia in the summer of 1941 to replace destroyed ones. This vehicle wears the standard camouflage of Soviet vehicles, with the code "I-36" painted in white. The meaning of this code is unknown, but it could be the unit code.

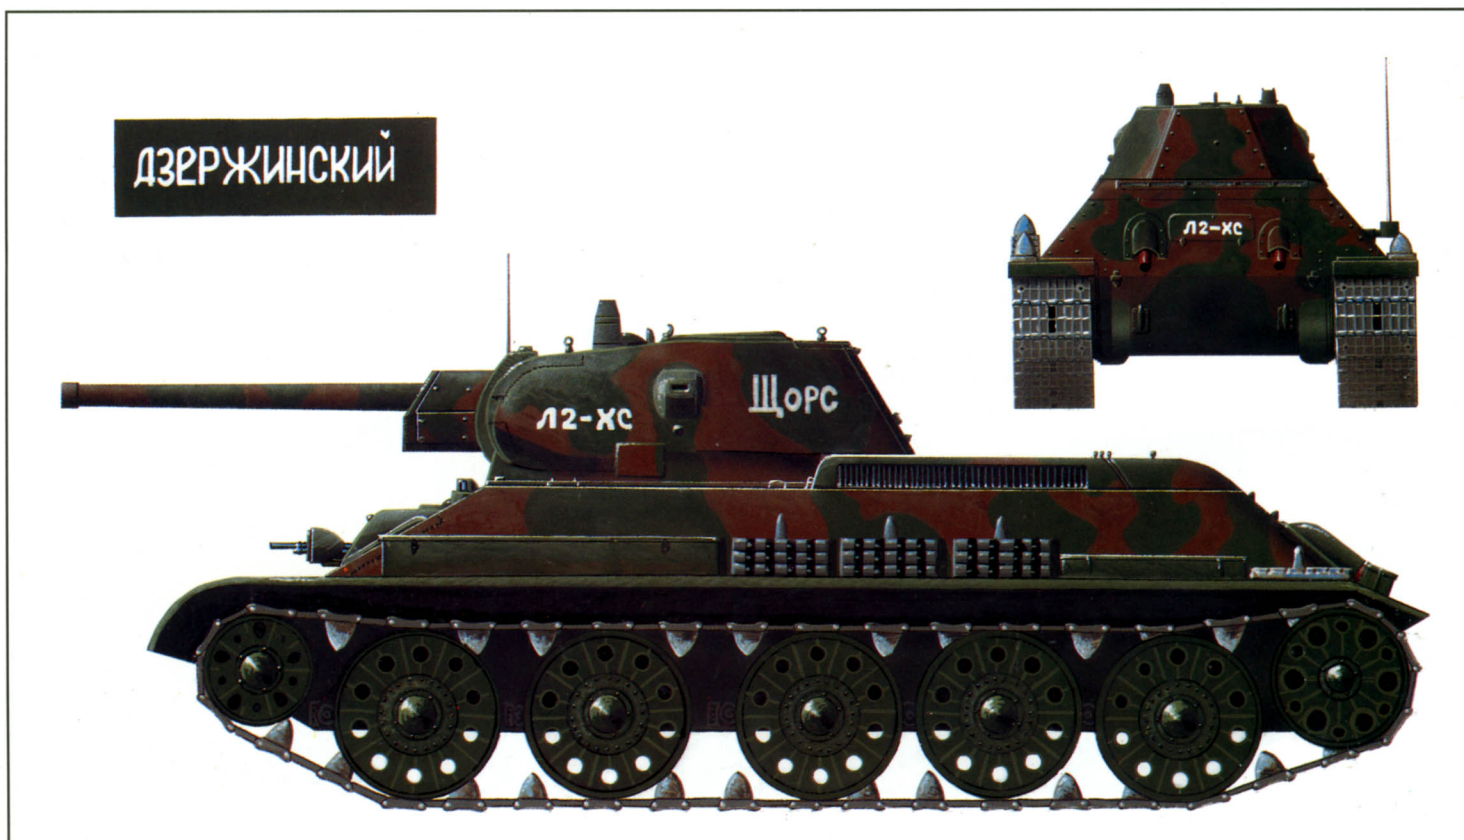
T-34 Model 1941, 4th Guards Tank Corps, South-West Front, May 1942

The unit code "L2-Khs" was painted in white on the glacis, rear plate and on both sides of the turret. The early cast turret is evident. The running gear uses the all-steel spoked wheels introduced in the spring of 1942. Each tank in this unit was named after a hero of the 1917 Bolshevik revolution (for example, Shtchor or Dzerzhinski) and wears a two-color camouflage of brown or dark earth over a dark olive-green background.

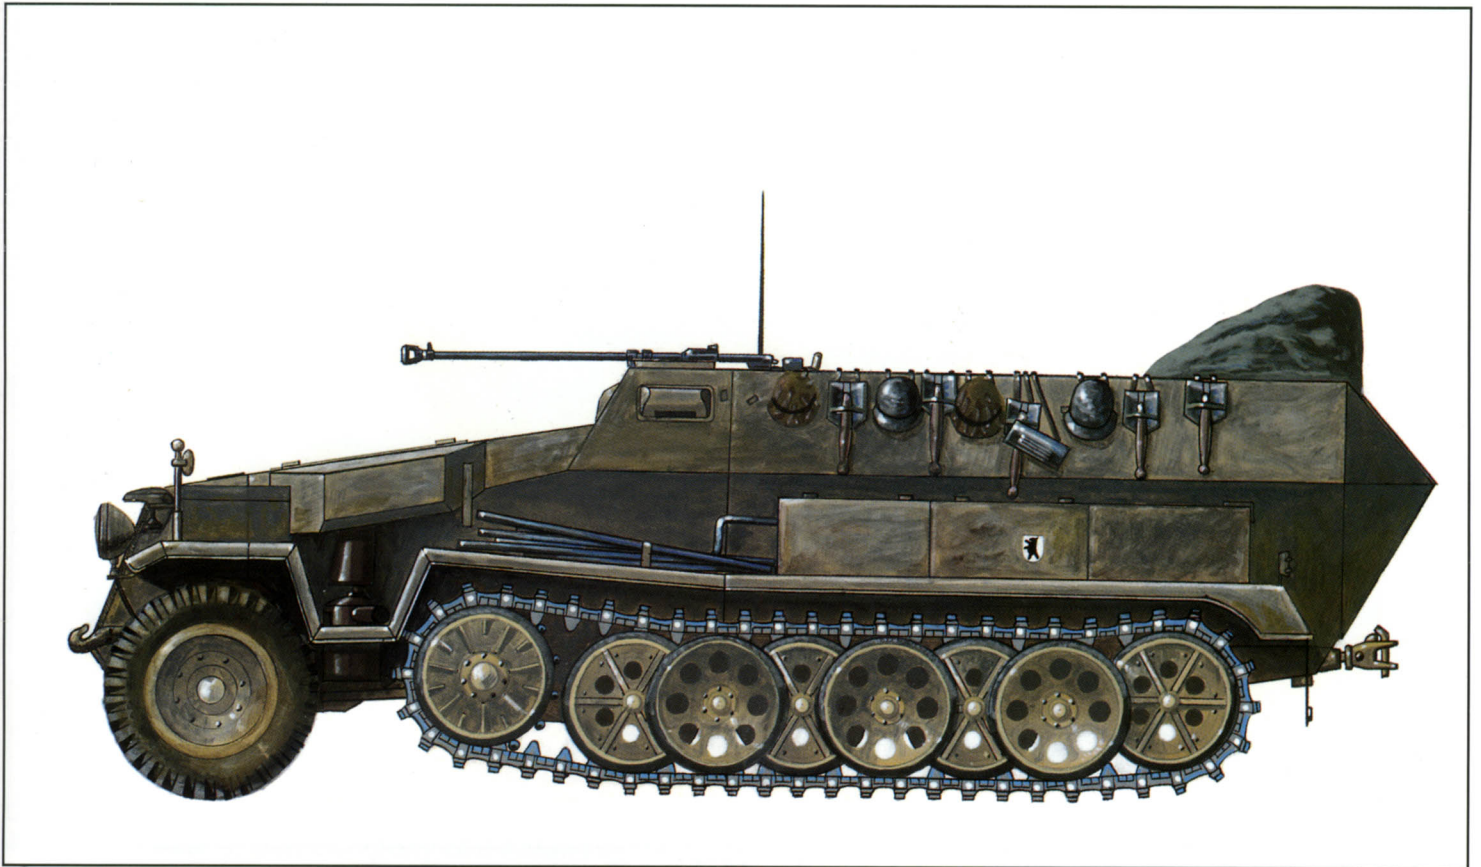
Sd.Kfz. 251/1 Ausf. C, 3.Panzer-Division, Caucasus, summer 1942

This half-track, which is painted in dark gray and covered with a heavy coat of dust, bears the divisional emblem of 3.Panzer-Division. It is armed with a captured Soviet anti-tank rifle. The crew's equipment hangs on the side of the vehicle. Two of the four helmets are fitted with cloth covers.

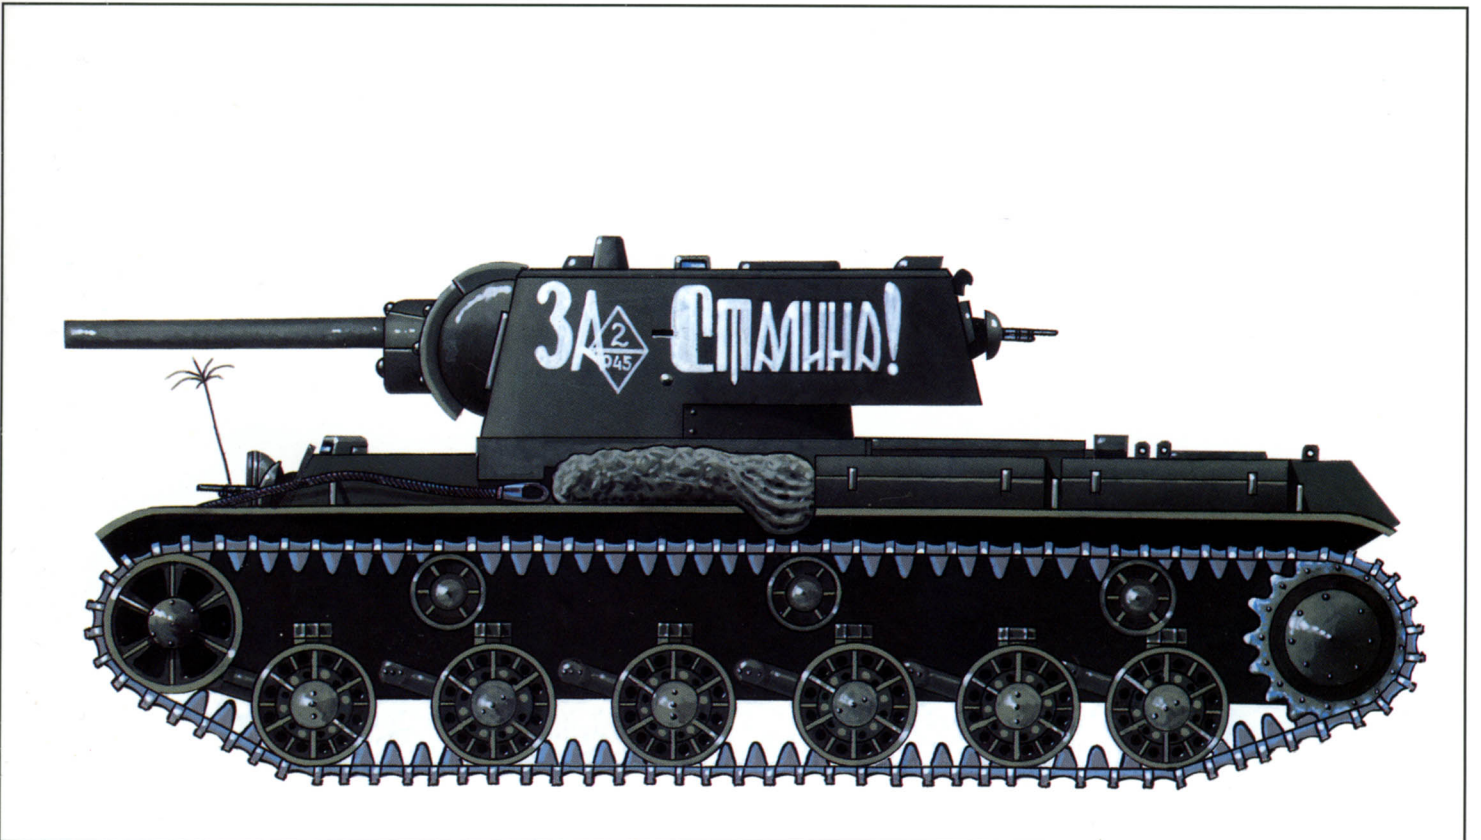
KV-1 Model 1941, 116th Tank Brigade, Voronezh Front, July 1942

The 116th Tank Brigade was formed in February-March 1942 and was sent to battle around Voronezh in July 1942. The turret on this vehicle is prominently marked with the patriotic slogan "For Stalin". The number "2" in the tactical marking indicates the second battalion of the brigade, the 324th Tank Battalion; the "045" is the brigade code number.

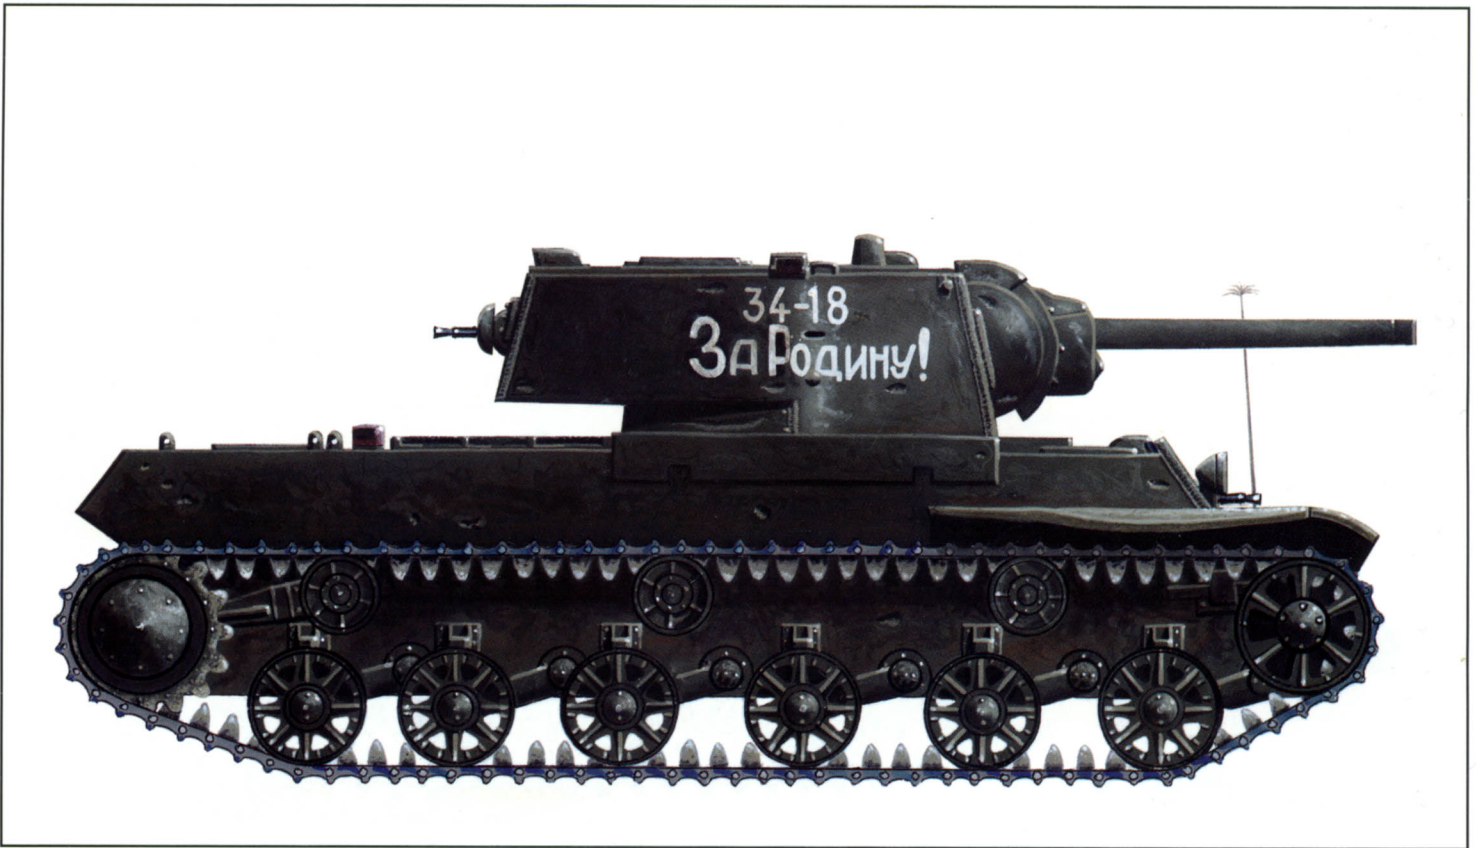
KV-1 Model 1941, unknown unit, Stalingrad, September 1942

This KV-1 heavy tank is painted in the standard camouflage color (dark olive-green) that was used throughout the war. On the up-armored welded turret are the unit markings, which consist of the unit code and the number of the battalion within the brigade, as well as the inscription "For the Homeland". The chassis and wheels of this formidable vehicle are different than those on the earlier model KV-1, as is the longer 76.2mm gun.

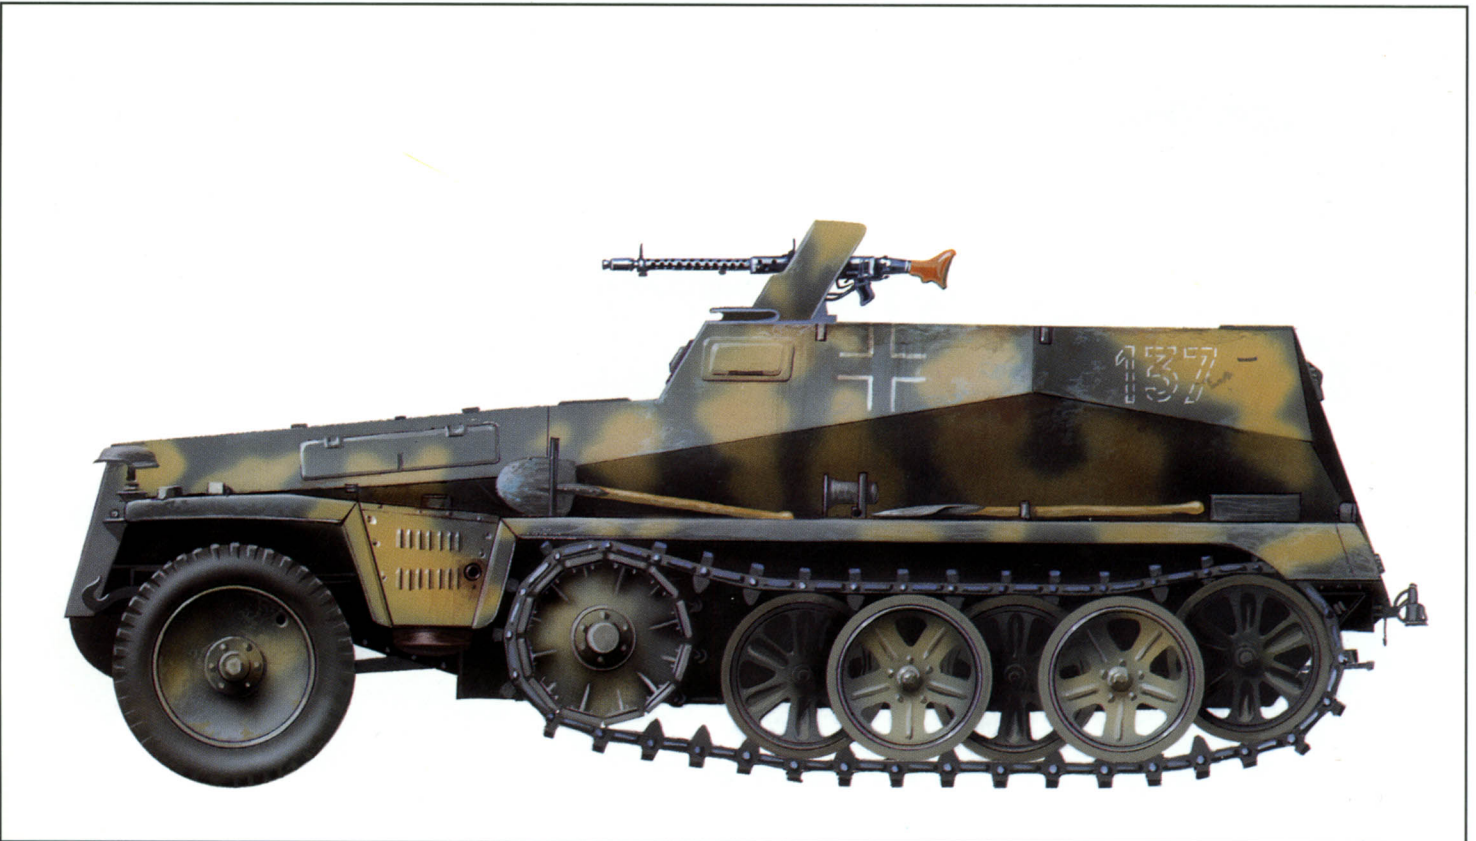
Sd.Kfz. 250/1, 16.Panzer-Division, southern sector of Eastern Front, autumn 1942

This Sd.Kfz. 250/1 wears the new type of camouflage introduced in the summer of 1942, when dark yellow and green paints first appeared in front line camouflage schemes. These colors helped to break up the outline of German vehicles painted totally in dark gray. The paint was usually applied with a brush without any strict regulations. The half-track is armed with the ubiquitous MG34.

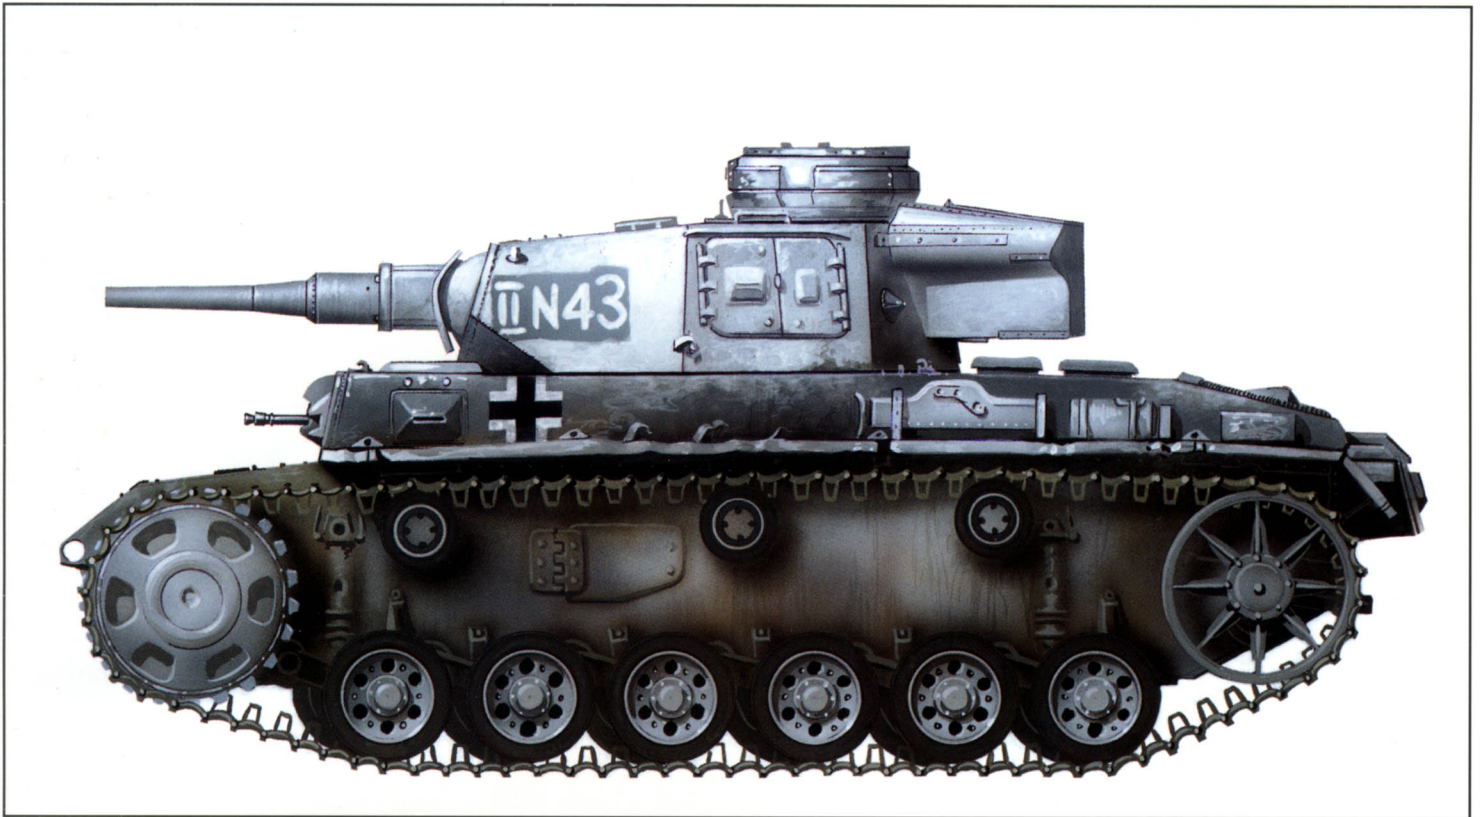
Pz.Kpfw. III Ausf. J, staff company of II.Abteilung, 16.Panzer-Division, winter 1942/43

This tank displays typical camouflage for this period, i.e., the dark gray background coated with a whitewash for the winter. The tactical markings on the tank are very unusual because no staff sub-unit could employ such a high number. The markings could indicate that this tank was incorporated into the staff company of 2nd battalion without a change being made in the previous numbering before the winter camouflage was added. The last digit in the number, which indicates a tank within a company, was painted larger than other two numbers. This style of marking was often seen on German tanks during the second half of 1942 in Russia, as well as in Africa.

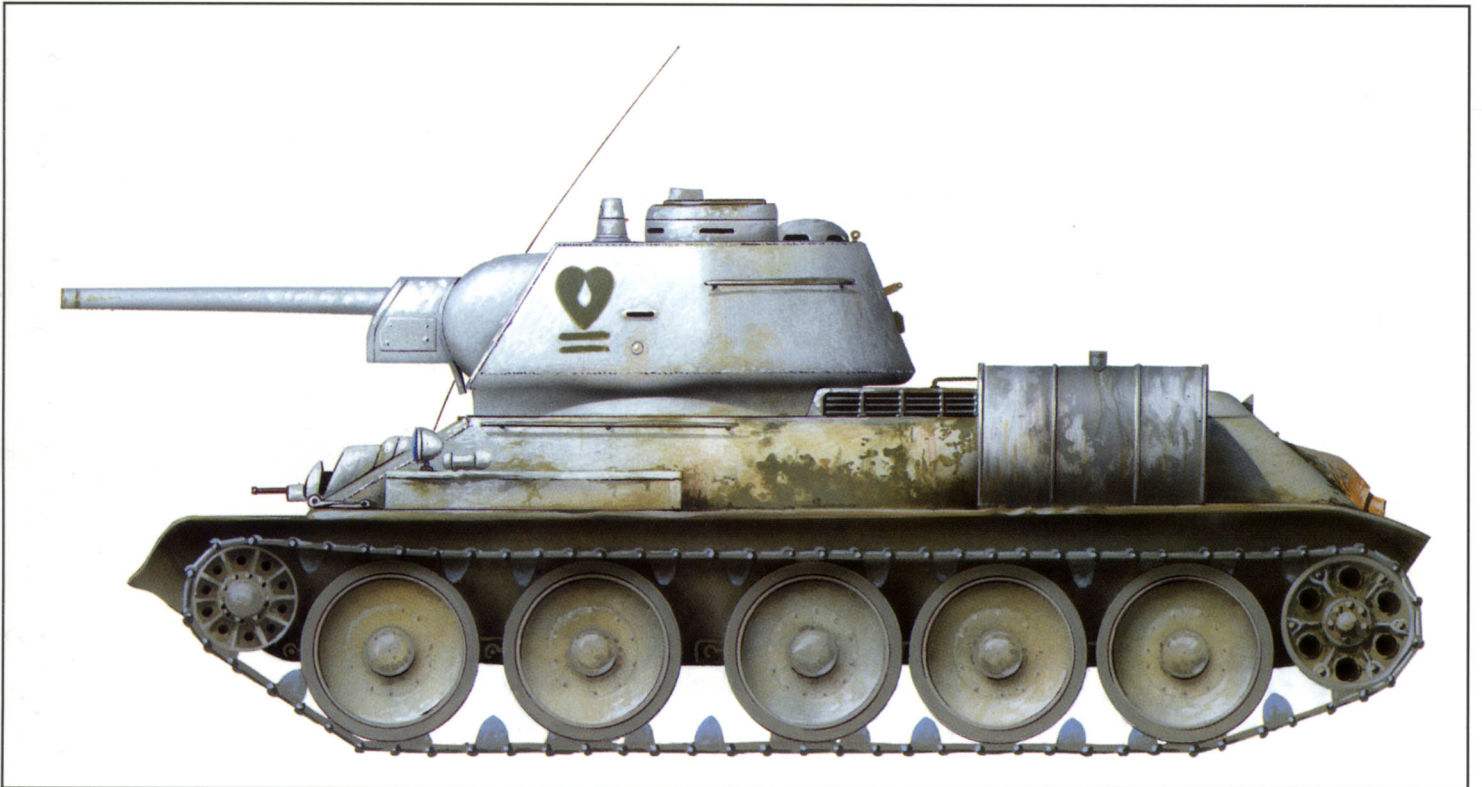
T-34 Model 1942, unknown unit, Upper Don area, Voronezh Front, winter 1942/43

This T-34, which is equipped with a new turret, is painted in the standard Soviet camouflage of dark olive-green on all the surfaces covered with a coat of white paint for the winter. The paint was not durable and was often rubbed off by troops being transported on the tank, leaving behind only remnants of the white camouflage on the surfaces that the soldiers were in contact with. A unit emblem is painted on the turret. Unusual by Soviet standards, it is composed of a heart with a diamond inside of it, with two bars located underneath, probably indicating a sub-unit within a tank brigade. The colors of this emblem are most likely dark olive-green and white, the standard camouflage paint colors.
