Armor Battles on the Eastern Front

(1) The German High Tide 1941-1942

Robert Michulec

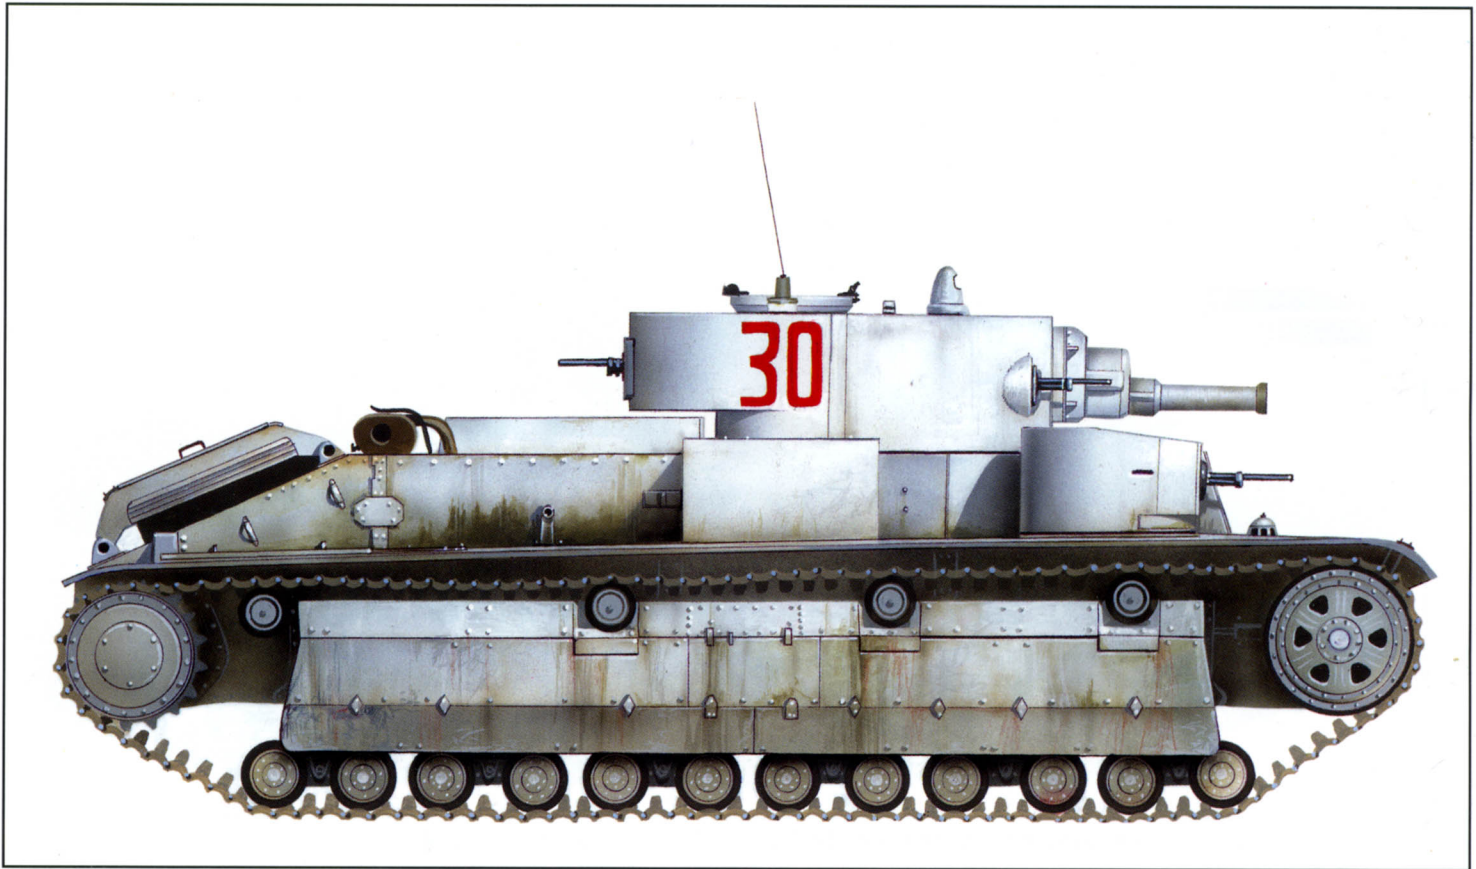
T-28 medium tank, unknown unit, Leningrad Front, winter 1942/1943

This T-28 carries a heavy coat of winter camouflage applied over the standard dark olive-green paint. The two-digit number in red could indicate a unit code rather than being the standard tank numbering for a small-scale armored unit. Despite the multitude of weapons carried by this tank, it was not much of a threat to the German forces it opposed.

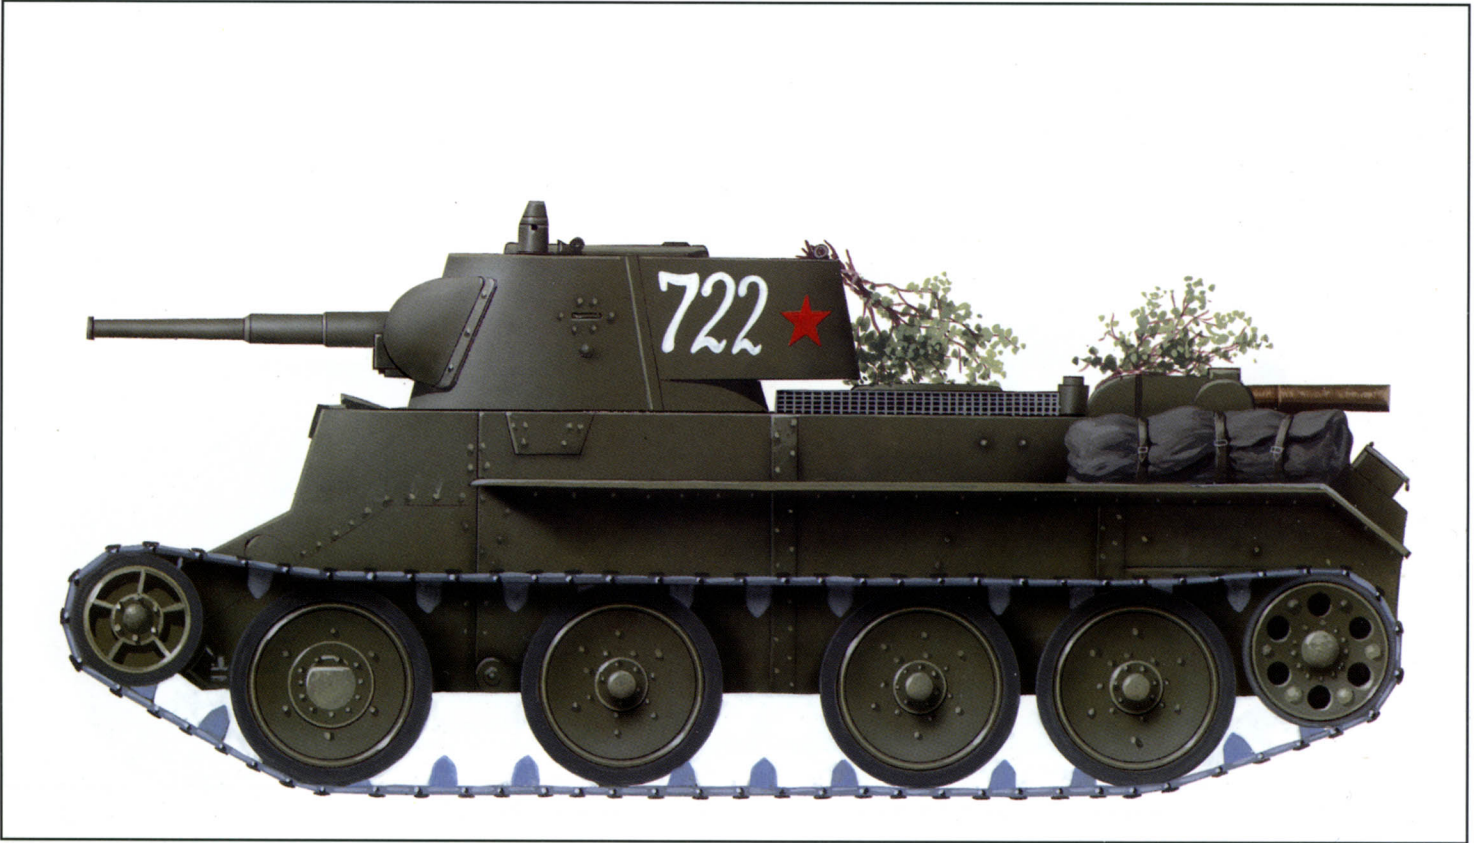
BT-7, 51st Independent Tank Battalion, Leningrad Front, early 1943

Prior to the January 1943 actions, this unit was incorporated into 220th Tank Brigade under the command of Col. V.L. Procenko. The tank is painted in the standard base color, but the markings are not at all typical ones. The Soviets applied a three-digit tactical marking starting with the high number "7", which could be the battalion code.

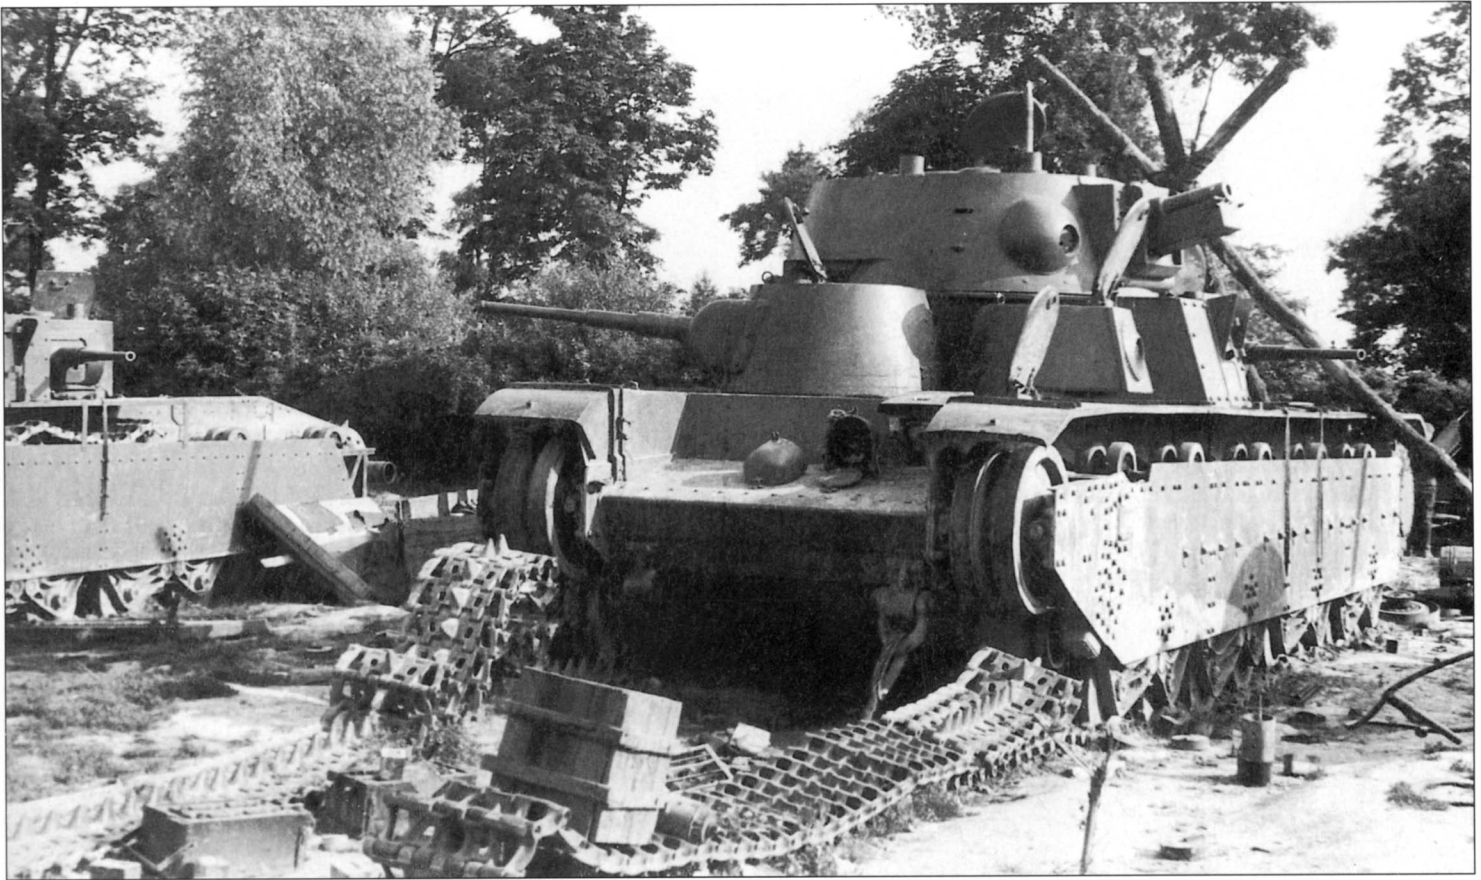
A photo taken at a repair depot created by the Germans for the re-building of T-35s. The German specialists were so impressed by this tank that they gave an order to send to Germany one fully serviceable tank (which had to be repaired by the use of parts taken from few other vehicles) for tests. No fewer than three of these "mastodons" were collected in this depot. One of them was sent to Kummersdorf, where it was tested by Heereswaffenamt. This photo shows the rarest version of the T-35, the Model 1939, of which only six pieces were built. This series differed externally from the older ones in the following ways: conical turrets (introduced on the Model 1938), sloped side plates of the superstructure and the new pattern of rivets on the chassis armor. To the left of this tank is part of another T-35, this time from the 1934-1936 production series.

Also photographed at the same repair depot was the central part of the third T-35 "fortress", which bears scars from no less than seven hits by 3.7cm rounds. This is the command version of the series produced in 1937, when modifications in the armor plate covering the chassis were introduced. Note the pattern of these modifications — it is different from similar patterns seen on the models 1938 and 1939.

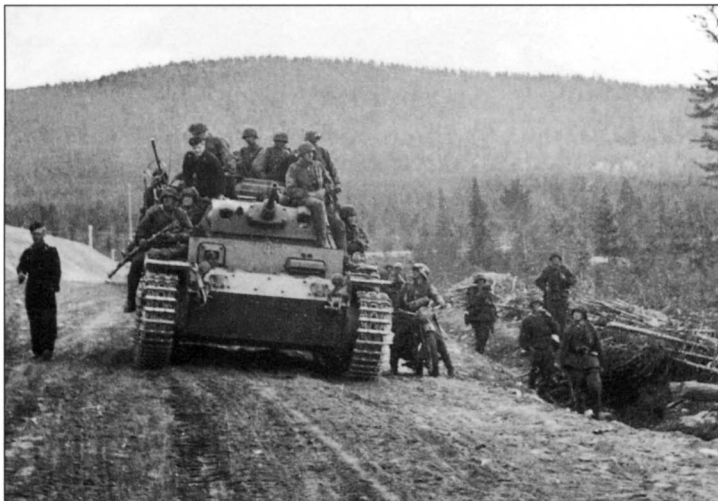
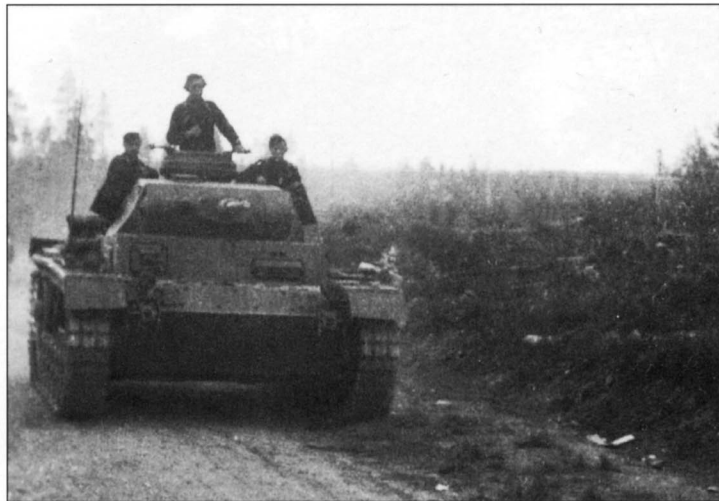
Two shots of Pz.Kpfw. IIIs from 1.Panzer-Division, which belonged to Pz.Gr.4, photographed in late summer 1941 during the advance of Pz.Rgt.1 of this division into the Leningrad area. There were three divisions involved in the battles for the Baltic states, all of them rather weak due to the poor quality of the equipment they employed. The strongest was 1.Panzer-Division, which was equipped with 145 tanks, among them 71 Pz.Kpfw. IIIs with the 5cm short-barreled gun and 20 Pz.Kpfw. IV tanks. Two other divisions had more tanks (6.Panzer-Division with 232 and 8.Panzer-Division with 212) than 1.Panzer-Division, but 6.Panzer-Division was mainly equipped with Pz.Kpfw. 35(t)s and 8.Panzer-Division fielded Pz.Kpfw. 38(t)s.

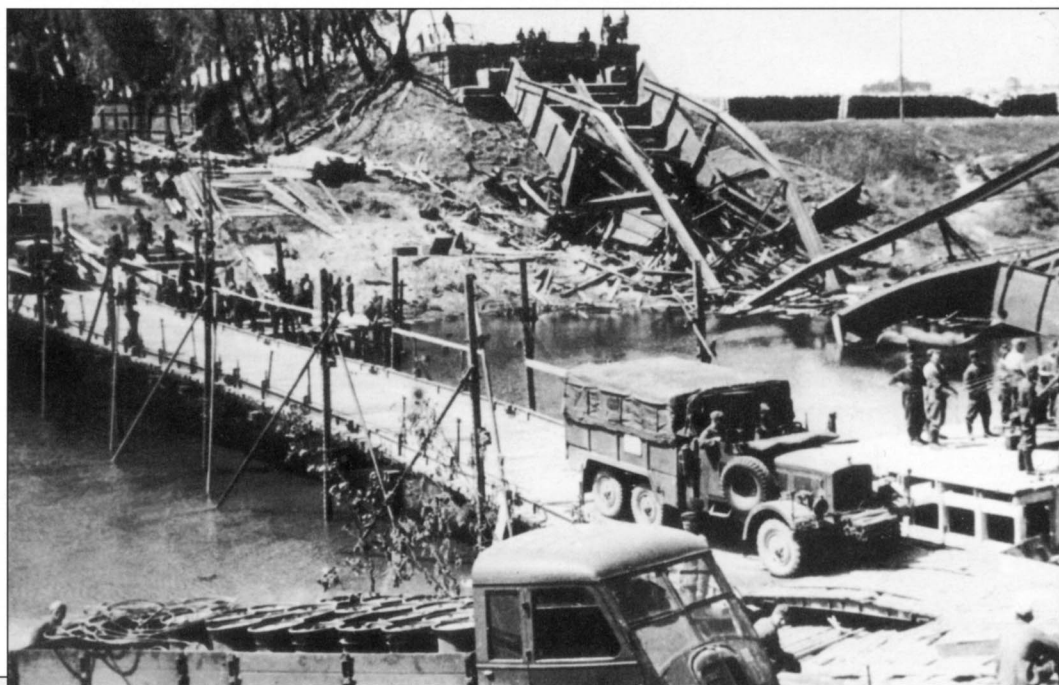
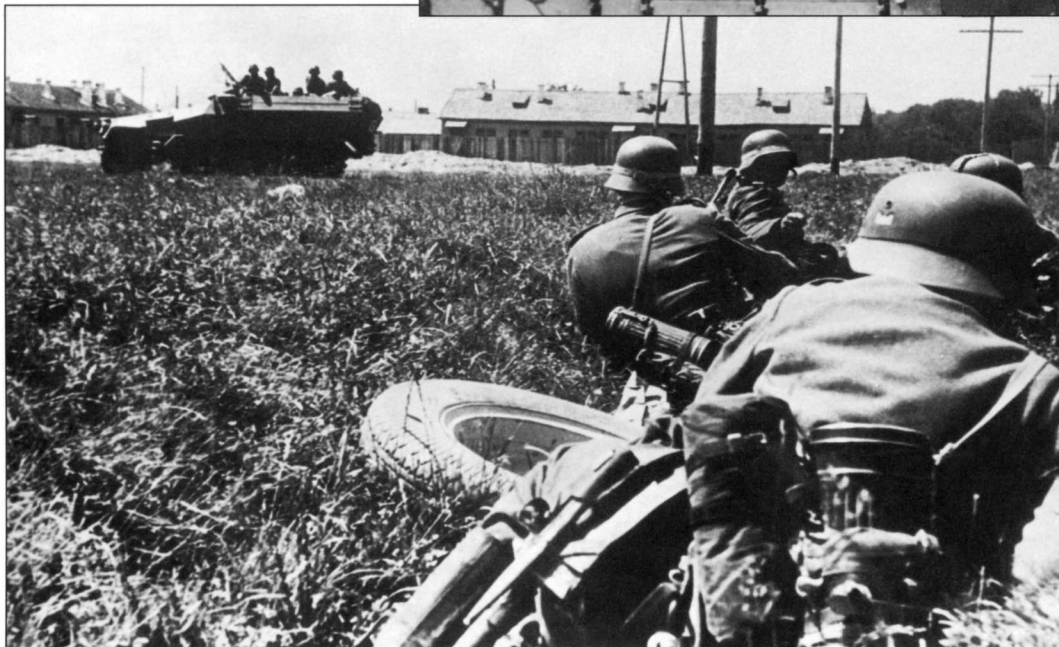
German troops keep alert as a Sd.Kfz. 251/1 Ausf. B advances towards an enemy position. Hanomag's from Pz.Gr.2, which was commanded by Generaloberst Heinz Guderian, were identified with a white letter "G" (for Guderian) on the rear of the vehicles. Note the strange equipment affixed to the upper portion of the side of the combat compartment.

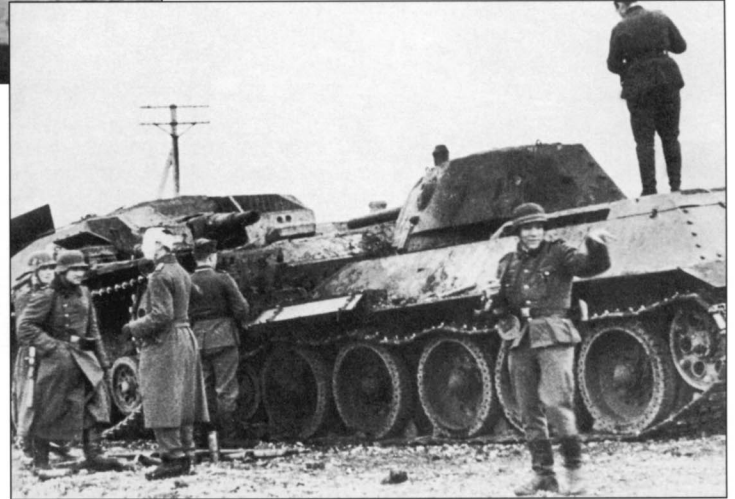
This photo shows the result of a collision between a StuG III and a T-34 in October 1941. Such a mishap was rare, even though large numbers of tanks on the battlefields were obscured by dust and smoke. One of the StuG III crew members, who was wounded in the head, is standing near his vehicle.

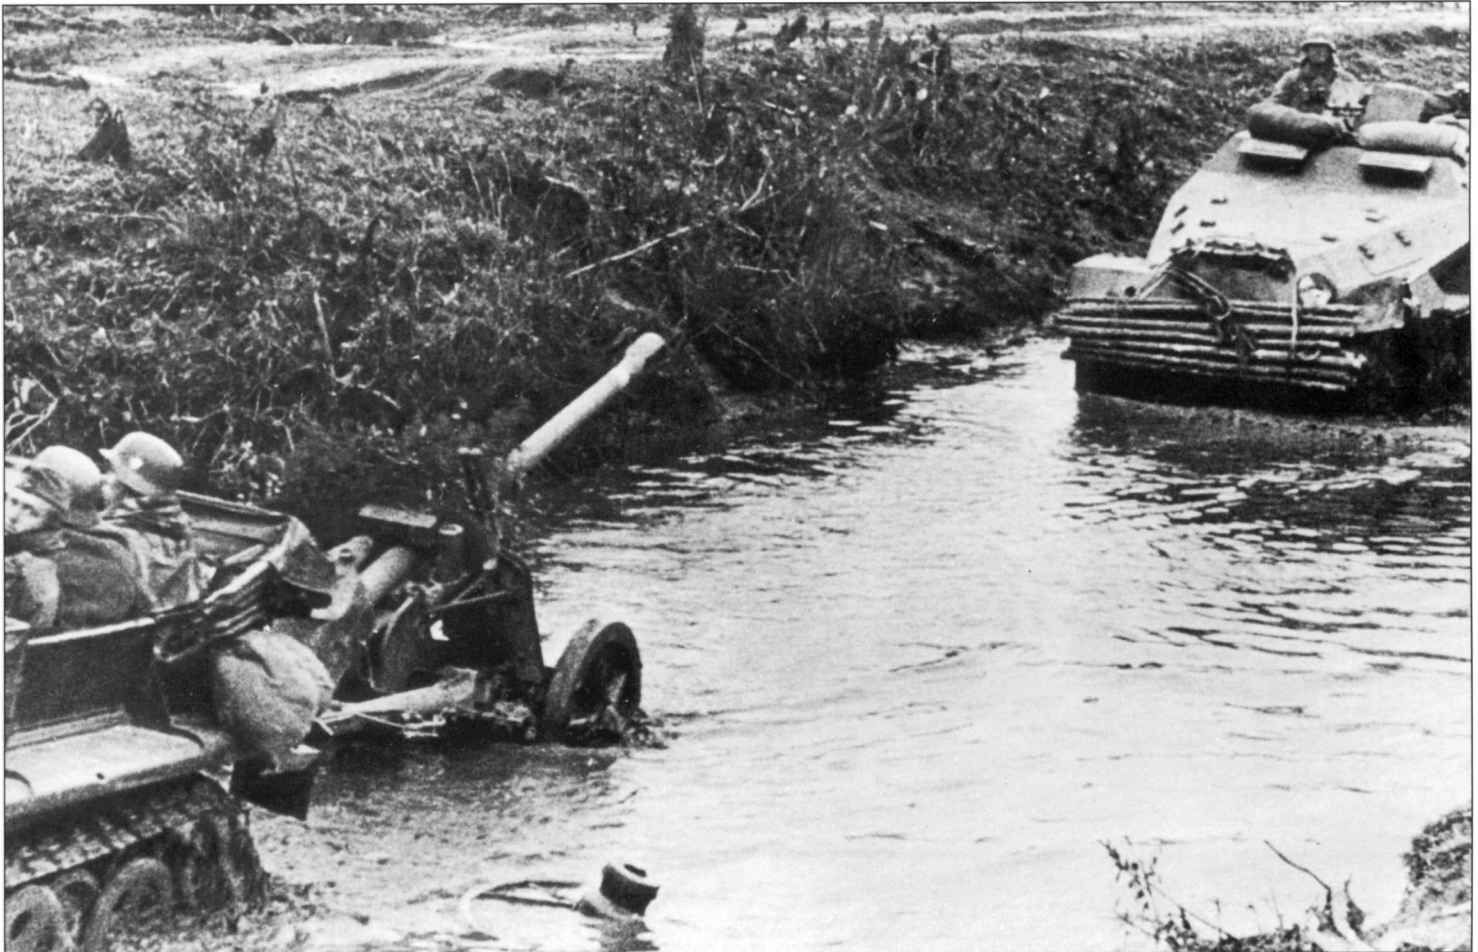
Vehicles of 1.Panzer-Division move through a stream in autumn of 1941. At left is a Sd.Kfz. 10 towing a 5cm PAK 38 anti-tank gun, while at right is a Sd.Kfz. 251/1 Ausf. B half-track. During the struggles for Moscow, this division belonged to XLI Ar.Kp. of Pz.Gr.3 and fought on the northern flank. Despite the lack of Pz.Gr.40, whose supplies had been cut off by Hitler's order, the division used the PAK 38 very successfully to repulse Soviet armored counterattacks until the beginning of December.

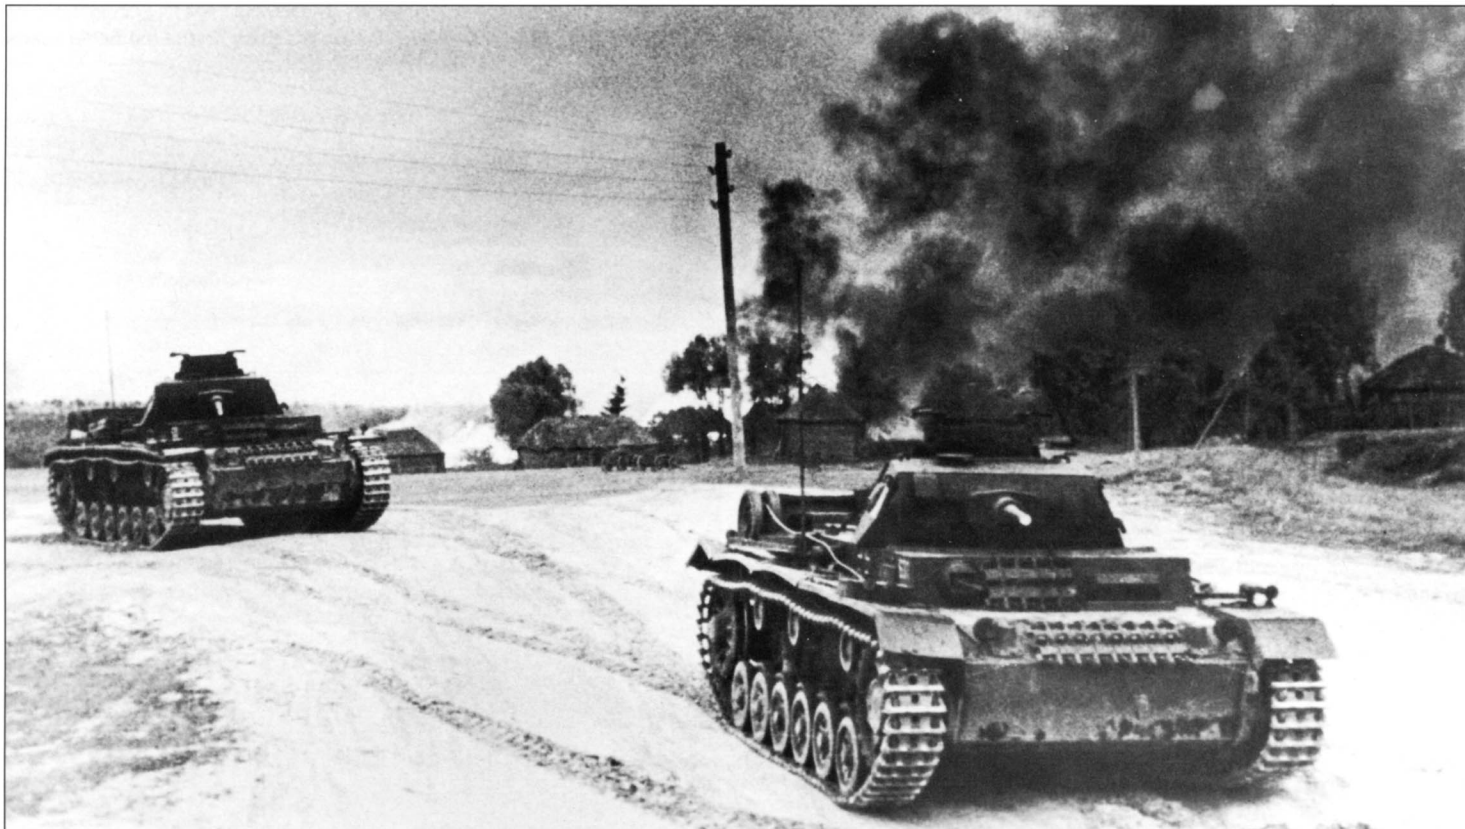
A pair of Pz.Kpfw. III Ausf. Js advance down a village road not far from Moscow in October 1941. There were 14 Panzer divisions involved in the operation to encircle Moscow. They were organized into eight Panzerkorps employed by three Panzergruppen, including one taken from Herresgruppe Nord, where only a Panzerkorps made up of two Panzer divisions equipped with about 250 tanks remained.

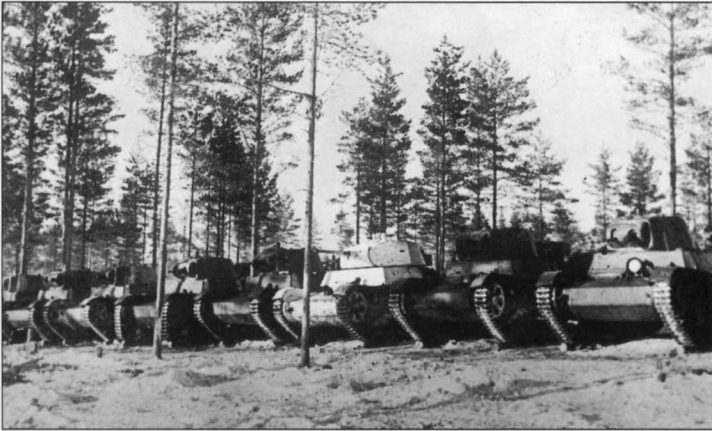
These OT-131s and OT-132s and the lone T-26 Model 1939 (painted with white camouflage) are ready for work. The Red Army was the only army in the world that possessed a large number of units equipped with almost 500 flame-thrower tanks, often ambiguously called “chemical tanks” by the Soviets. Most of them were lost while fighting in the frontier area, but the rest were put into action during the defense of Moscow.

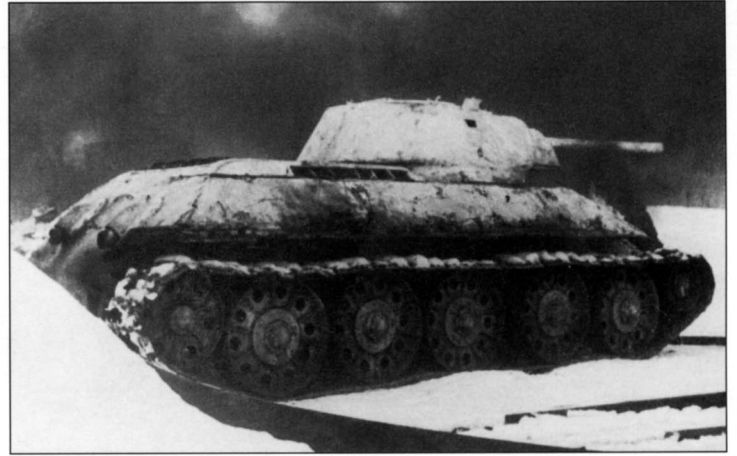
The T-34 at the end of the 1941 production series was built in as simple a shape as possible. Vehicles from this period usually had no storage boxes (except the standard one on the front part of the left mudguard), and the equipment was very limited. All of the road wheels were made of steel. They were first introduced in the autumn of 1941 in the Stalingrad factory because of a lack of rubber.

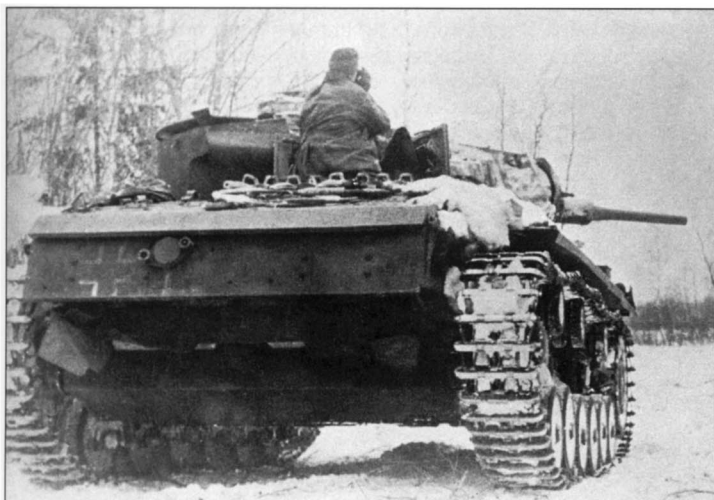
This Pz.Kpfw. III Ausf. H was photographed while patrolling village roads in February 1942, when heavy fighting erupted behind German lines. The crew members are bundled up against the cold weather of the winter of 1941/1942. The frontal part of the turret is covered with whitewash camouflage.

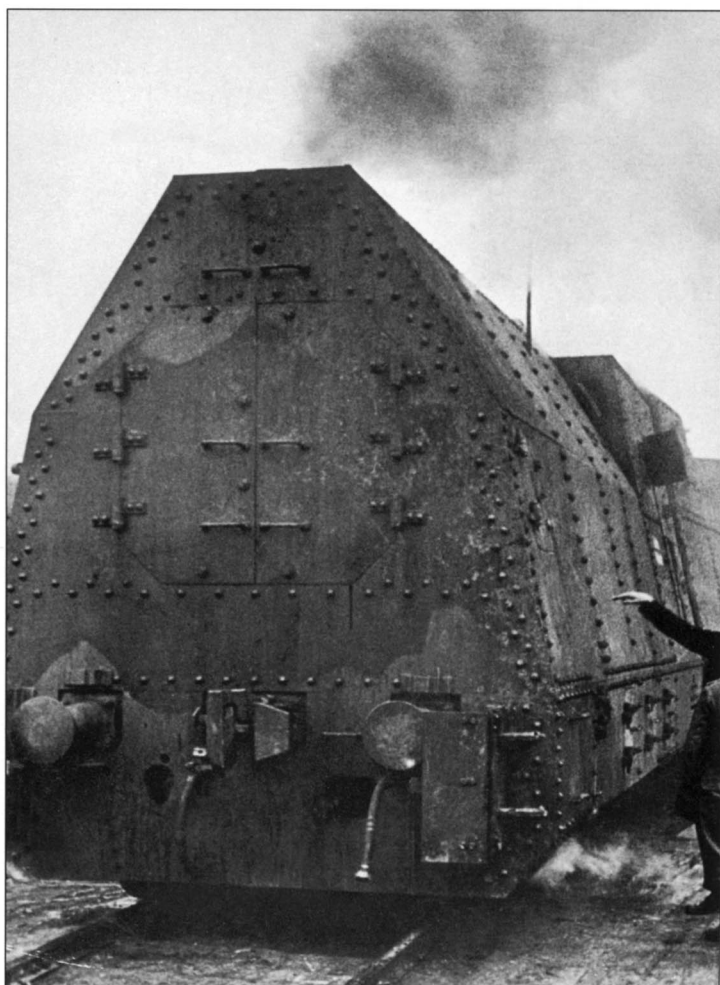
Seen here is the locomotive of one of dozens of improvised Soviet armored trains built in the late summer and autumn of 1941 by different railway factories. They were unlike trains seen previously and those that would appear in the future. Note the two-color camouflage pattern of dark olive green and light brown. An armored train towed by this locomotive was captured by the Germans in near-perfect condition.

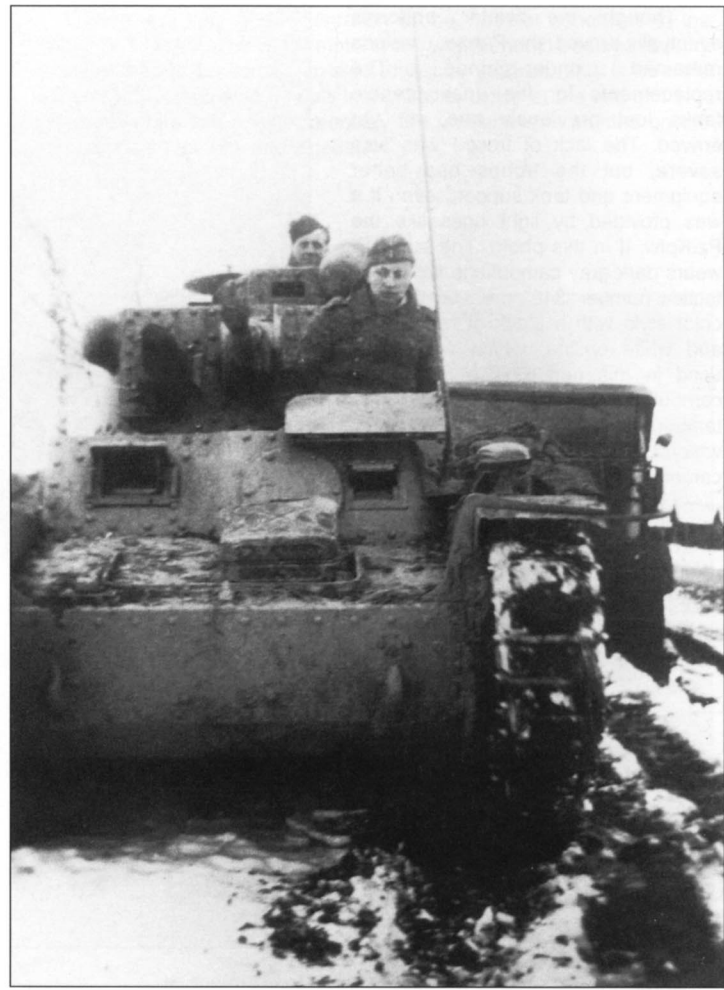
Another shot of a Pz.Kpfw. 38(t) from the same unit traveling down a Russian country road. This photo gives a good indication of the size of the tank, which was too small by German standards, making it quite uncomfortable for the crew. Note that all surfaces on the front of the tank are covered with a solid coat of mud.

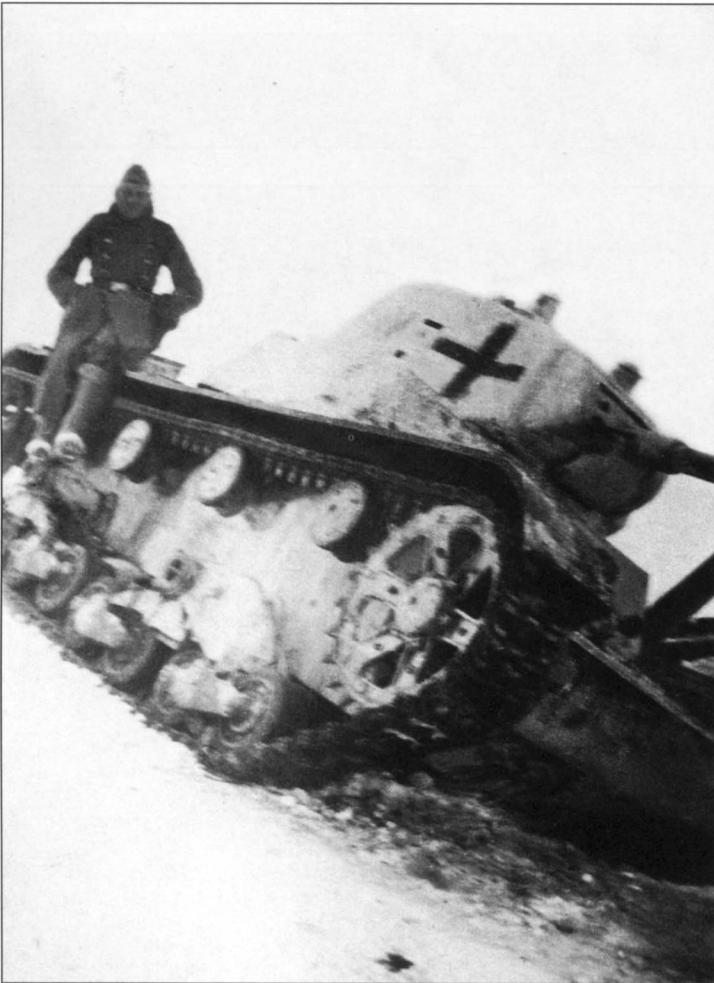
Another victim of the winter fighting — a Soviet T-26 Model 1939 captured by the Germans and then abandoned during a march due to mechanical breakdown or bad weather. The tank wears a solid coat of white camouflage and the black national cross on the front part of the turret. A similar cross was probably applied to the rear, too. Note that the tank has no additional markings. This may indicate that it was a supplementary tank in a unit.

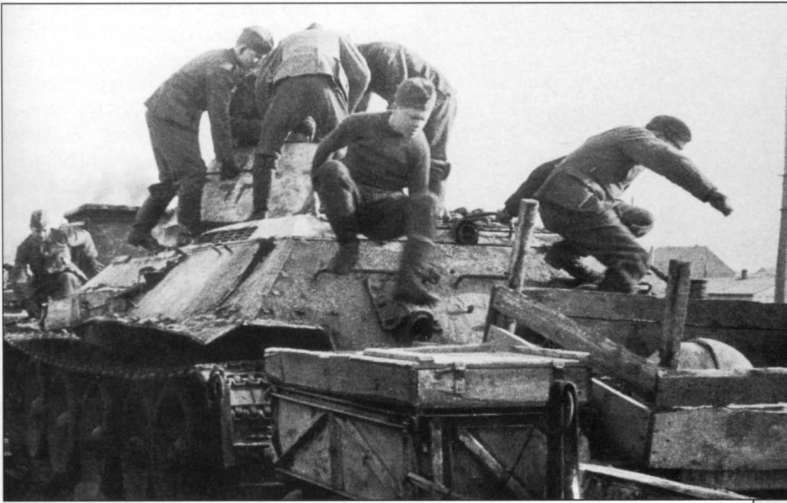
A captured T-34 tank is ready for transport by rail to the rear. The tank, which is from a pre-winter 1941 series, is covered with a thin coat of whitewash and has the German black national cross on the turret. The soldiers of the Panzerwaffe greatly appreciated the T-34, mainly due to its simplicity and good maneuverability. Therefore, this tank saw service in many German armored and anti-tank units.

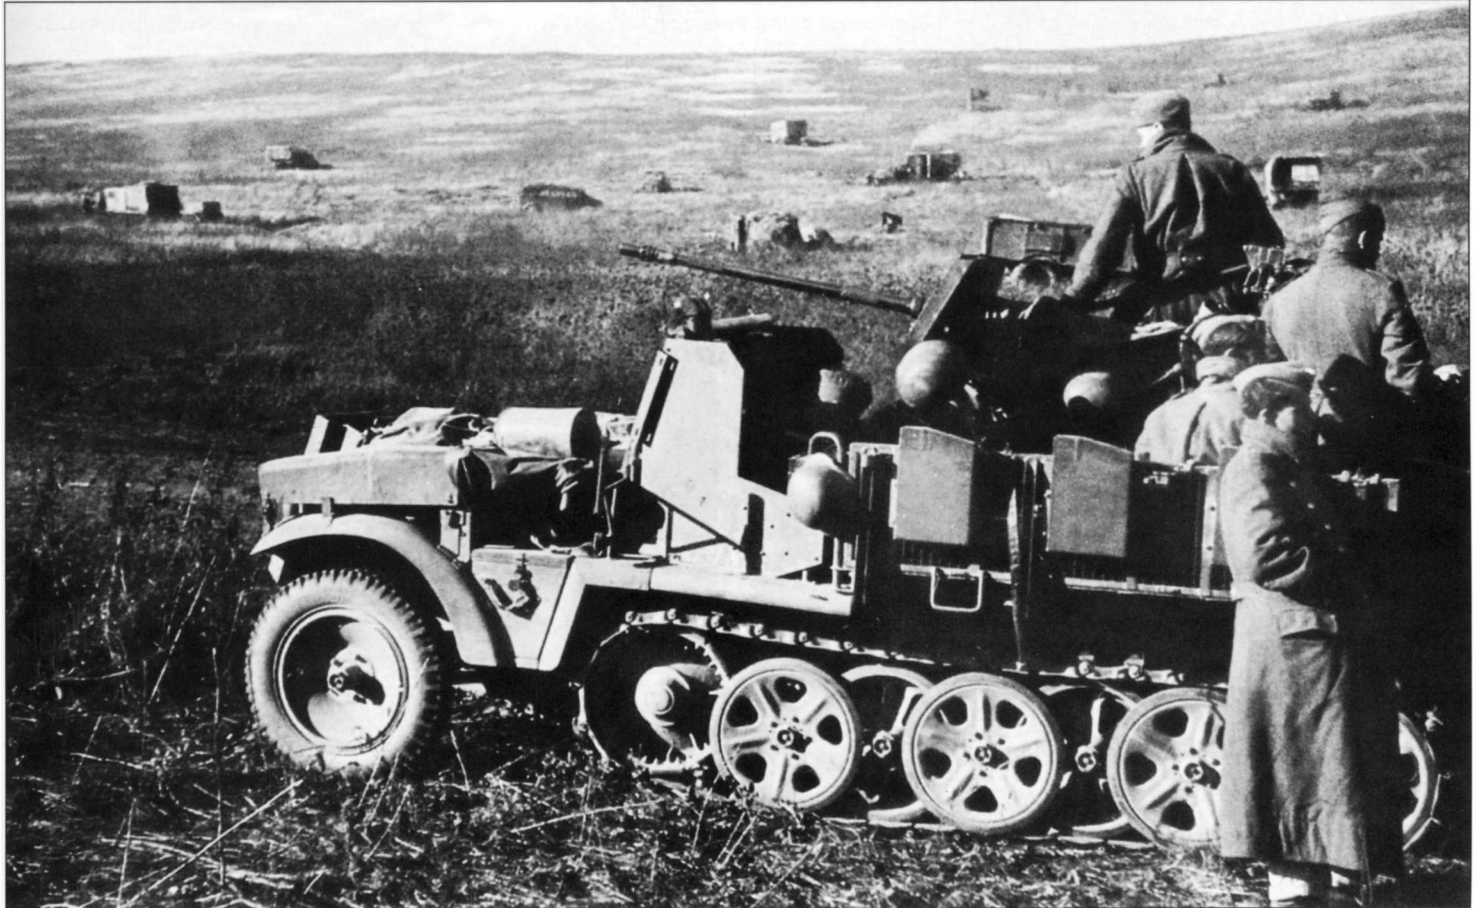
A Sd.Kfz. 10/4 with a partially armored cab and armored shield in front of the engine guards a unit's assembly area on the eastern Ukrainian steppes in the early spring of 1942. Note the binocular-type telescope installed in the driver position — a very rare piece of equipment for such vehicles, especially in this location.

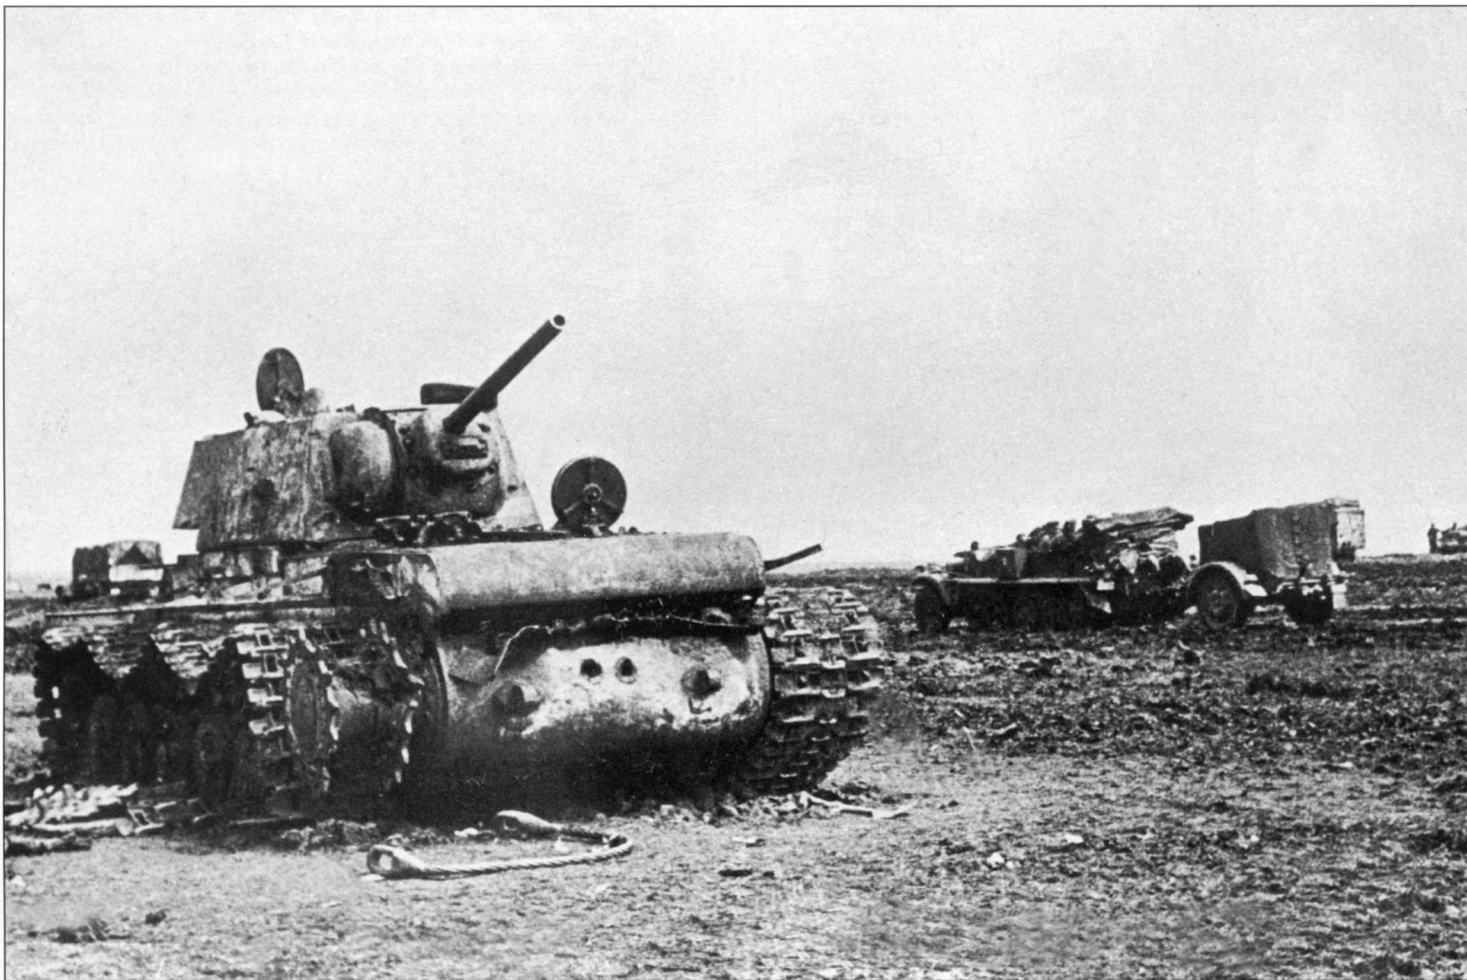
A Soviet KV-1 heavy tank demolished by German 8.8cm rounds during the spring battles. Two of the hits received by the tank are clearly visible on the rear plate of the hull. There are three other hits visible, including one on the side of the turret and two near the gun mantlet.

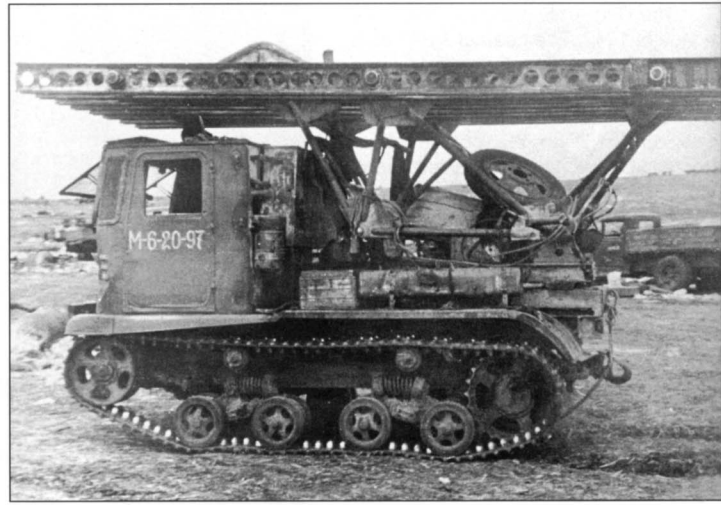
One of the rarer vehicles — the BM-13-16 missile launcher installed on the STZ-5 tractor chassis. The "Stalin organ", which was usually installed on a truck chassis or obsolete combat vehicle, could launch 82mm (M-8) or 132mm (M-13) missiles with, respectively, 3-kg and 18.5-kg warheads at ranges of 5.5 km (3.4 miles) and 8.5 km (5.3 miles). This vehicle was captured by the Germans when they eliminated the Soviet troops in the deadly cauldron east of Kharkov. It may belong to the 206th or 110th Independent Guards Rocket Squadron. Note the unit markings painted on the door of the cab.

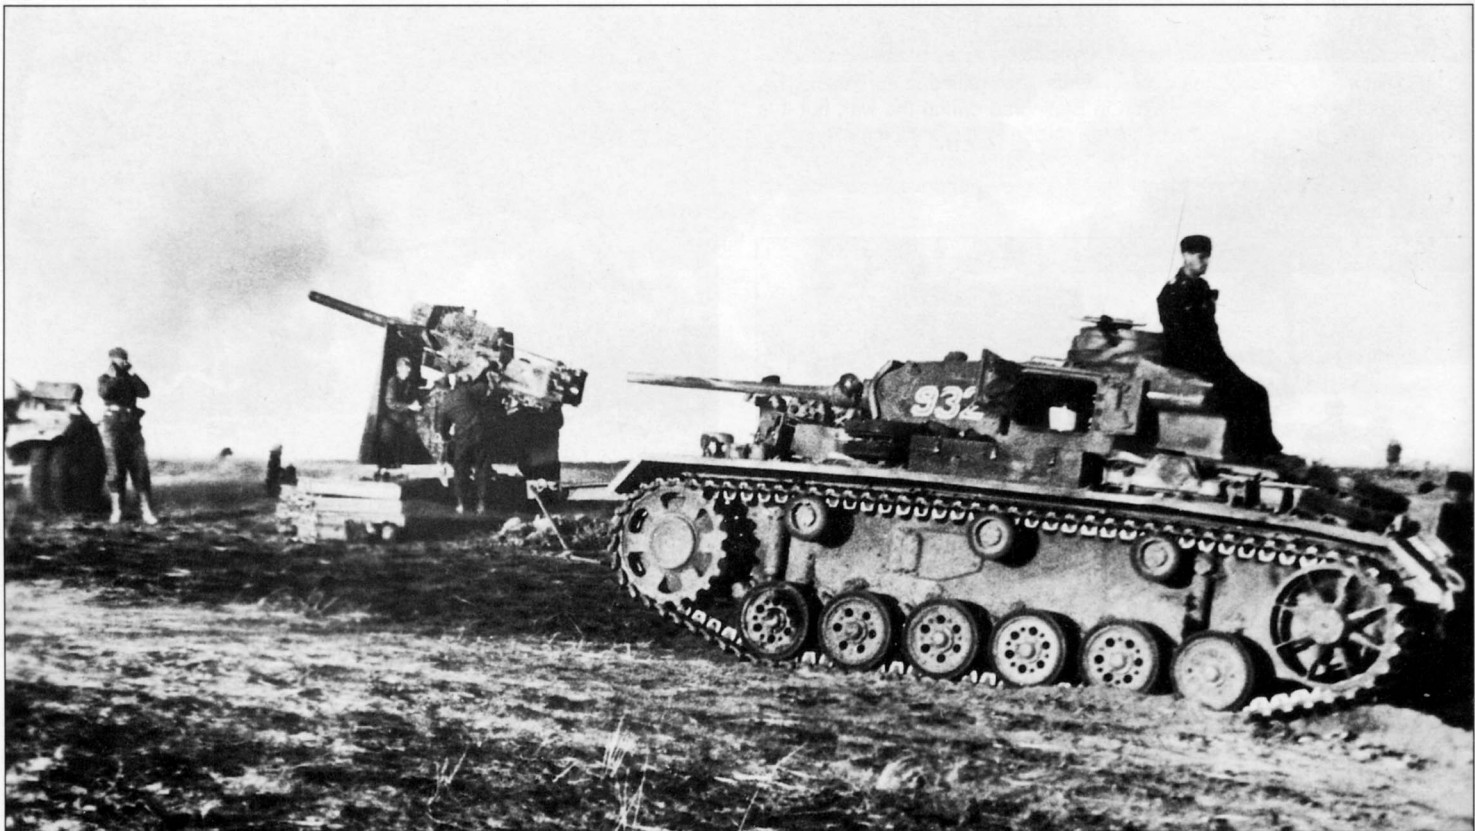
When enemy counterattacks were too strong, the 8.8cm batteries replaced tanks at the first line of defense, repelling all of the Red Army's tank assaults. This photo shows a weak German tank unit being supported by Flak 36/37 guns. Note that the Pz.Kpfw. III is camouflaged with a green pattern (most clearly visible on the commander's cupola) supplemented with a few patches of dark yellow color (note the gun barrel, jack and signal light on the front part of the mudguard).

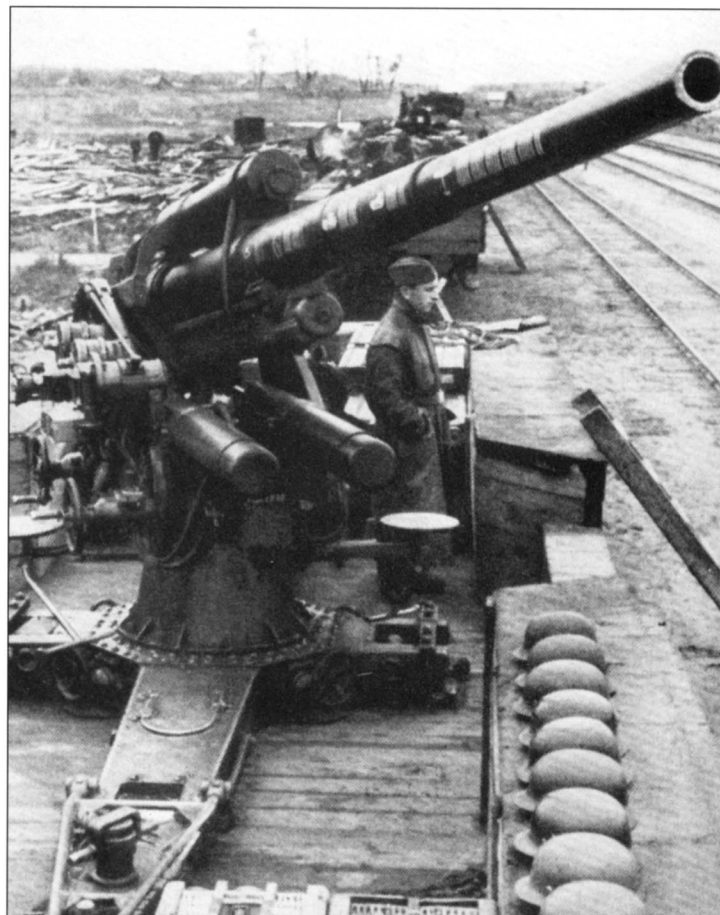
The front-line units equipped with 8.8cm guns and supported by "Flak trains" could often inflict tremendous losses on the Soviet troops. The longer range of the 8.8cm guns was especially useful on the wide, flat steppes. Here we have a shot of a railway flatbed acting as a Flak platform. The low walls were originally designed as a cover for the gun crews. The markings on the gun barrel indicate the victories achieved by this gun: 22 aircraft shot down, 17 tanks of two different types destroyed, 11 infantry attacks repulsed (marked with German Infanteristurmabzeichen, or infantry assault badges) and 6-7 strong-points destroyed.

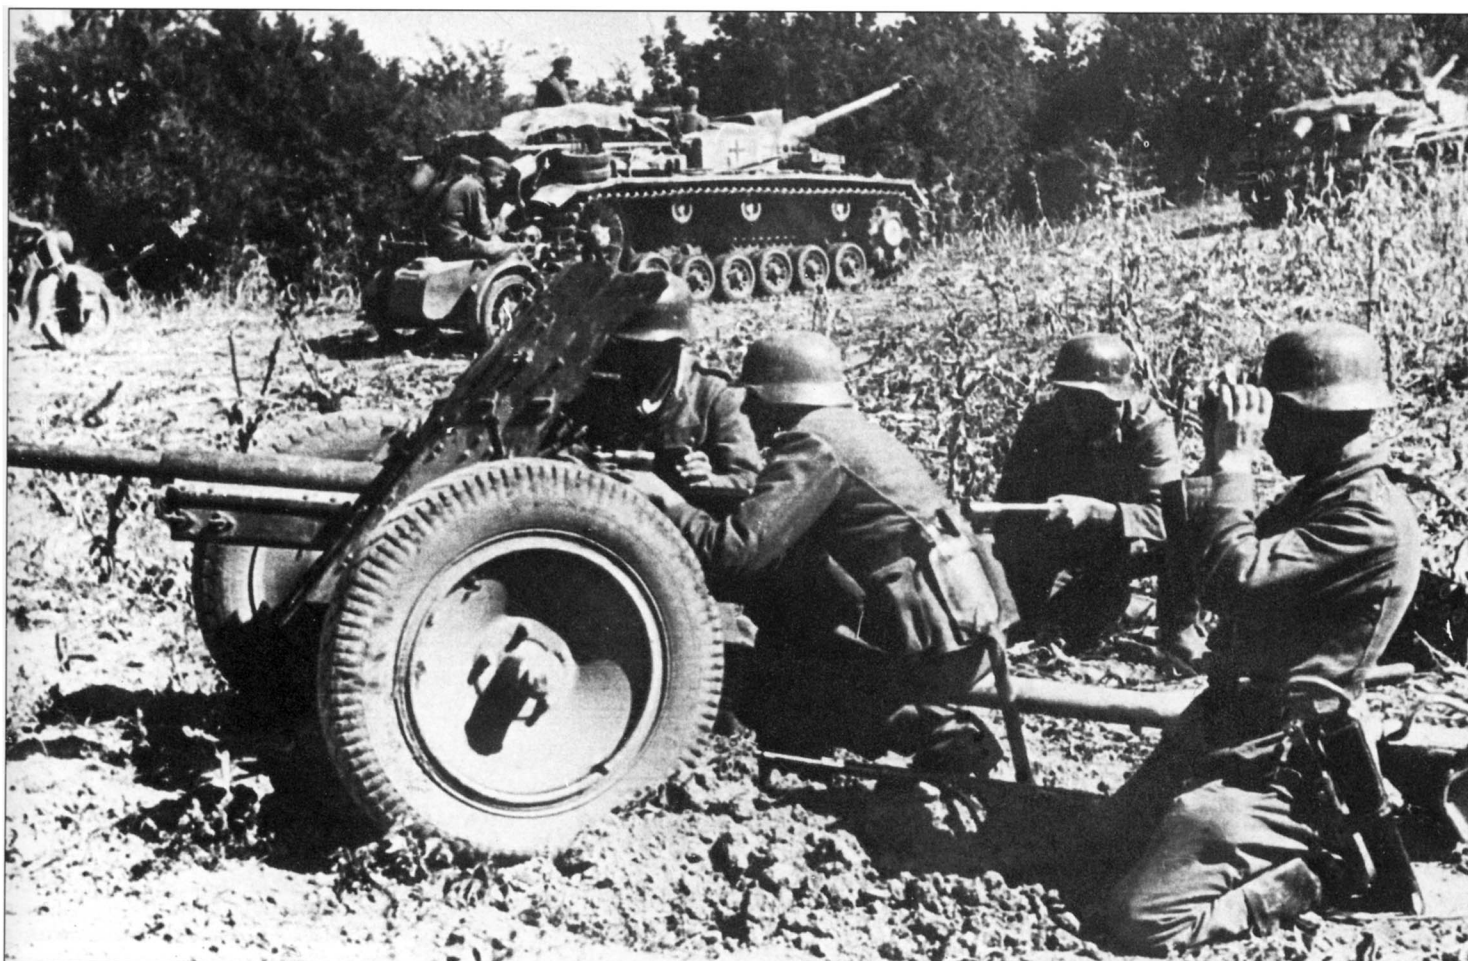
A PAK 36 anti-tank gun combat station covers a road occupied by a StuG.Abt. equipped with StuG III Ausf. F/8. The StuG seen in the center of the photo features the non-standard markings used by this unit for vehicle identification. Usually StuGs carried number codes, but this StuG wears the white letter "F".

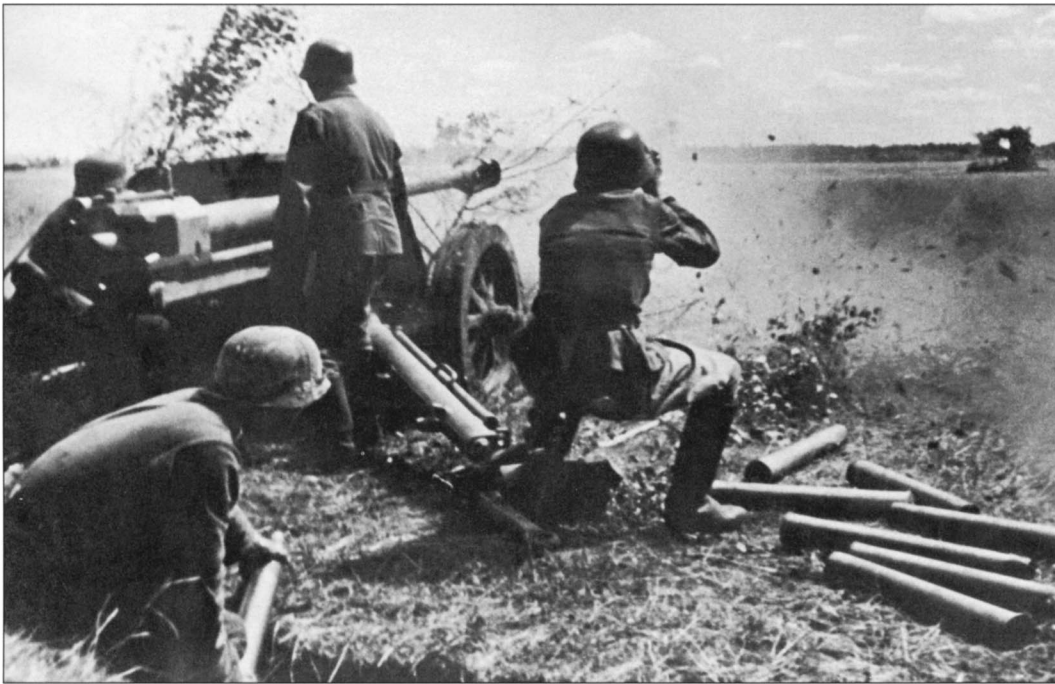
The target practice of a PAK 40 crew was captured on film just after a round was fired into an abandoned T-34 tank, the target of choice for the exercises. The range of this shot was about 500 meters (546 yards). At that distance any Soviet tank would be helpless against the powerful armor piercing rounds fired by the PAK 40.
