Armor Battles on the Eastern Front

(1) The German High Tide 1941-1942

Robert Michulec

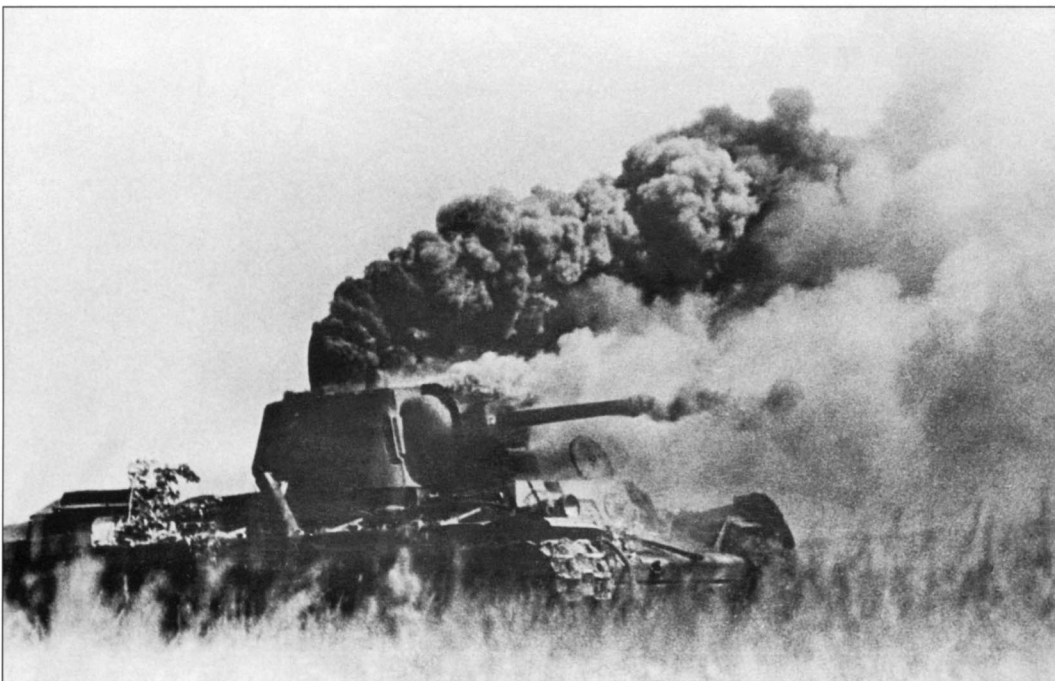
Billows of smoke pour from another KV-1 after taking a direct hit from an anti-tank gun. The engines of the Soviet main tanks were propelled by oil, so the fires spread more slowly at first than in an M4 Sherman, for example, which would be consumed by flames within minutes. However, when the fire warmed up the oil, Soviet tanks burned long and intensively, and the possibility of extinguishing the fire was smaller than with tanks with fuel engines.

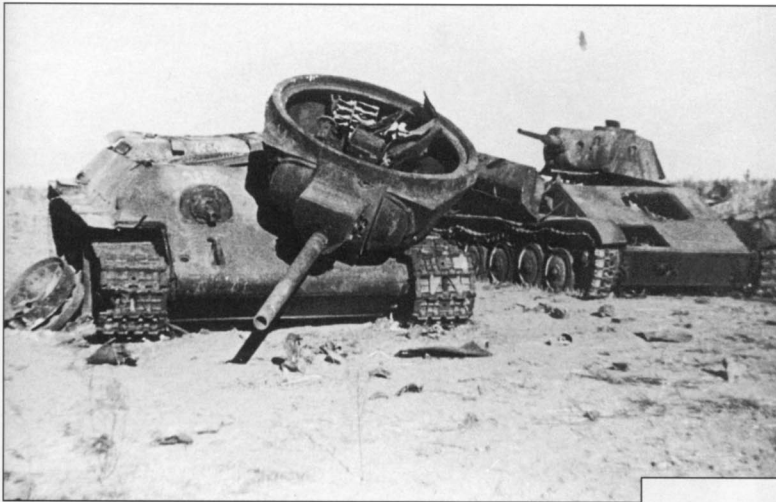
Two more Soviet tanks demolished by German anti-tank rounds. At left is a T-34 with a torn-off turret; at right is a T-70 whose superstructure is ruptured. In those days Soviet tank units had limited chances for success due to the lack of radio, good tactics and knowledge of co-operation with other sorts of weapons — they could only charge straight into enemy guns until the last tank was

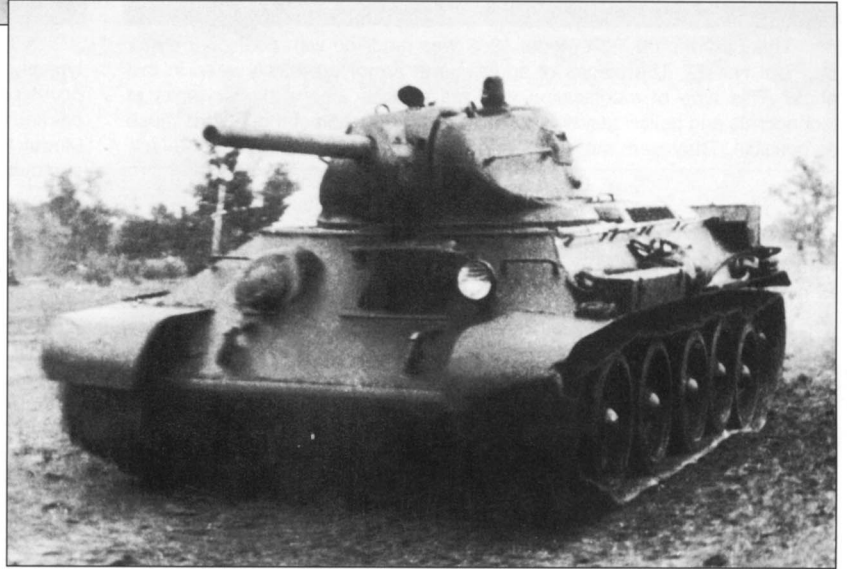
Prior to the winter of 1942, the main version of the T-34 in Soviet tank units was the Model 1942 with the old type of turret and often featuring additional fuel tanks. There were still Model 1941 tanks in service, but few of them were involved in front-line action. The T-34 seen in this photo was built (or repaired, or even re-built) by Plant No. 112. The tank is distinctive due to its many infantry handles.

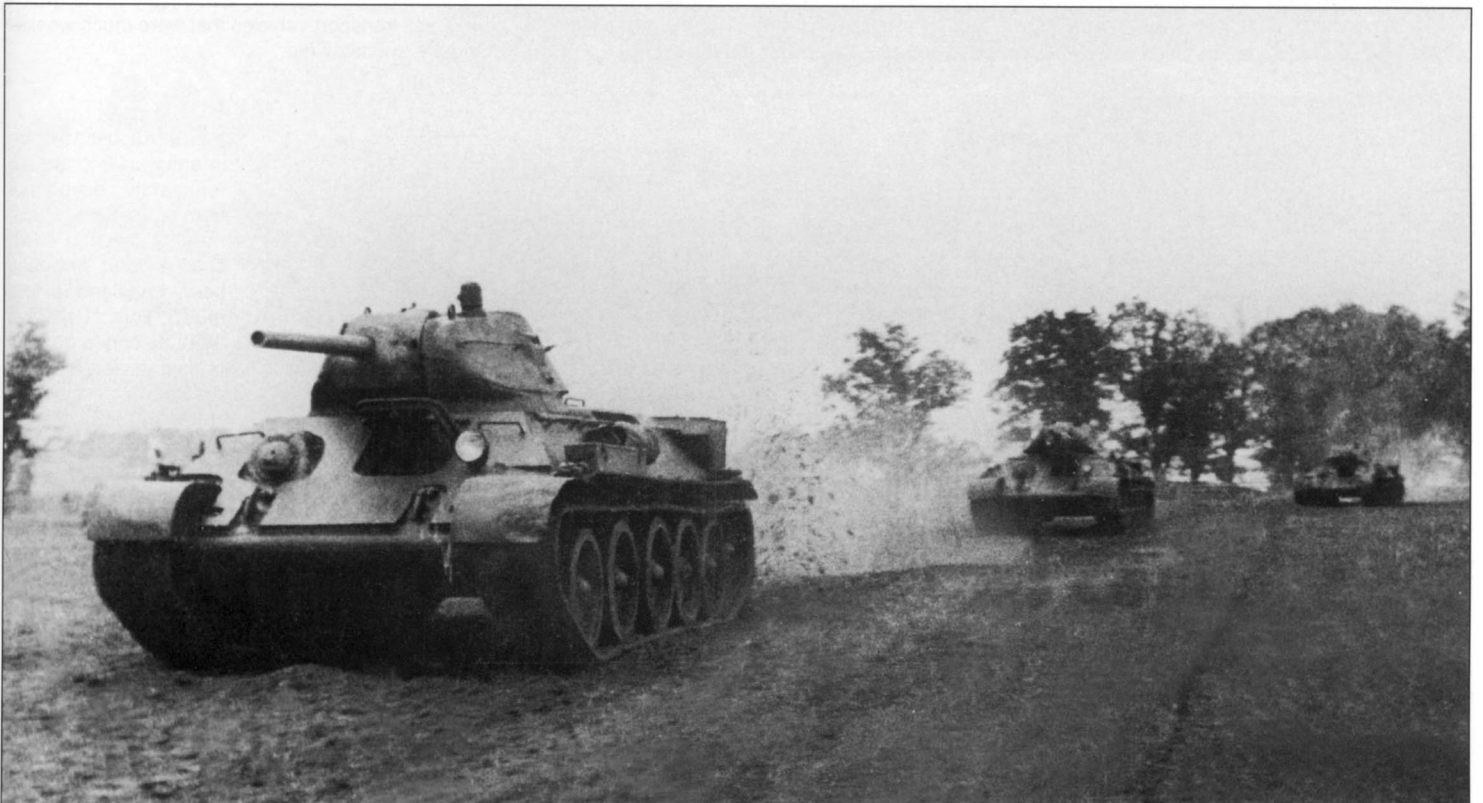
Another shot of T-34s from the same unit shows more T-34 Model 1942s produced by Plant No. 112. The lead tank has appliqué armor (about 30mm [1.25 inches] thick) welded onto the glacis front. Two factories made this modification: Plant No. 27, which produced such armor plates in 6 pieces for glacis and another for the turret, and Plant No. 112, which produced these additional plates in one piece on the glacis only.

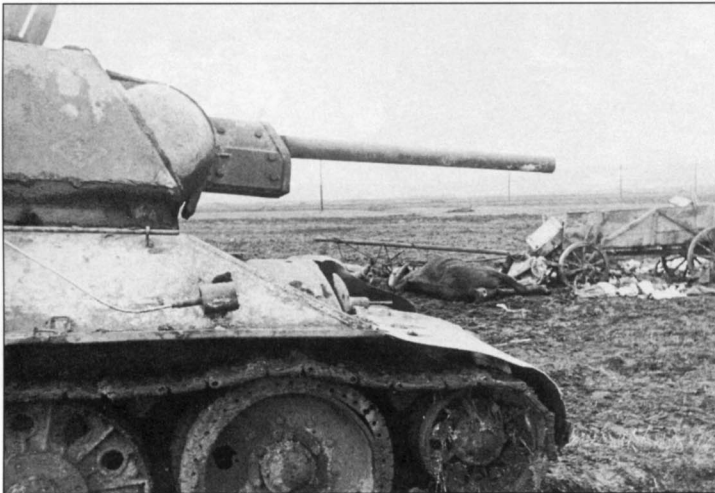
This up-armored T-34 Model 1942 was modified with additional armor by Plant No. 27. The pieces of added turret armor are easily seen in this photo. This type of modification was not popular among higher ranks of technocrats and politicians, who forced mass production of the T-34 as much as possible. They were more interested in more, rather than better, T-34s.

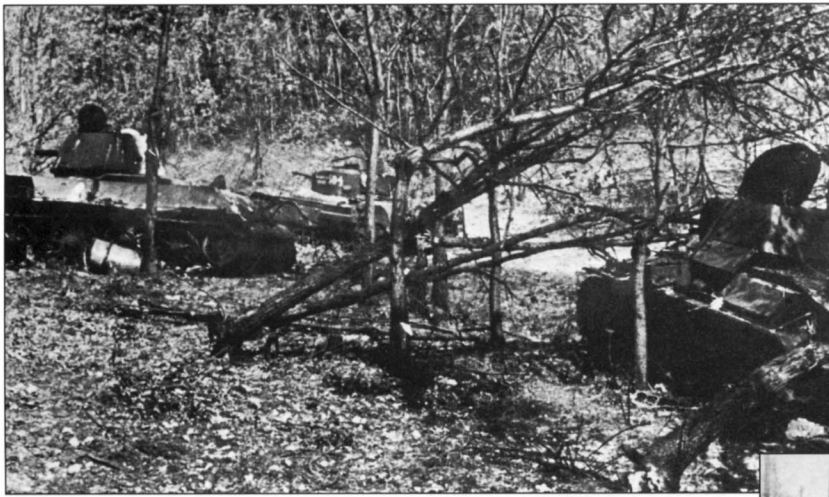
Vicious armored combat took place in the Western Front sector of the Soviet Union, where the Germans defended the front line in the Rzhev area and launched Operation "Wirbelwind" south of Vyazma. The Soviets concentrated strong armored forces in these areas. At the beginning of August the Rzhev area was attacked by 6th and 8th Tank Corps, supported by almost 15 tank brigades. During "Wirbelwind" the lead unit of the attack group, 11.Panzer-Division, was counterattacked by five armored corps. Many of these units were equipped with Lend-Lease tanks, such as the two destroyed British Valentine tanks seen in this photo.

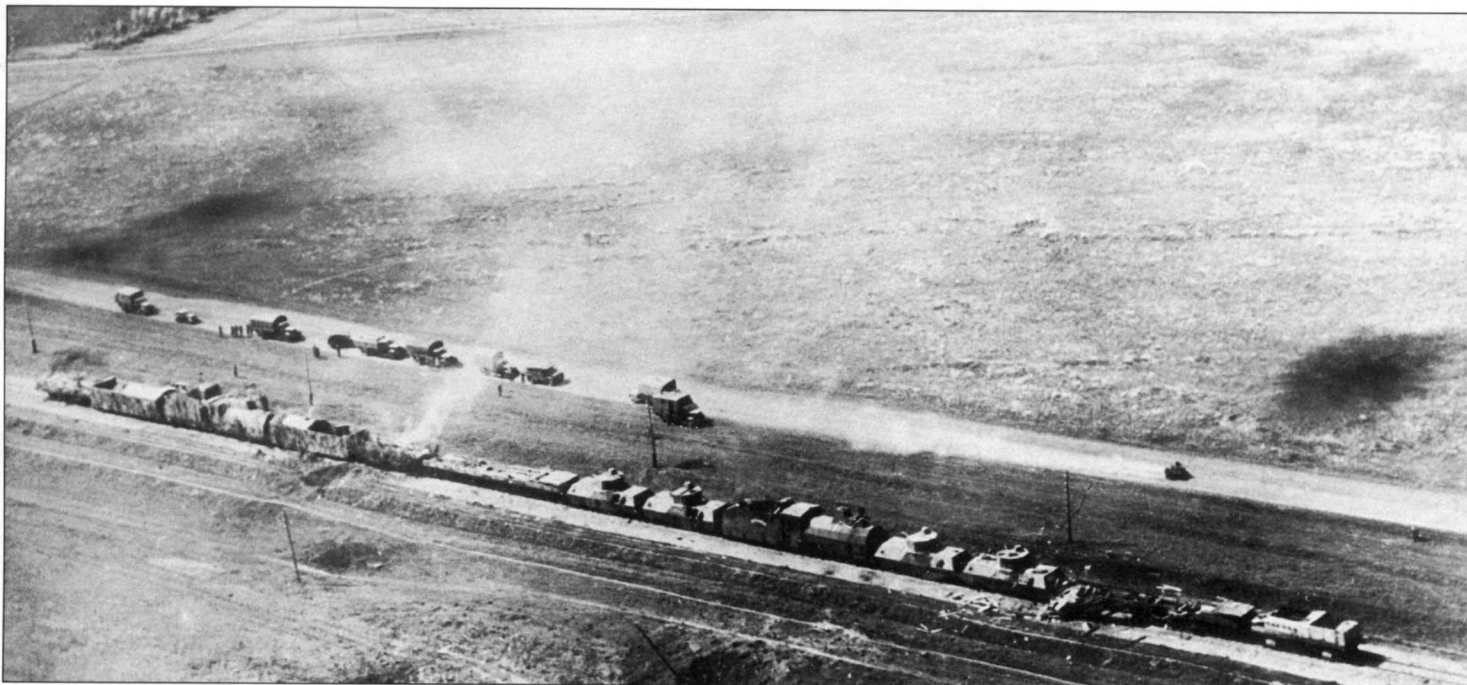
During the first one and a half months of the Stalingrad battle the Soviets employed eight armored trains, including one for anti-aircraft duty: 24th, 25th, 28th, 30th, 40th, 51st, 59th, and 377th AA. They were useful due to their impressive firepower, but they were also easy targets since the Soviets had very few railroads in this area. Here we see part of one of the armored trains produced during the first year of the war and later destroyed by the enemy. The wagon was hit by four rounds (all holes are visible under the last gun), which created an inferno inside the railway fortress. In the middle of the wagon is the turret from a T-26 tank.
