American Civil War Fortifications (1)

Coastal brick and stone forts

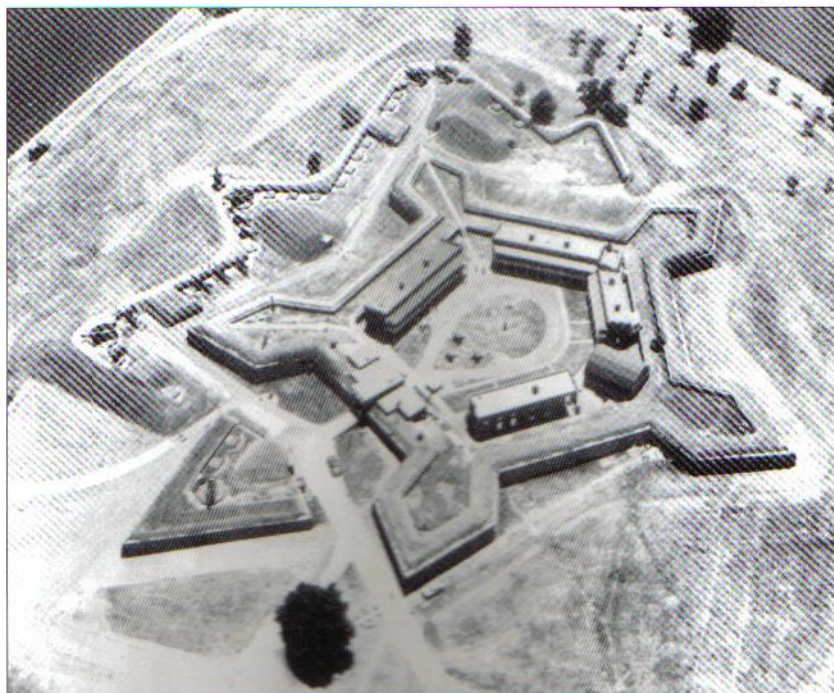
Fort McHenry was first built around 1800 to defend Baltimore Harbor, and became famous in 1813 when it resisted a furious British bombardment. The action inspired the composition of "The Star Spangled Banner." Third System-era outer works augmented the initial five-pointed Second System fortification. (Clyde Hensley Collection)

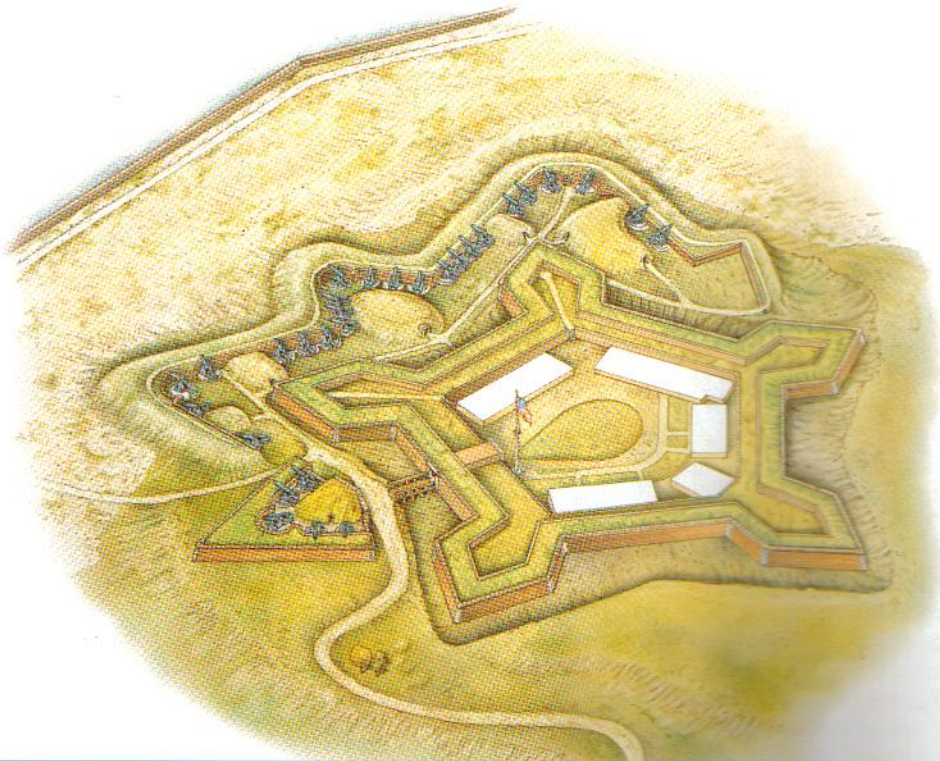
Forts Marion and McHenry

Many forts built before the Third System of fortifications was introduced were converted to conform to the latest notions of coastal defense. Fort Marion (**top**), at St. Augustine, Florida was the oldest example of these refurbished coastal fortifications. Built as the Castillo de San Marcos by the Spanish in 1672, the fort was built along classical Vauban lines, and the modernization as limited to the addition of outer works, and the emplacement of more modern guns. Similarly Fort McHenry (**bottom**) played a major part in the War of 1812, and was then brought up to date in the same manner during the mid-19th century.

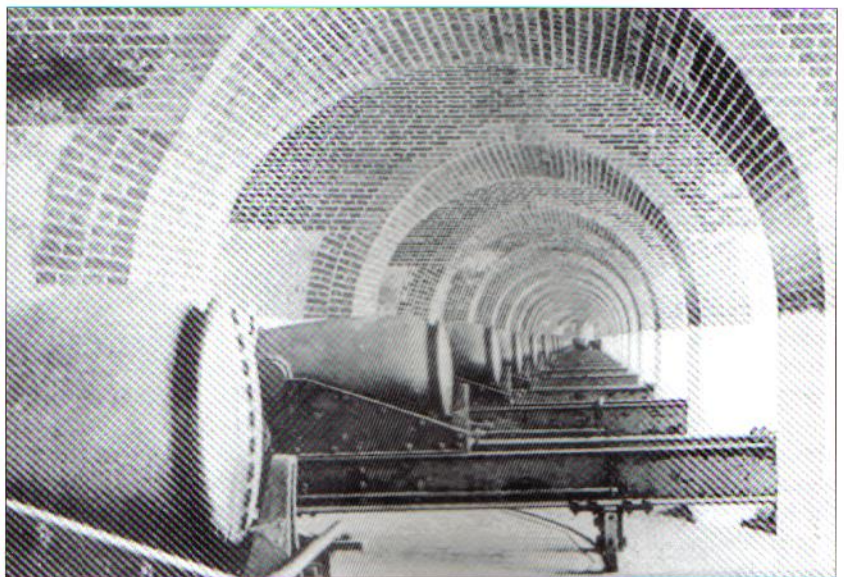
Smoothbore columbiad pieces mounted on iron casemate carriages in the water battery of Fort Monroe, Virginia, photographed shortly after the Civil War. Note the unusual color scheme of the fort, where the lower casemate walls have been painted white. (Estate of Wright Langley)

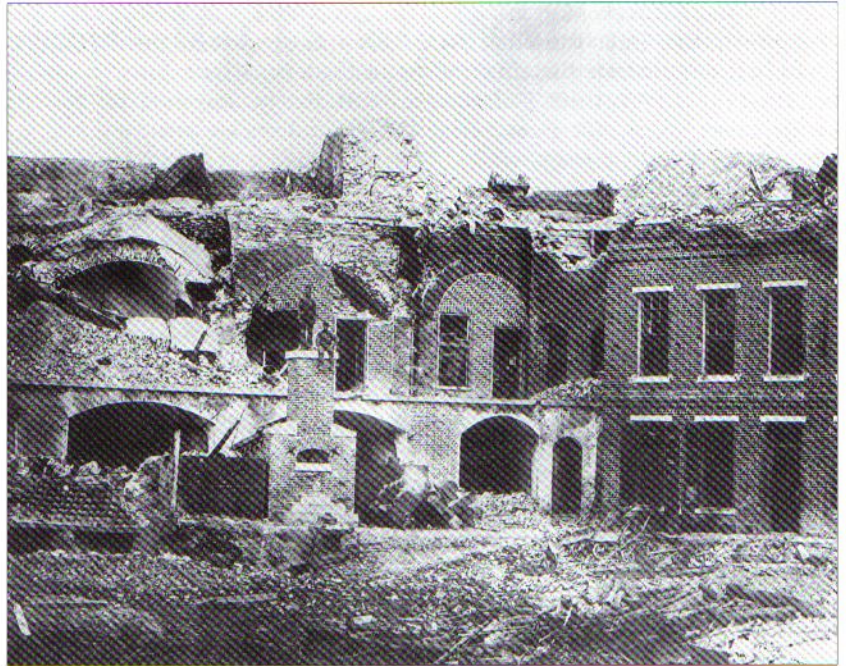
The interior of Fort Sumter photographed in September 1863. The hot-shot furnace appears undamaged, but the northeastern casemate wall and the casemate wall above it have suffered extensive damage. (Clyde Hensley Collection)
