# Fortresses of the Peninsular War 1808–14

Ian Fletcher • Illustrated by Chris Taylor

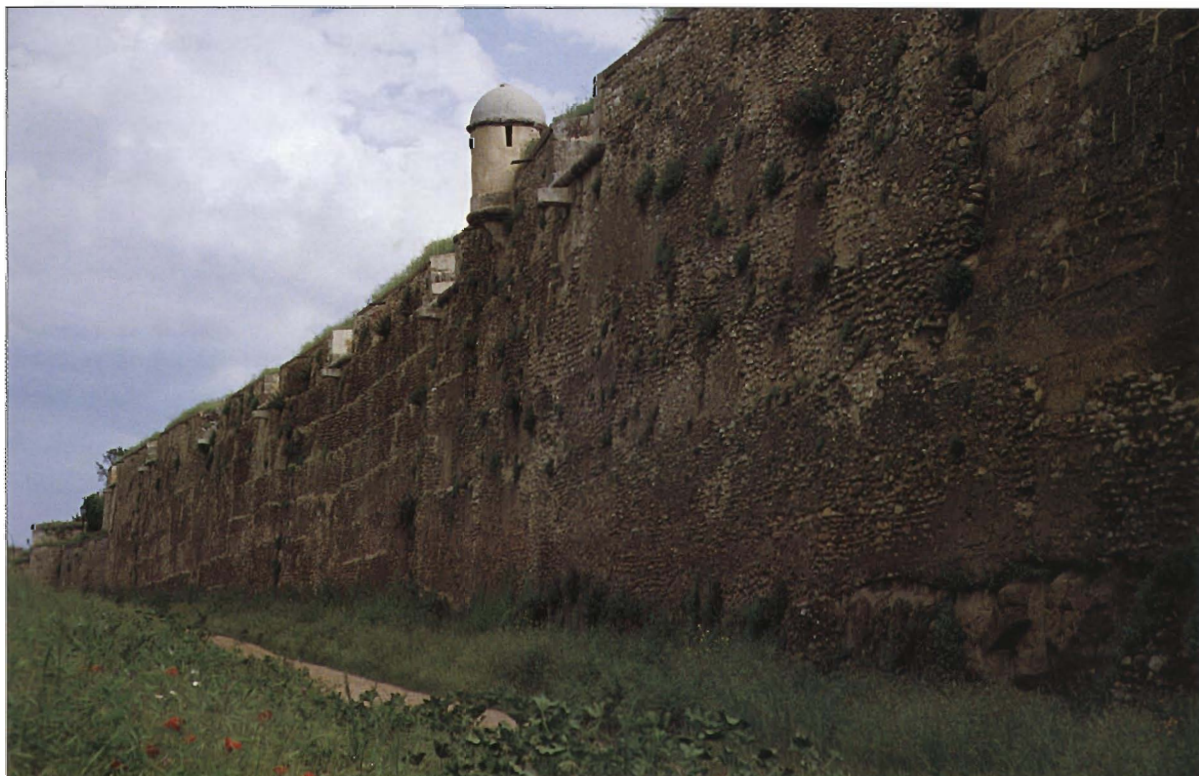
The flat, Moorish walls of Ciudad Rodrigo, as seen from within the inner ditch. Save for the introduction of embrasures for artillery these walls had remained the same for years. They provided no protection whatsoever against modern artillery. The walls were never modernised, angled or improved. Only the raising of the glacis and the building of the *faussebraie* gave the town any degree of protection during the Peninsular War.

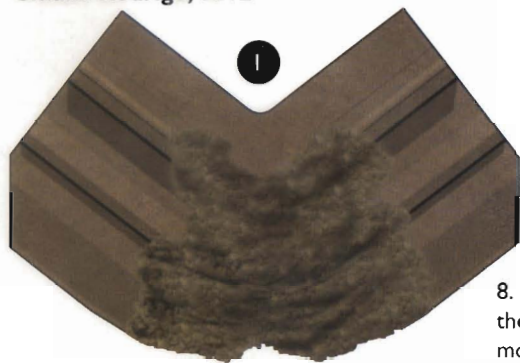
1. A plan view of the Great Breach. The Breach was stormed by the 3rd Division, many of whom were killed when the French detonated a huge mine beneath it.

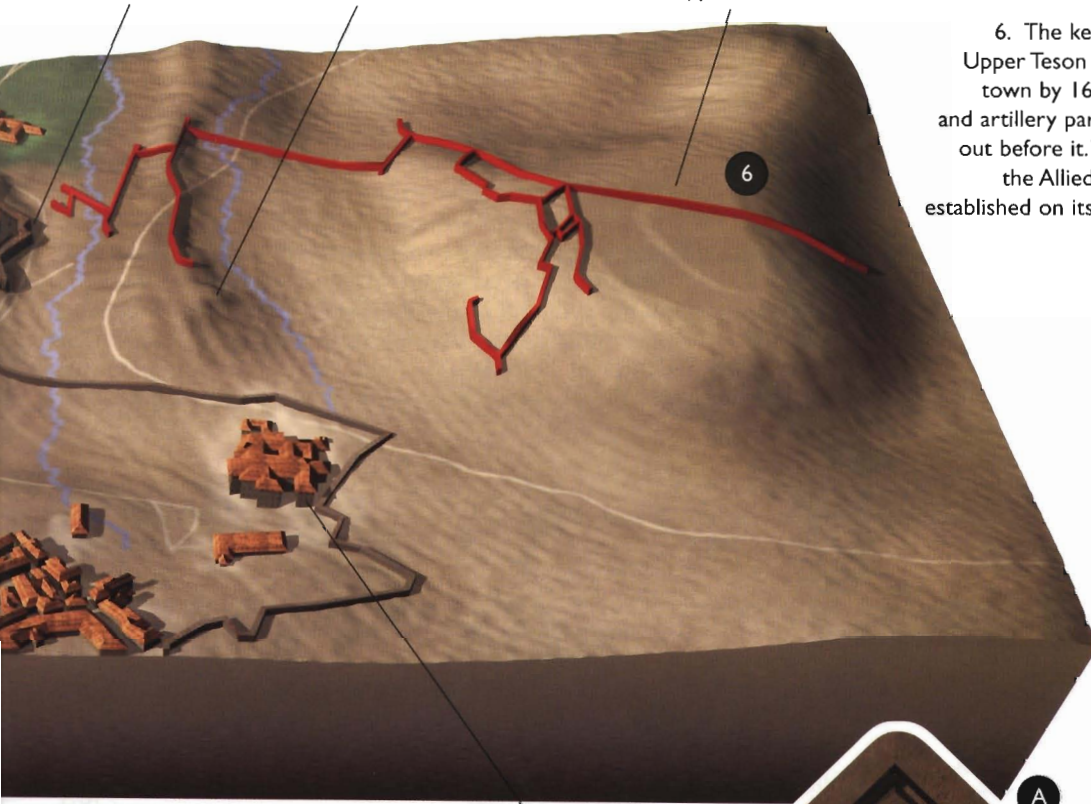
6. The key ground of the Upper Teson overlooked the town by 16ft. The engineer and artillery parapets were laid out before it. The majority of the Allied batteries were established on its forward slope.

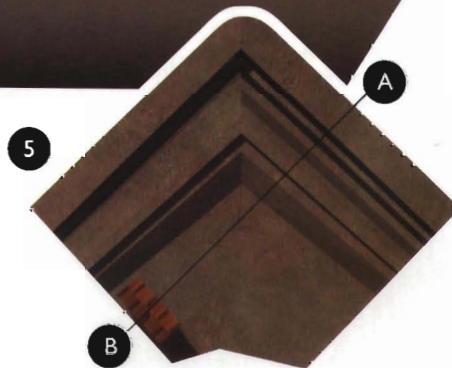
5

5. A plan view of the Renault redoubt, situated on the forward slope of the Upper Teson, though it did little to deny Wellington access to this feature.

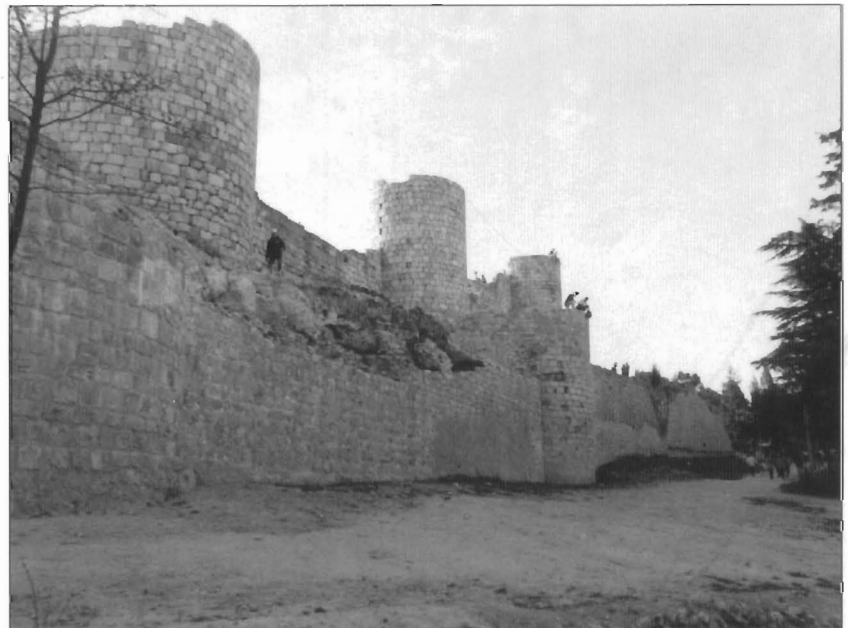
The strong walls of the eastern side of the castle of Burgos are pictured here. No attacks were made against this section of the walls.

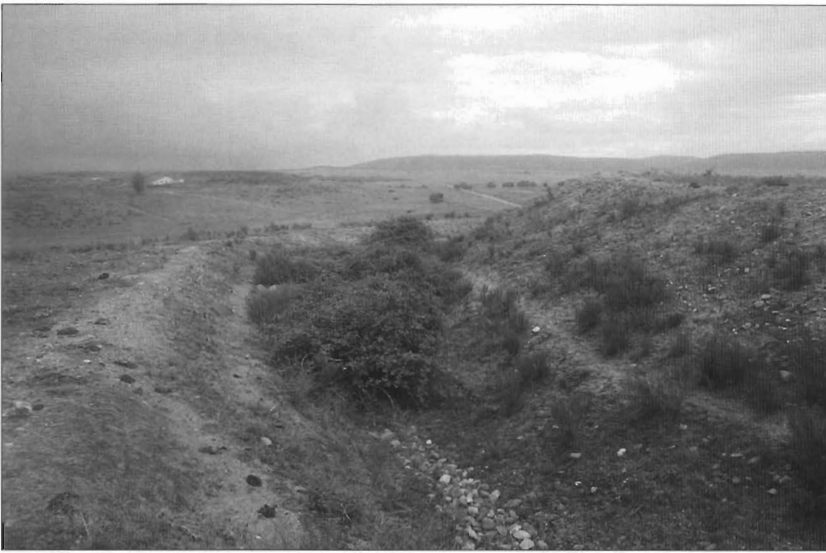
The deep ditch of the northernmost fort on the Upper Teson, at Ciudad Rodrigo. The ditch here is about 30ft deep.

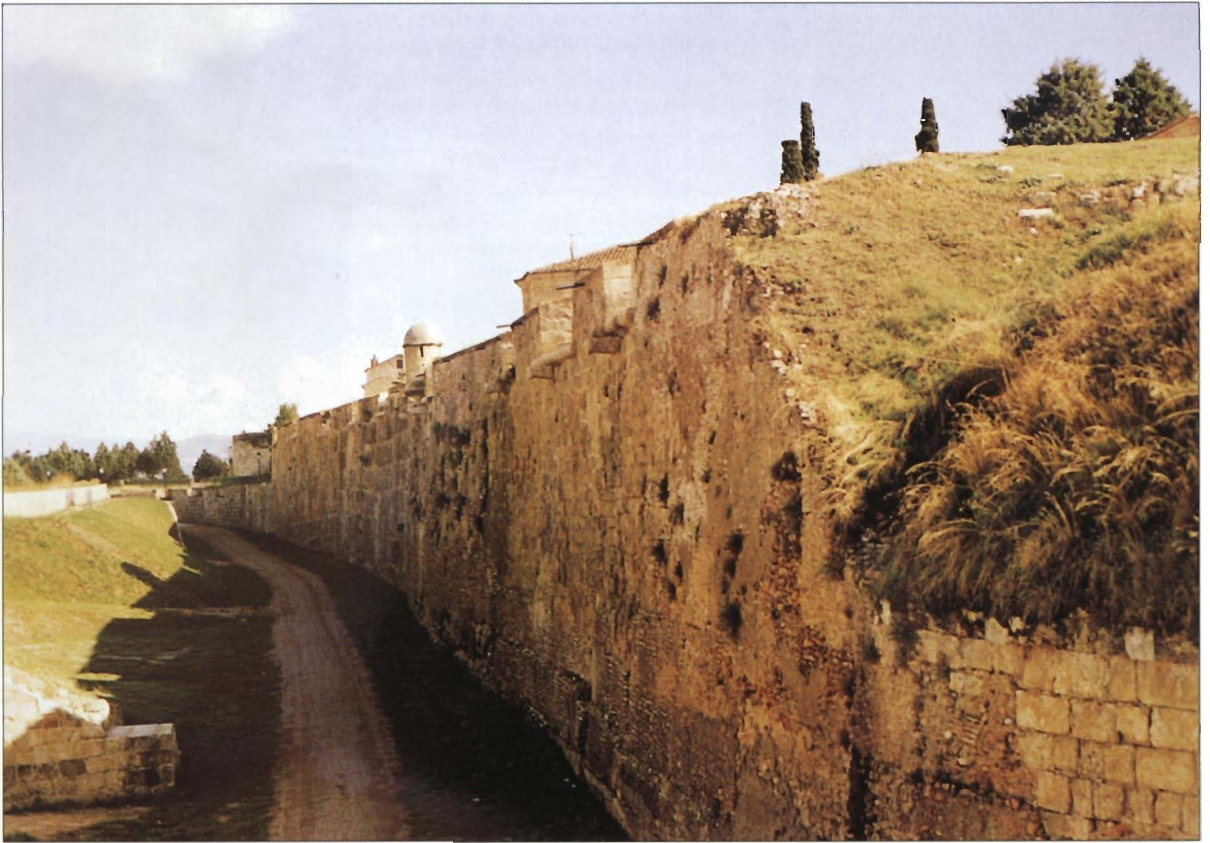
The site of the Great Breach at Ciudad Rodrigo, with the actual breach at the right-hand edge of this photo. The flat walls illustrate perfectly just how easy it was to shoot down the entire length of the ditch. However, the walls afforded little protection against artillery fire. There are no ravelins or bastions, only a *faussebraie* to protect the walls.

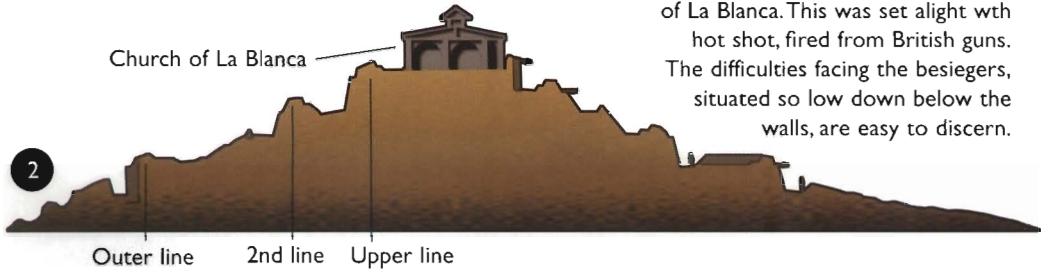
2. A cross-section through the church of La Blanca. This was set alight with hot shot, fired from British guns. The difficulties facing the besiegers, situated so low down below the walls, are easy to discern.

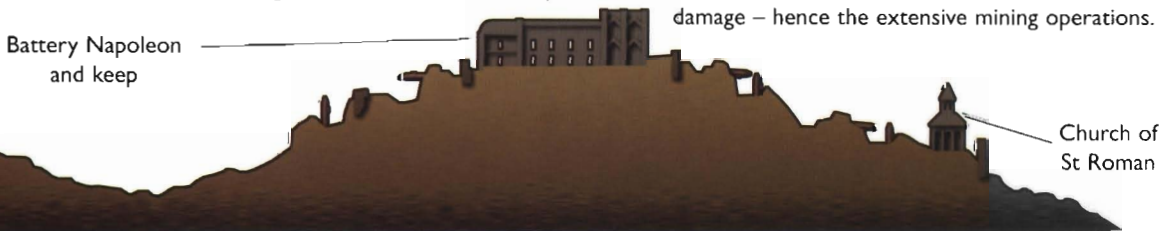
3. This cross-section best illustrates the problems facing Wellington's artillery. Not only were the guns too few in number, they were sited far too low to cause the walls of the castle much damage – hence the extensive mining operations.

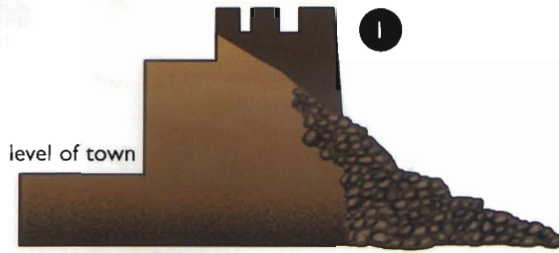
1. A section through the breach in the tower at the right-hand end of the curtain wall (see main illustration for location).

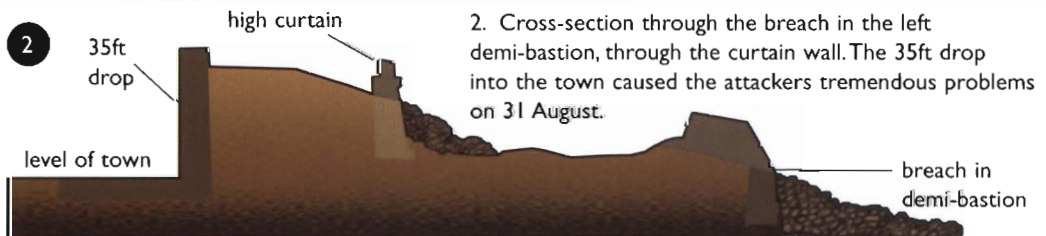
2. Cross-section through the breach in the left demi-bastion, through the curtain wall. The 35ft drop into the town caused the attackers tremendous problems on 31 August.
